STRENGTHENING OF THE TIMBER ROOF OF THE SECOND TURKISH NATIONAL ASSEMBLY BUILDING IN ANKARA

S. Toker Beeson¹, E. Ozkan Yazgan², and A. I. Unay²

Keywords: Timber roofs, Strengthening of historical buildings, Steel trusses in strengthening.

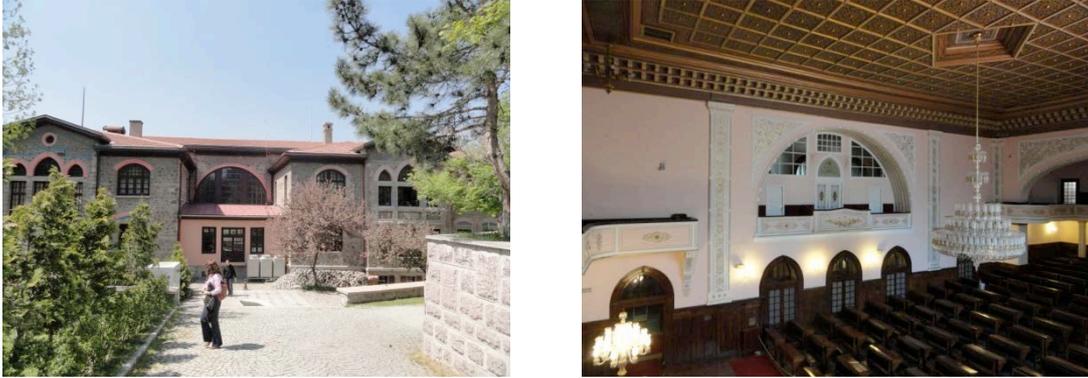
Figure 2: Arch-shaped opening on the east and west wing walls.

No other significant structural problems were observed in the Main Hall during the visual inspections in its current condition. However, the load bearing walls supporting the suspended ceiling would pose a serious threat in an earthquake due to the discontinuity because of the arch shaped openings at the eastern and western wings.

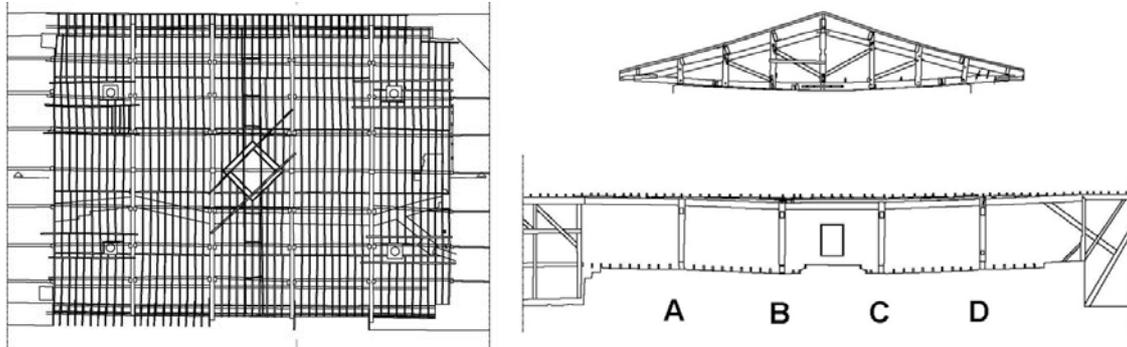
Figure 4: Plan and sections of the suspended truss over the General Assembly Hall [6].

In the analyses, the largest vertical displacement in the roof structure was calculated as 18.63 mm at the mid-span of the trusses at rows B and C in the sections in Figure 4. However, according to the laser scanner measurements, the largest vertical displacement value on the ceiling at the same location is 140 mm. There might be several reasons for the excessive deflection at the ceiling of the Main Hall. A detailed research such as material's chemical properties and detecting the deterioration at the connection points is necessary to find the reasons for this deflection. Obtaining similar vertical displacements at similar locations, on the other hand, have been considered of significance in understanding the behavior of the roof structure when the analyses were performed according to the original geometric dimensions, disregarding the subsequently developed excessive deflection in the ceiling.

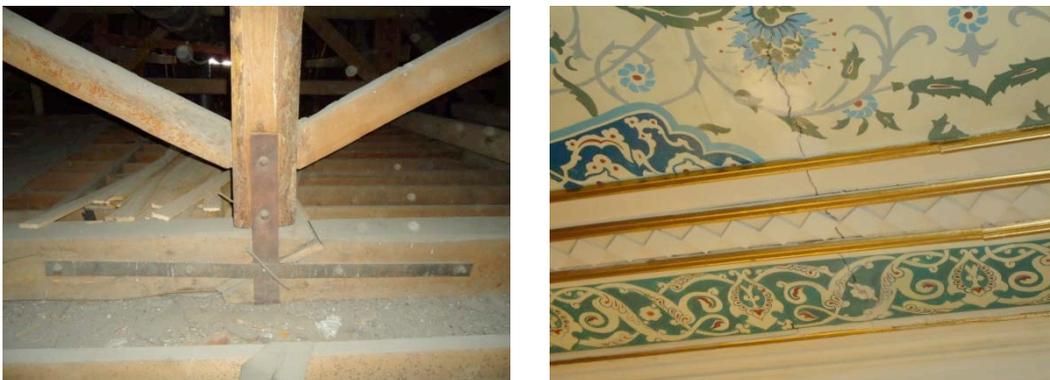
The excessive deflection and vertical displacements in the transverse direction of the General Assembly Hall's ceiling are clearly visible even to the naked eye. The suspended trusses at the roof are in good condition in terms of physical and chemical material properties. However, the working mechanism of the trusses is dubious due to the connection details and the geometrical layout of the members. As it can be seen in Figure 5, the connection between the post in the middle of the trusses and the tension members underneath is provided by only a simple metal plate.

The most significant structural issues on the ceiling are the visible deflections and occasional cracks. The concern about keeping the historical and artistic value of the original ornaments that cover the entire ceiling makes it almost impossible to remove the ceiling deck tied on the timber beam, as it would be seen in the Figure 5.

Figure 5: Suspended trusses and cracks in ornamented ceiling plate.

According to the proposed strengthening project, the original trusses will be reinforced by using additional steel trusses. These steel trusses will be clamped to the wooden beams that support the ceiling with the least possible damage by using a special system that will provide false cambering. These adjustable steel clamps are designed with simple metal plate and bolt connection.

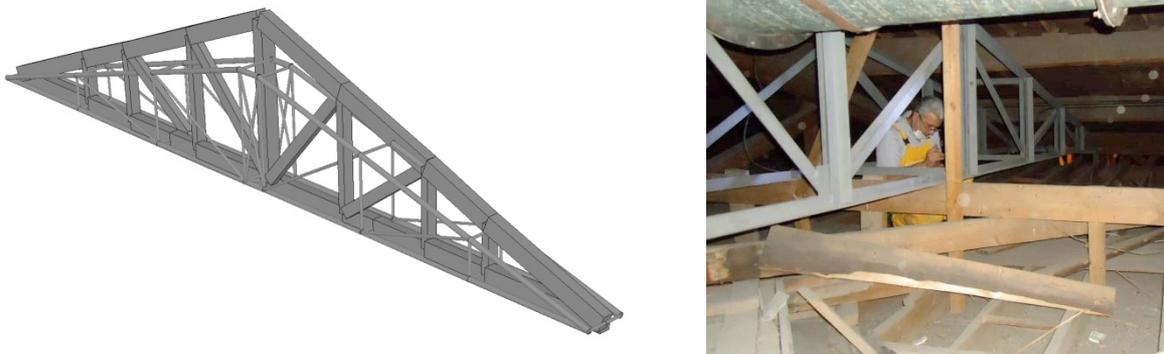
Figure 6: Additional steel trusses for strengthening of the roof structure.

Dismantling and renewing the ceiling and the trusses to resolve the vertical displacements and excessive deflection is one of the last methods due to the probable damage that would be imposed to the originality of the structure [7]. Additional steel trusses that would be placed to provide extra support around the chandelier can be seen in the Figure 6. Using similar steel trusses has been proposed to control the excessive deflection and the vertical displacement without damaging the original condition of the ceiling, which can be seen in the same figure.

- The additional steel trusses would be designed to be in contact with the existing trusses on either side only at the connection points as shown in Figure 6.
- Manufacturing the additional steel trusses out of a lightweight material would both decrease the additional forces that would be imposed on the structure and provide connection with the least possible damage to the originality of the structure. Heavy steel trusses might require drilling large holes on the ceiling. This would destroy the original value of the ceiling.
- The additional steel trusses that would symmetrically be placed on both sides of the existing trusses would be connected by means of easily assembled connection members and bolts. Hence, the original trusses would not be damaged during assembly.

- Connecting the additional steel trusses to each other by means of an easily dismantlable system perpendicular to the plane of original hanging trusses would provide general stability of the roof.
- All this assembly process could be performed without using crane or heavy equipment. Hence, the use of lightweight material becomes more crucial.
- The present deflection and vertical displacement values of the roof has been determined and recorded. If excessive deflection or displacement occurs during the assembly, instant intervention would be possible.

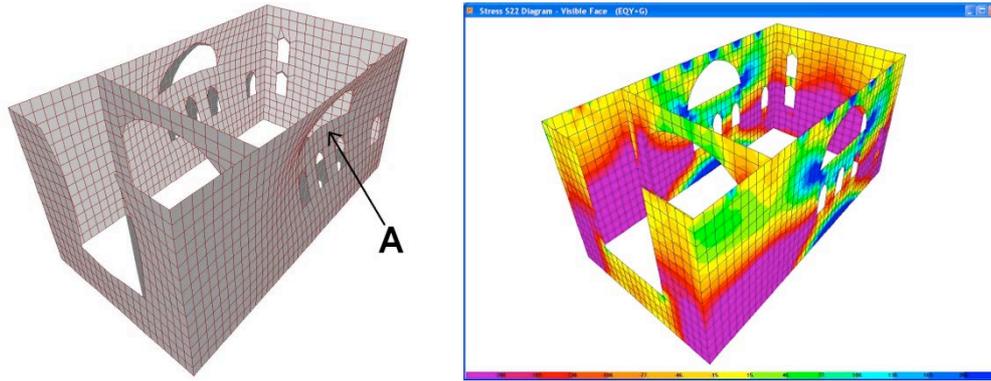
Additionally, the analyses of the General Assembly Hall under gravity and earthquake loads have been informative about the effects of the proposed additional steel trusses on the behavior and performance of the arched openings on the eastern and western wings of the structure. According to the analyses results, the vertical loads due to the additional weight of the steel trusses have not caused significant changes on the performance of the walls and the arched openings. Even though the analyses are linear static, the alterations in the stress levels are negligible.

Figure 8: Displacements and stresses on the east and west wings walls.

Using hinges on the walls to support steel trusses have lead to a serious increase in the lateral displacement near the arched openings at +5.00 m above the ground, particularly in the transverse direction due to the increase in rigidity at the ceiling level. This can be attributed to the probability that the additional steel trusses would change the dynamic behavior of the structure. Figure 8 shows the displacement under G+Ey loading. The vertical displacement at point increased to 36.90 mm ($\Delta'_y=36.90$ mm) from 26.53 mm ($\Delta_y=26.53$ mm) after strengthening. Similarly, the maximum tensile stress at point A went from 0.14 MPa ($f_A=0.14$ MPa) to 0.35 MPa ($f'_A=0.35$ MPa) after strengthening. Because the structural analyses were not performed regarding the nonlinear material properties, these values would not provide enough information for an accurate interpretation about the structural fate of the walls. However, they provide significant findings about the importance of the details of the connection and support of steel trusses on the walls.

The analyses also show that the dynamic characteristics of the structure change. This change might lead to structural problems on the walls of the eastern and western wings in a possible earthquake. In order to minimize this risk, frictionless supports have been proposed on the masonry walls to support the steel trusses that are to be added on both sides of the existing trusses.
