DAMAGE EVALUATION OF MASONRY HOUSES AFTER VAN EARTHQUAKES (23 OCTOBER 2011 AND 9 NOVEMBER 2011)

Keywords: Van Earthquake, Vernacular Masonry Buildings, Seismic performance of masonry buildings.

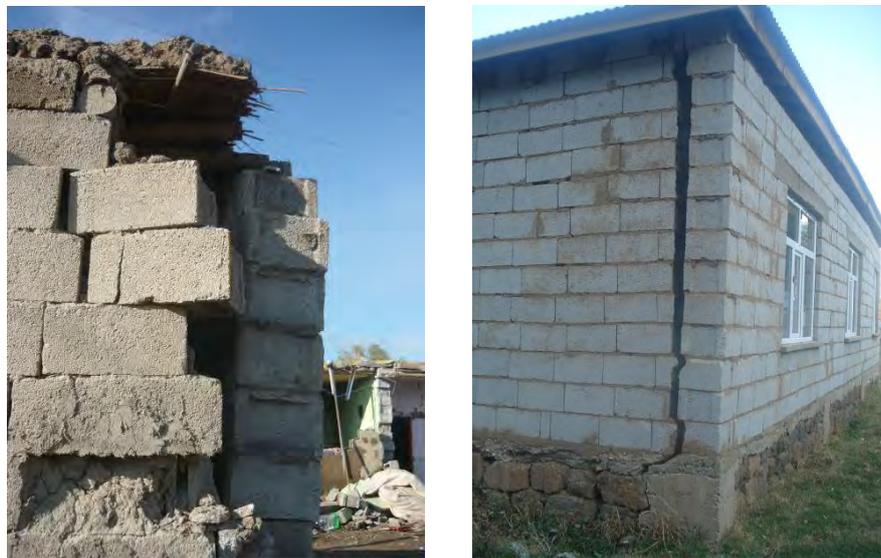
As shown in Figure 6, inadequate foundation conditions led vertical separation and local collapse of buildings. Besides, earth mortar used to connect briquettes was also another reason for damage.

Figure 6: Damaged briquette masonry building

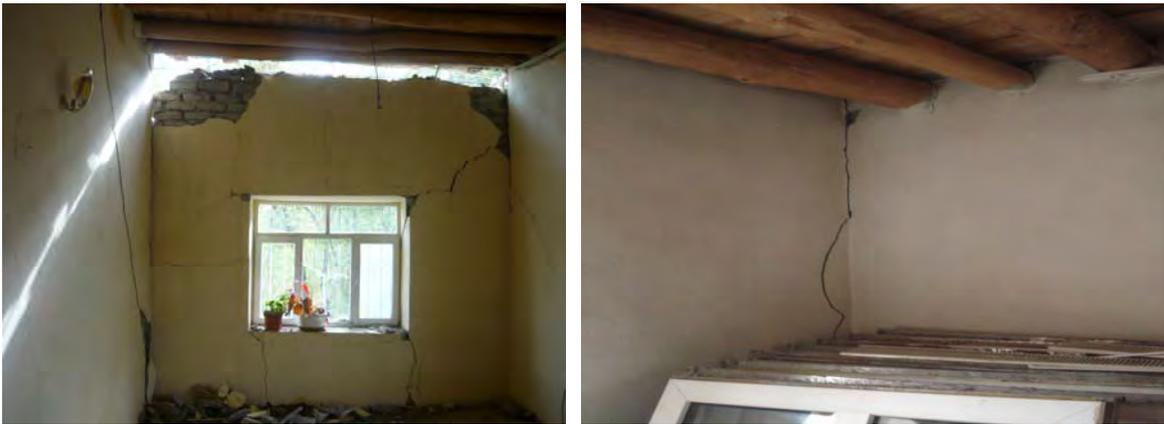
The out-of-plane motion of walls often results in horizontal cracking where the vertical location depends upon the loads induced by the weight of the wall or other tributary loads. Vertical or diagonal cracks at the wall intersections may be due to the out-of-plane motion of the walls that cause excessive bending and tension reactions at these locations. Non-load bearing walls that don't carry floor/roof joists often are the first to collapse when there is no restraint provided at the roof or floor connections (Figure 7). The bearing walls carrying the floor/roof joists may also progressively move out from under the beams and collapse, where there is no adequate connection between roof or floor beams and the wall top. The primary factors affecting the out-of-plane stability of a masonry wall during the earthquake are its absolute thickness, its slenderness ratio (height/thickness ratio), and the degree of restraints that may limit the deflection at the top and added gravity loads from roof or floor framing.

Figure 7: Damages on non-load bearing walls

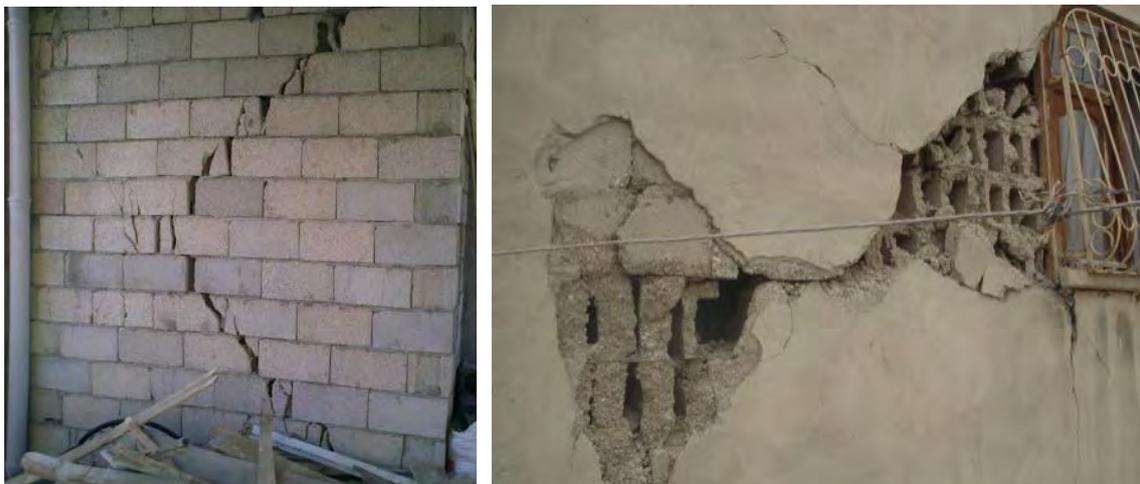
Generally in-plane earthquake forces lead diagonal cracks on masonry walls (Figure 8). When the cracks intersect each other, each wall becomes independent cracked blocks where in-plane motions and gravity loads lead the broken sections of the wall to fall out.

Figure 8: Cracks on masonry walls

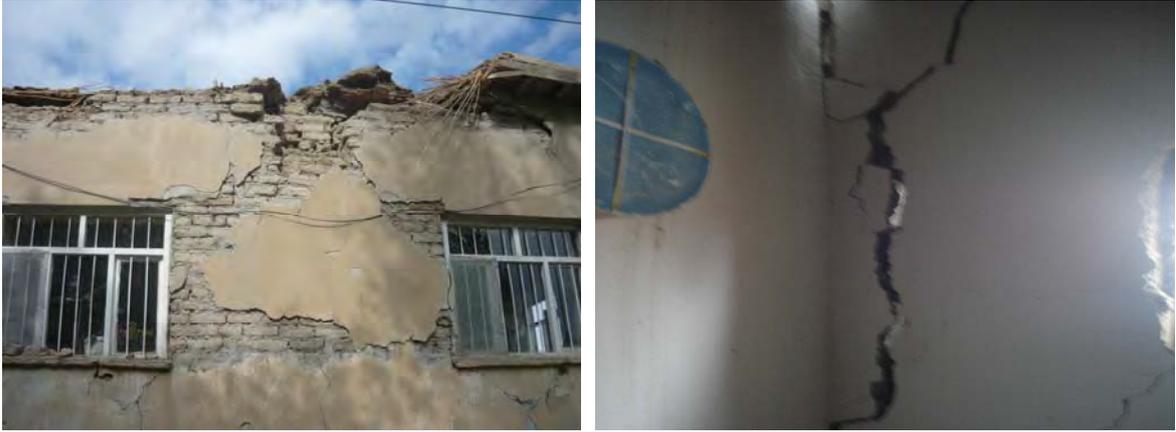
Another common reason for damages in the buildings hit by earthquake is the inadequate distance between two openings and the inadequate wall length (Figure 9). The buildings having bonding beams at the top of the walls may diminish the damage level of the wall.

Figure 9: Damage caused by distance between the wall openings

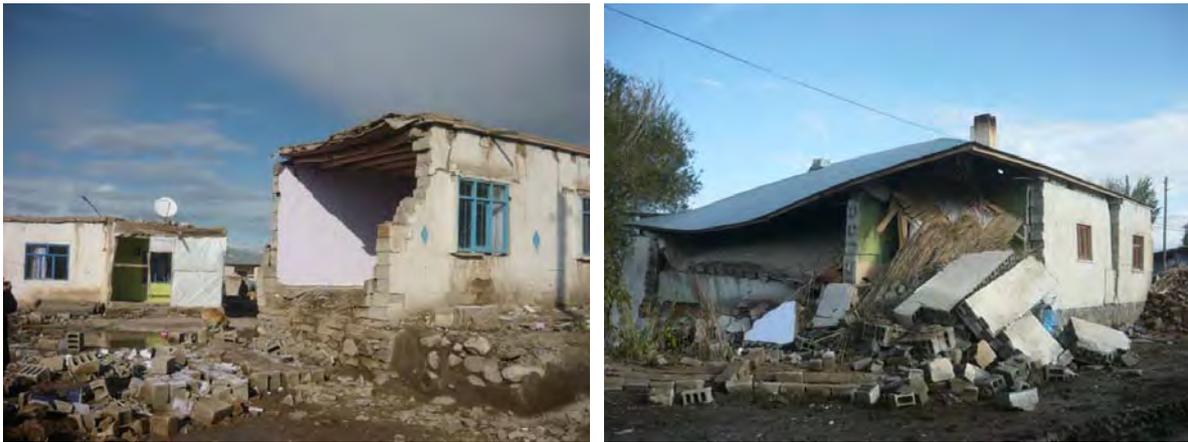
Although the bond beams on top of the walls are very crucial for seismic resistance, damaged unreinforced masonry buildings did not have this type of beams on the top. In addition, a heavy earth roof with inadequate in-plane stiffness does not provide a rigid diaphragm effect, which is also one of the important reasons for this kind of failure (Figure 10). Because walls, bond beams and roofs were not properly connected to each other. They could not transfer the seismic loads to each other. These walls performed beyond the desired level for they behaved as free-standing walls.

Figure 10: Out-of-plane failure of briquette masonry house due to long span (Güveçli village, Van)

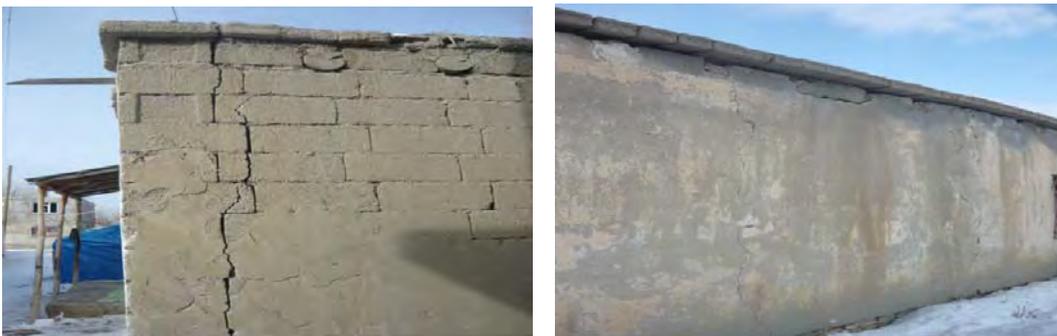
In this region agriculture and livestock are very important for local economy. However, many animals shed built by briquette masonry experienced serious damage in the area. Many of them collapsed or were seriously damaged. Compared with the residential houses, these sheds were poorly constructed (Figure 13). They had long spanning walls due to lack of partitioning walls. These long unsupported walls collapsed under out-of-plane earthquake loads.

Figure 13: Damages on animal sheds

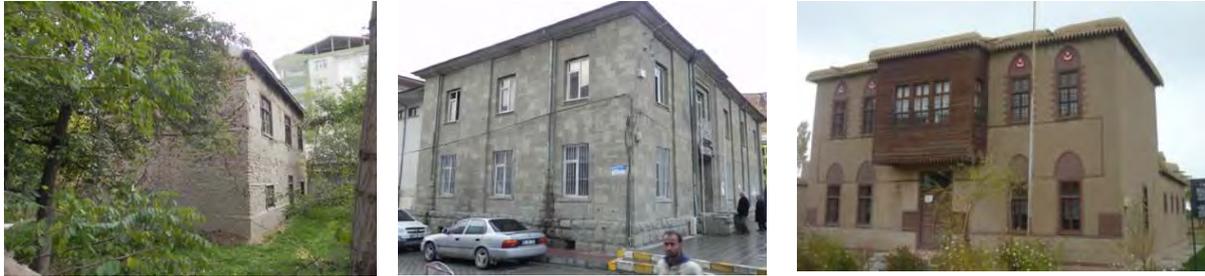
Although most of the masonry buildings had damages, there was also adobe, brick or stone masonry buildings that had no damage (Figure 14). When their construction year is investigated, it is seen that the buildings constructed before 1970s has no or slight damages. The reason might be in the organization of the foundation. Building masters, being aware that rigid building on rigid soil might be dangerous for the building, had introduced special techniques to change the natural frequency of soil or provided flexible footings at high seismic zones [7]. As also pronounced by old villagers, the foundations of masonry village houses were constructed on a layer of ~40cm sand till 1960s. The thick layer of sand, gravel or stone pieces

provided a change in the natural frequency of soil as well as adequate subsurface permeability to avoid a high water table condition [8]. Because this traditional construction method was forgotten, many masonry buildings had suffered during these earthquakes.

Figure 14: Undamaged masonry buildings in the region
