AN INVESTIGATION INTO THE ARCHITECTURE AND RESTORATION OF THE DİVRİĞİ MÜHÜRZADE HOUSE IN ANATOLIA

A. Erdem

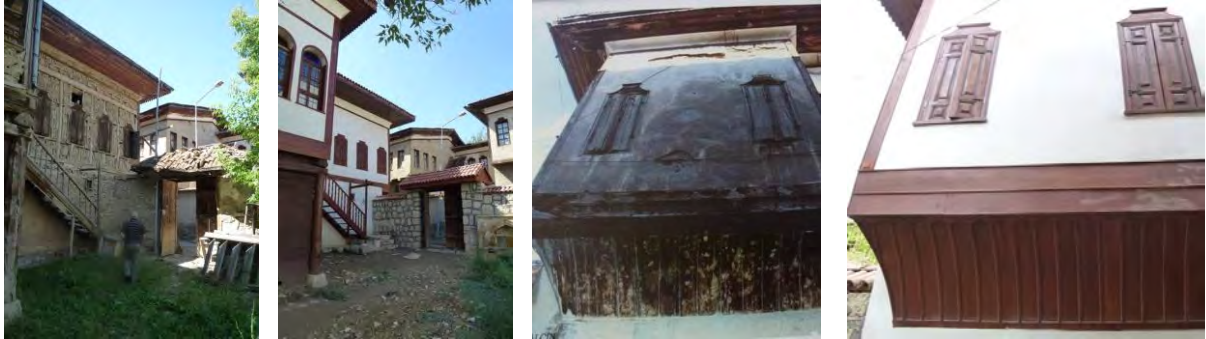
Figures 33-36: Northern and western (street) facades, before restoration and after restoration.

During the actual restoration work, for some unknown reason, the interior and exterior plasters were removed and the out-buildings that served to divide the courtyards of the house into two discrete spaces were torn down. After the plaster was removed, the building was left exposed for some time to the elements, causing the adobe brick packing to erode in some places and for the timber to degrade in others. While the restoration work did advance efforts to preserve the original architectural features of the house, the work was carried out in a careless and uninformed manner (Fig.33-49). Some examples of this include how the adobe brick courtyard wall facing the street was completely torn down and replaced with a new wall made of stone and cement and how the hipped roofing over the courtyard door was transposed into a gabled roof (Fig.33, 34). The area under the guest room projection that extends over the street was restored, but planks narrower than the originals were used. The wooden shutters are not the same as the originals (Fig. 35-36). In the restoration of the facade it was seen, however, that the adobe packing in the timber framing was completed, the mud mortar and gypsum plaster were reapplied, and the roof was repaired and covered with Turkish style tiles (Fig.37-39). The original details of the *divanhane*, *örtme* and staircase overhang railings were preserved, but in inadequate numbers (Fig.40-43). In the *toyhane*, the railings separating the seating "carpeted" area from the floor brazier area / *kürsübaşı* were omitted, as was the shelf in the entryway /*sekialtı* (Fig.44, 45). The floor planks in the hearth area were also laid in the wrong, opposite direction (Fig. 16,46), and – despite the fact that they had remained intact – the wood pillars were replaced by pillars that did not resemble the originals. The upper windows in the servant's room were replaced with those that were larger than the originals (Fig.47,48). The original features of the overhead windows in the *nimsekili* space in the small

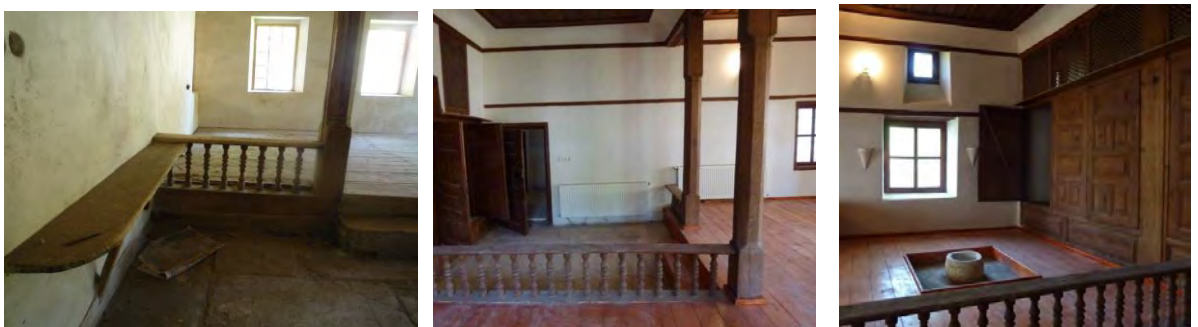
Figure 45, 46: *Toyhane and kürsübaşı* after restoration, 2013.

While the restoration project plan suggested that the structure be used as a hotel, it also specified that the building be restored while preserving all of the original features and building materials of the home. It was decided that the wet areas required for the hotel were to be built in the western facing spaces on the ground floor level, doing so with the aim of preserving the original and complete features of the upper level rooms and the *toyhane*.

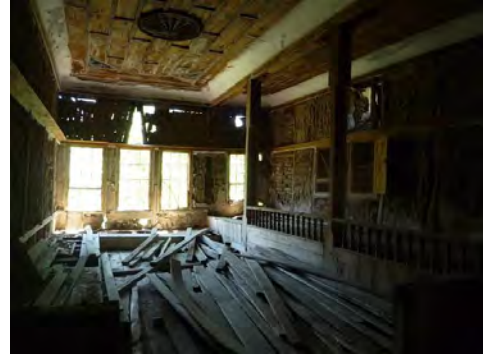
Figure 49: *Small summer room*, 2011.

summer room were not sustained (Fig.49-51), and the stone sink in the coffee room was eliminated (Fig. 20,52). Because no decisions have as yet been made as to how the building will be utilized, the building is not currently being used.
