## STRUCTURAL EVALUATION OF KILITBAHIR CASTLE IN CANAKKALE, TURKEY

A. Turer<sup>1</sup>

**Abstract.** *Kilitbahir castle was constructed by Fatih Sultan Mehmet in 1452 – 1463 at European side of Canakkale city to control passage in the strait from the Aegean Sea to the Sea of Mar-mara. The castle has a very interesting shape in the form of a clover leaf surrounding a tri-angle shaped central tower. Additional exterior rampart walls protect the castle from the land side. The castle is recently going through a restoration work, while the earlier major restoration works were carried out in 1541 and 1870. This paper consists of visual structural evaluation of the castle and highlights on various structural issues to guide some of the restoration work. The castle suffers from material degradation on the masonry walls due to water leakage from the roof level. All of the floor beams holding the walls together were lost. Various cracks on the castle walls and surrounding rampart walls show indications of structural deficiencies and possible damage due to temperature shifts or soil settlement. The conclusions of this paper try to set a path for structural interventions during restoration

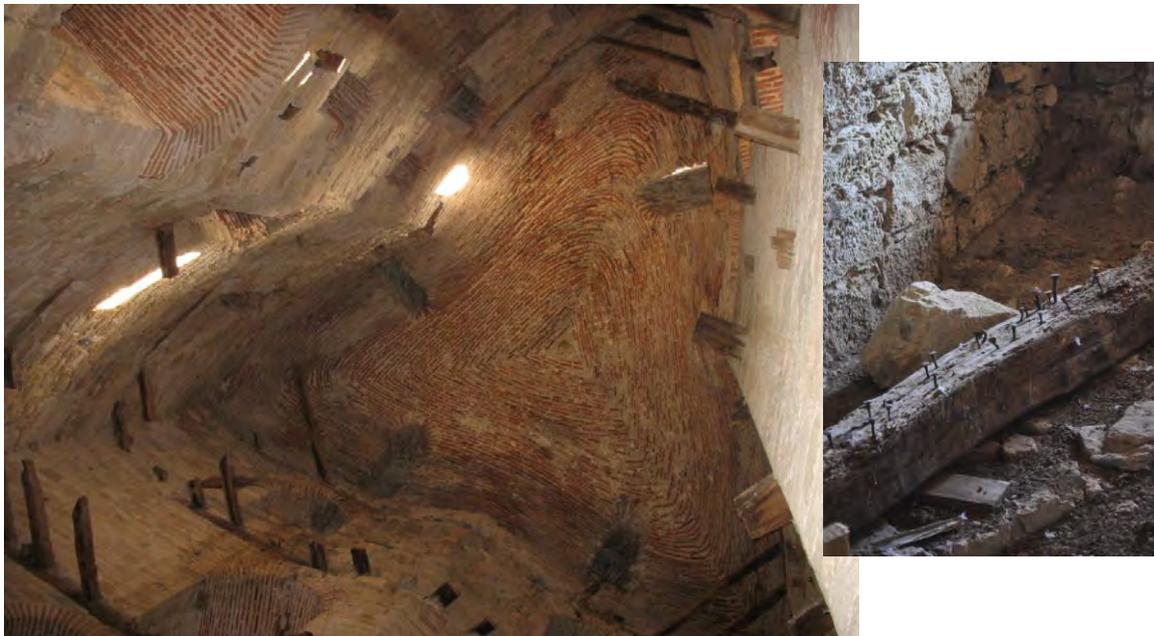
One of the major problems with the tower is the loss of wooden floor beams which structurally used to form a platform in the past. The castle walls reach unsupported height of 25 meters above ground (Fig. 3) over a water cistern which is more than 3 meters deep. The out-of-plane bending stability of the walls is improved by the presence of such horizontal beams connecting opposing walls in alternating directions. Logs found in the tower that has original nails on them also is an indication of thick wooden floor covering over beams which might in a way form diaphragm action as well. The floor should be reconstructed to structurally connect the opposing walls and at the same time for non-structural purpose of providing walking platforms for visitors.

Figure 3: Interior view of the Kilitbahir Castle tower (looking up) and damaged floor beams.

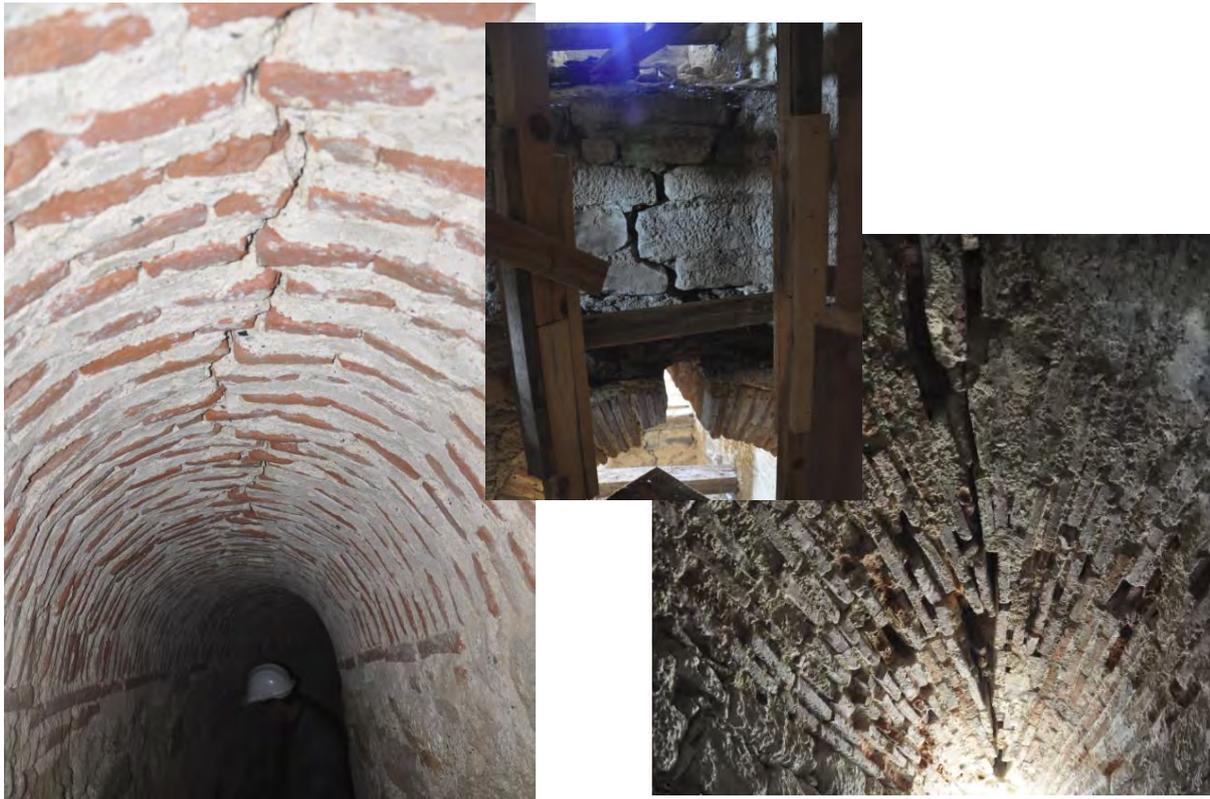
Almost all of the openings in the walls, which includes tunnels and window openings, have structural cracks clearly visible on the upper parts (Fig. 4). The cracks on the floor are possibly covered and filled with dust and earth. Similar cracks were also traced from the outside.

The crack formation on the walls indicate that the 3m to 4m thick tower walls have suffered dismantling by forming vertical cracks in planes that have horizontal normal vectors perpendicular and parallel to the wall surface. Majority of the wooden members horizontally placed inside the walls during the construction in parallel and perpendicular to the wall surface were lost over time due to dampness and possible biological activity (Fig. 5). The loss of wooden members, which are responsible for holding the wall's building blocks together in horizontal planes (parallel and out-of-plane directions), caused walls to crack possibly during a past moderate seismic activity.

Figure 4: General view of the structural cracks on the tower wall sections.

The cracks that are heavily visible from the inner side and window openings and trace-able from the outer surface are critical because they form weakness layers for shear stresses developing during a possible horizontal in-plane loading such as earthquakes. Similarly, out-of-plane bending of the castle walls during a possible earthquake is also quite vulnerable, since the bending capacity of the walls are depreciated due to surface cracks as well as missing floor beams cannot contribute to the transfer of out-of-plane forces to other walls that are oriented in their stronger axis of in-plane shear due to triangular shape of the castle. On top of that, the cracks are forming weakness against vertical dead load stresses and additional vertical forces that may form during earthquakes due to Poisson's effect: vertical forces cause tensile stresses in the horizontal directions which are in the in-plane and out-of-plane directions. Possible double-leaf architecture of the walls loses much of its strength as the wooden beams are missing across the thickness of the walls.

It is not possible to place wooden members inside the walls as their original size. Either smaller sized but stronger material wooden members can be placed in voids with mortar injection or *stainless steel* bars can be placed in those void spaces with proper infill mortar. The wooden members may create better adhesion with the existing walls since they have larger surface area. Similarly, smaller diameter but larger number rebars may be used instead of missing wooden members to increase the adhesion surface area. Development length of rebars is a function of the bar diameter and if smaller diameter bars are used the forces can be transferred on rebars at shorter distances increasing the efficiency of application. The smaller diameter rebars at larger numbers (e.g. 4 to 8 bars) placed inside the void spaces left from wooden members can also be connected to each other using stirrups which would add shear resisting capacity to the application as well (Fig. 5). In this way, a modern and compatible intervention to the historic castle using smaller and large number of stainless steel bars with stirrups can mimic the performance of wooden members and practically lasts for the rest of structure's life.

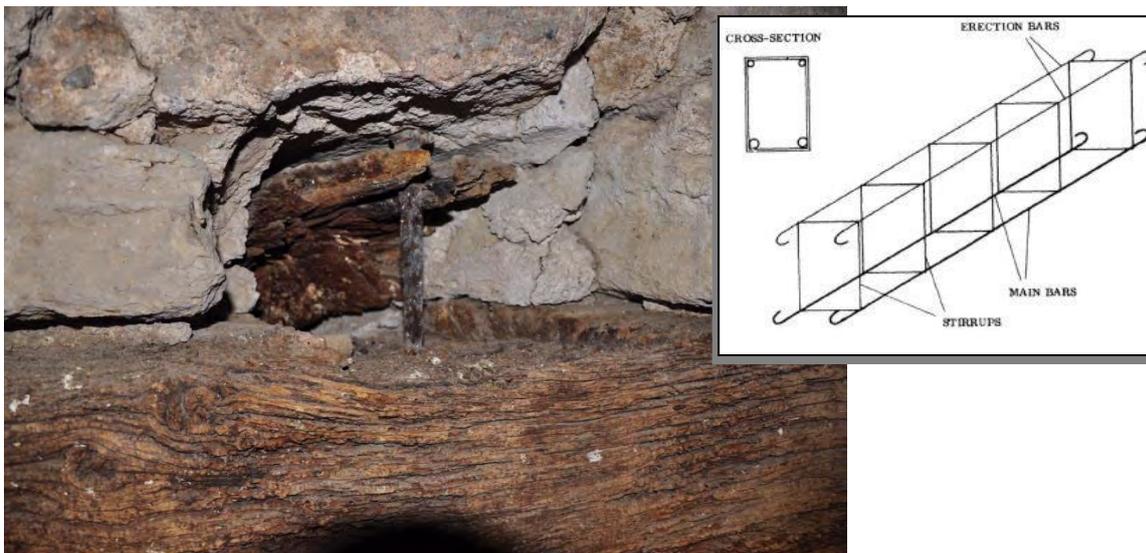
Figure 5: One of the remaining wooden wall members.

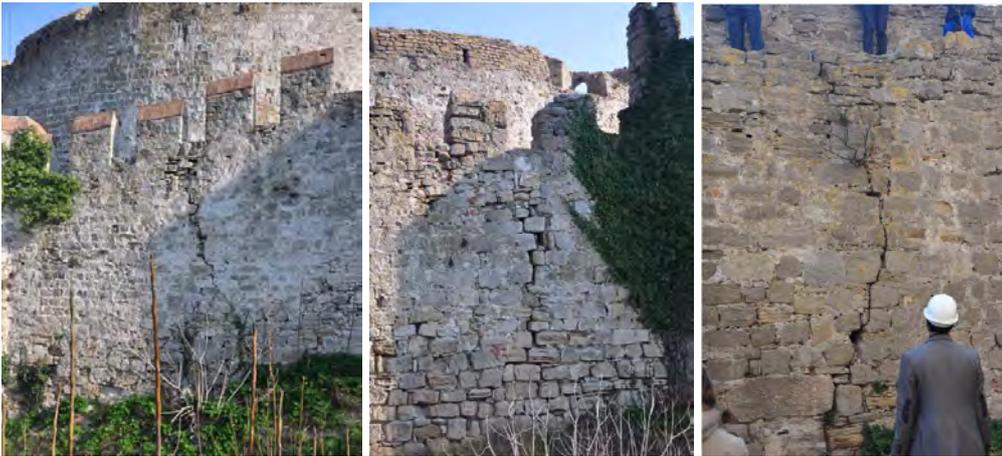
The outer walls are 8 to 10 meters high but relatively thinner, having only 2m thickness with about 5:1 ratio. Vertical cracks on the exterior walls from inside and outside (Fig. 6) were observed indicating a) possible support settlement, b) temperature related expansion joint formation, and c) out-of-plane bending. Out of these three possibilities, temperature loading and out-of-plane bending are thought to be more effective since the cracks mostly have vertical patterns. A differential settlement would be expected to generate diagonal cracks except if two sides of a section settle down at the same time causing a negative bending forming a vertical crack starting at the top of the wall.

Figure 6: Vertical cracks observed on the exterior walls.
