THE MODELLING, ANALYSIS AND ASSESSMENT OF THE IRON BRIDGE, SHROPSHIRE, UNITED KINGDOM

James D Miller, Carl L Brooks

Abstract. *The Iron Bridge in Shropshire, UK is the world's first iron bridge. Dating from 1779, it is a Grade I listed structure – the highest national category - and lies in a UNESCO World Heritage site in the Severn Valley at the heart of the Industrial Revolution.*

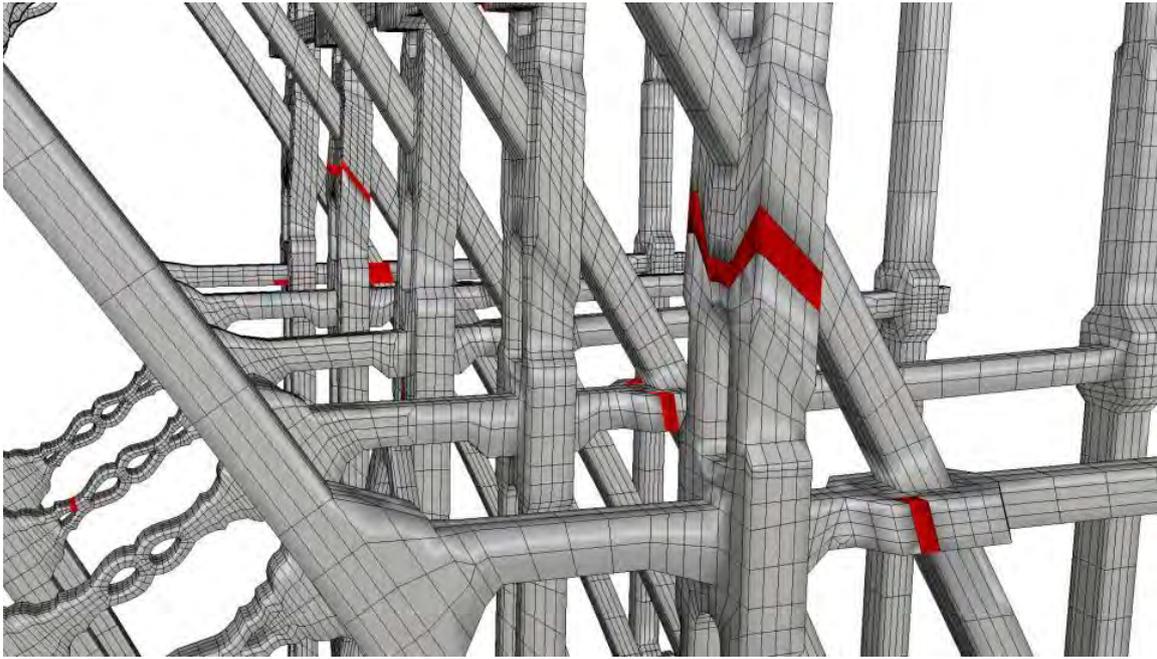
Figure 5: Modelling of the defects.

Defects include cracks, breaks and parts of connections that are obviously loose. Defects in the geometry, for instance where parts are distorted or bent, are captured in the overall modelled geometry as this has been precisely measured. The defects have been introduced by either deleting elements to introduce a physical break, or by softening parts of the modelled cast iron so that very little load is carried. In this way load is distributed through the bridge frames, bracings and deck in a realistic way.

The way in which defects are introduced into the model is shown in Figure 5. About one hundred defects were modelled in this way.

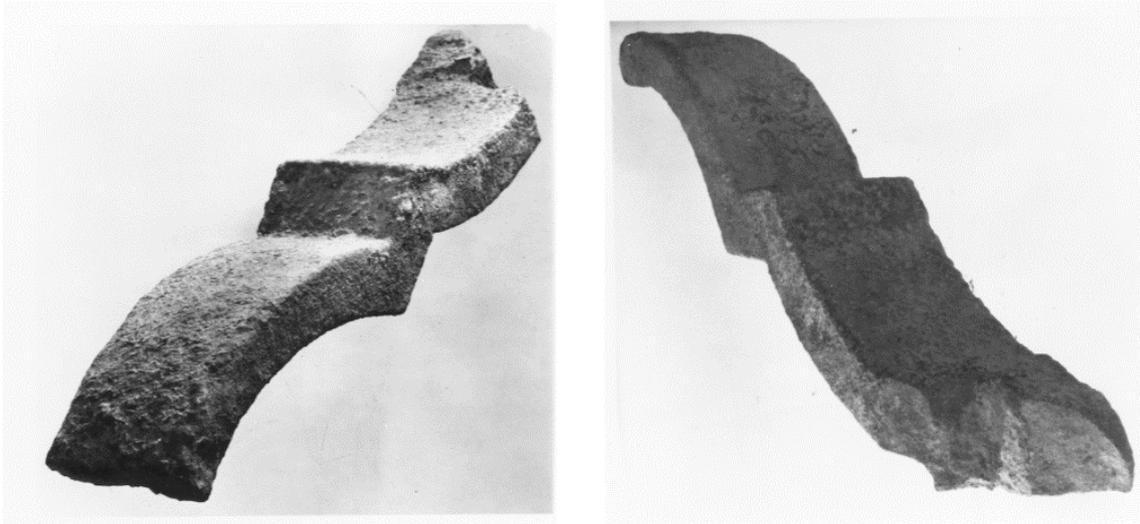
Figure 6: Photographs of fallen Cantilever Brackets used for material testing.

The material properties of the cast iron were considered in some depth. Little is known about the mechanical properties of the iron used in the bridge. However, limited tests were carried out in August 1969 on a single, original bracket that had fallen from the parapet⁷. Figure 6 shows photographs of this bracket. In the absence of a large sample of data, the material properties proposed in Highways Agency document BD21 have been used in conjunction with these test results^{8,9}. This is expected to give a conservative assessment.

The following were the test results obtained from a cantilever bracket that fell from the bridge. Due to the nature of the cantilever bracket the tests were carried out on fairly small samples.

- Tensile strength 8.5 ton f/in² (131 N/mm²) based on three results.
- Compressive strength 13.5 ton f/in² (208 N/mm²) based on one result on a 1" diameter x 1" long cylinder.
- Bending strength 10.0 ton f/in² (154 N/mm²) based on one result.
- Impact 1.25 ft lb based on one result using notched specimen.
- Hardness 149 using 10 mm ball with a 3000 kg load.

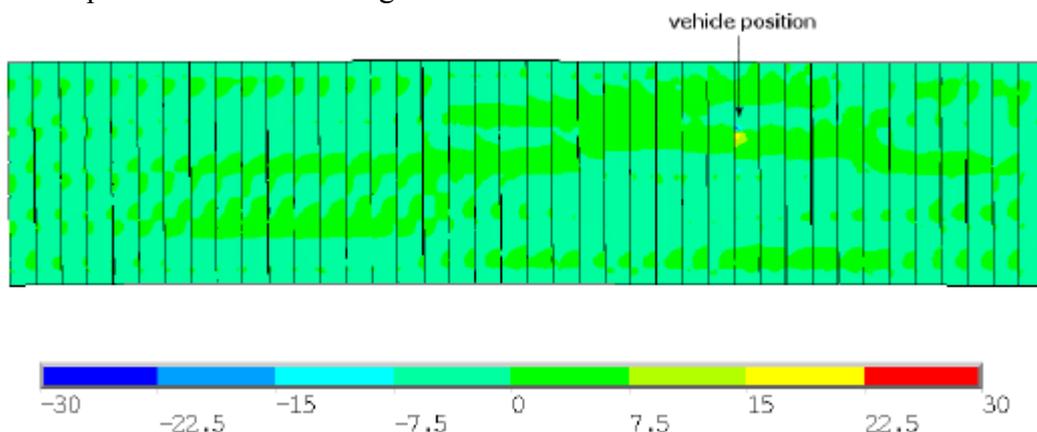
Figure 9: In-plane stresses within the deck plates

Figure F59 Load Case 7 – Stress in the lateral (y) direction

The cast iron deck plates, found across all spans, are able to take the load of pedestrians at 3 kN/m² and inspection vehicle. However, some plates are cracked and so outrigger loads should always be spread across the deck.
