MONITORING AND EVALUATION OF CONSTRUCTION IMPACT OF SHANGHAI BUND TUNNEL ON NEIGHBORING HISTORICAL BUILDINGS

Abstract. *The monitoring and evaluation of the entire construction process of Shanghai Bund tunnel was performed for protection of the neighboring historical buildings. It was conducted in three stages regarding the different stages of the entire construction process. In the first stage, which consisted of the preparation work of the construction, the structural system and the damages of the historical buildings were identified, based on which quantitative indicators of the critical deformation and damages were established. During the second stage, during which the tunnel was constructed, the structural deformation responses and damage developments of the neighboring buildings were recorded and analyzed. The results were used as reference for early-warning. The third stage was performed right after the construction, and the monitoring data were integrated and analyzed to assess the final effect of the construction activity on those buildings. The results indicated that the relationship between the tunnel construction and the increase of the structural deformation or the de

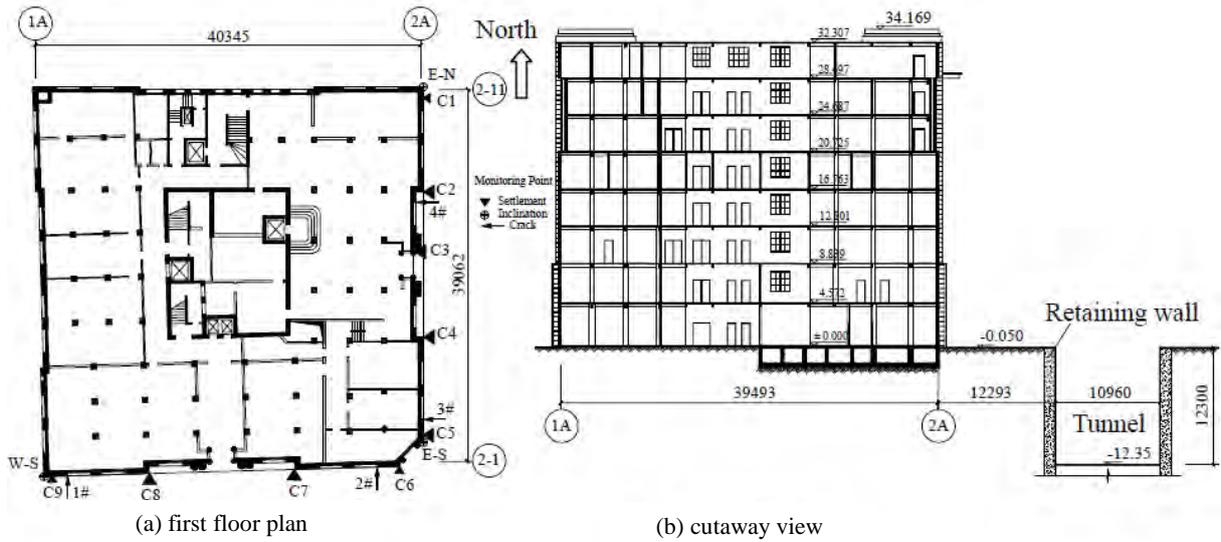
Figure 2: Asia Building (No.1).

Before tunnel construction, there were 17 cracks observed on the façade walls of the first floor (“↑” marked in Figure 2). The maximum width of the cracks was measured (less than 0.4 mm) and marked for further measurement (Figure 5a). It was also found that some concrete slabs on the 6th, the 7th and the 8th floors cracked in the corners of the building (Figure 5b). These nonstructural cracks were usually caused by thermal expansion and shrinkage of structural materials.

Since the tunnel construction may cause ground movements, the absolute altitudes of the monitoring points (C1~C9 in Figure 2) and the initial inclination of the building were measured, which would be used as the reference to assess the development of settlements and inclination of the building in the construction of the tunnel (Figure 5c and Figure 5d).

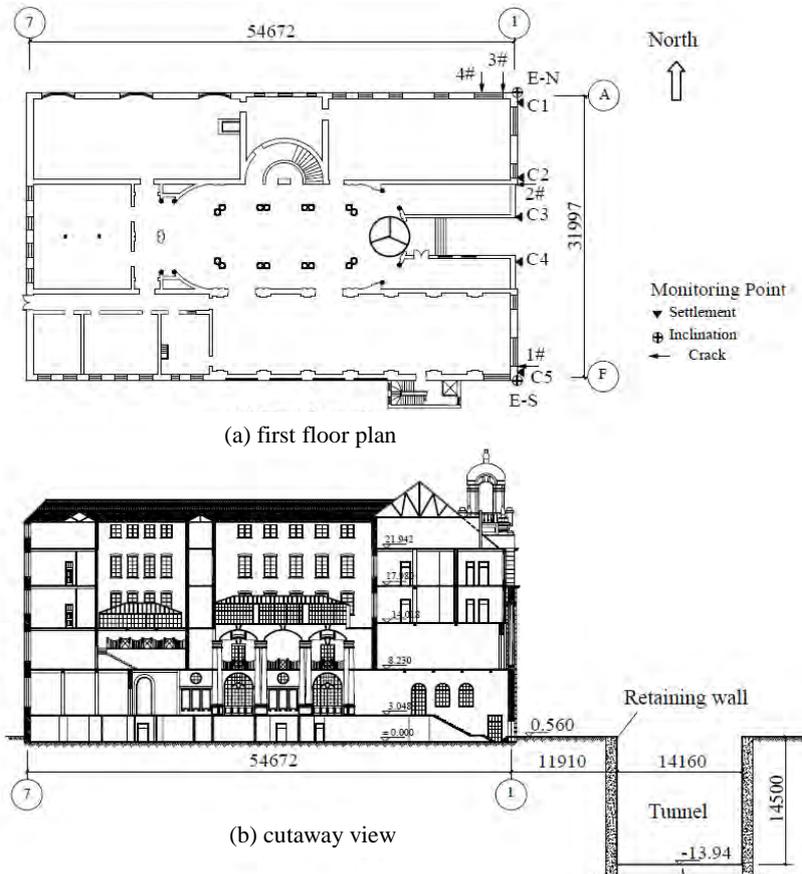
Figure 3: Shanghai Club Building (No.2).

The depth of the tunnel was about 14.5m, the horizontal distance at the northeast and the southeast corner of the building varied from 7.44 m to 14.44 m. Limited by the field condition, the northeast corner (point marked as ‘E-N’ in Figure 3) and the southeast corner (point marked as ‘E-S’) were used as the inclination monitoring points. Five settlement points were used on east façade walls.

17 cracks in the first floor were selected as monitoring point (marked “↑” in Figure 3), 5 points on the east exterior wall were set as settlement monitoring points (C1~C5 in Figure 3), northeast and southeast corners of the building were selected as the measuring points for inclination observation. The initial values of the crack widths, absolute altitudes of the monitoring points and the inclination of the building were measured also.

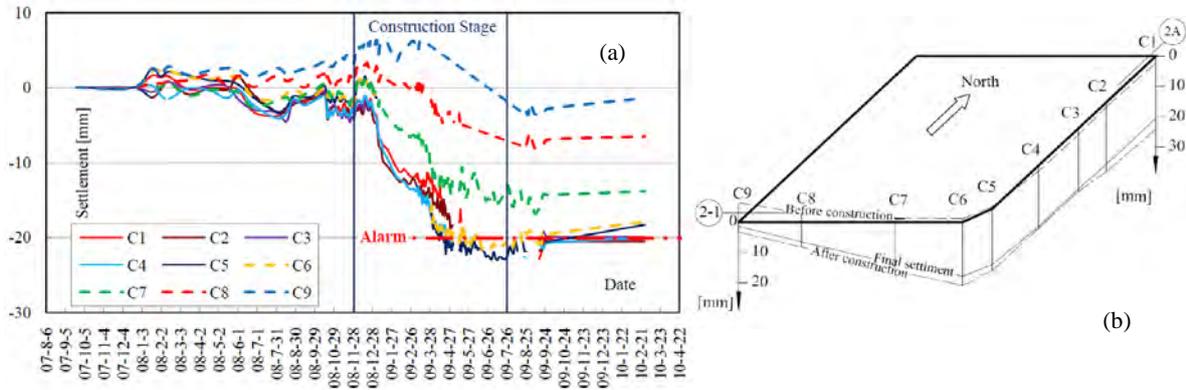
Figure 6: Settlements of Asia Building (No.1).

Being sensitive information for evaluating structural safety, settlements of three buildings were measured. Before construction, the monitoring results of the Asia Building always fluctuated around zero line, but C8 and C9 went up due to expressway dismantlement (Figure 6a). When the retaining wall was constructed, all of the points sank obviously, especially the

points at the southeast corner. The cumulative settlements of points C1, C5 and C6 exceeded the alarm limitation for a long time, but they decreased at last. Half year later, these settlements tended to be stabilized after construction. As shown in figure 6b, the building sloped away to the east and north in three stages.

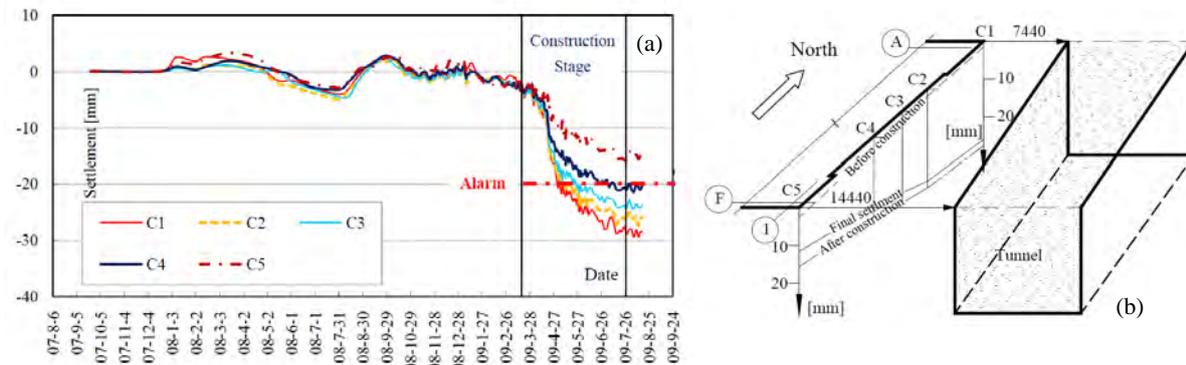
Figure 7: Settlements of Shanghai Club Building (No.2).

Similar to the Asia Building, the vertical movement of the Shanghai Club Building varied slightly at the first stage. After the soil was removed in the tunnel construction, the settlement increased significantly (Figure 7a), the cumulative settlements of three monitoring points exceeded the alarm line before the tunnel roof was constructed. From the south end to the north, the settlement increased gradually, in an inverse proportion with their distances to the tunnel (Figure 7b). The east wall of the building sloped to the north after the construction. The settlements were finally recovered slightly.

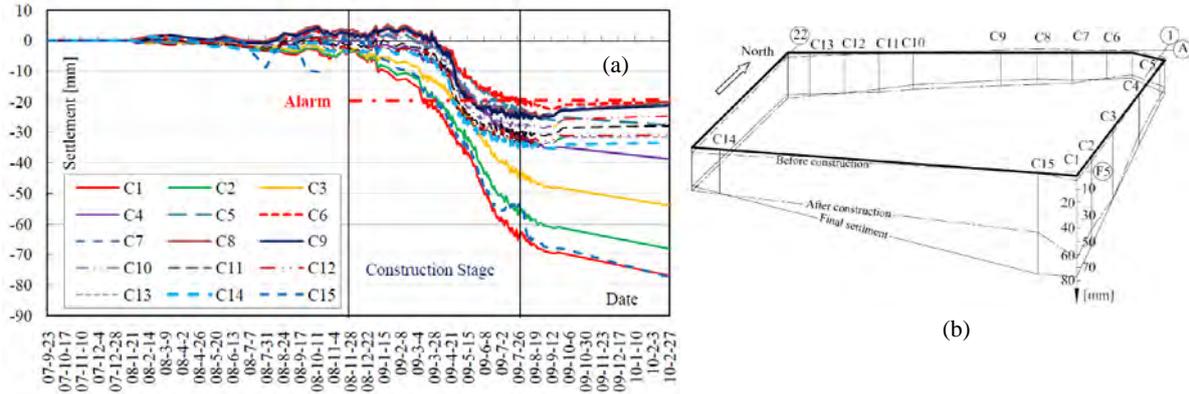
Figure 8: Settlements of Union Building (No.4).

The structural settlements of the Union Building increased gradually after the construction, especially point C1 at the southeast corner of the building, which was the nearest monitoring point to the tunnel (Figure 8a). Three months later, the cumulative settlements of some points exceeded the alarm value. The shoring system of trench was strengthened. Though the maximum settlement rate reduced 0.0011 mm/day gradually, the development tendency of the settlements was clear until the project was finished in 2010. As seen in Figure 8b, the building sloped away to the east and south finally.

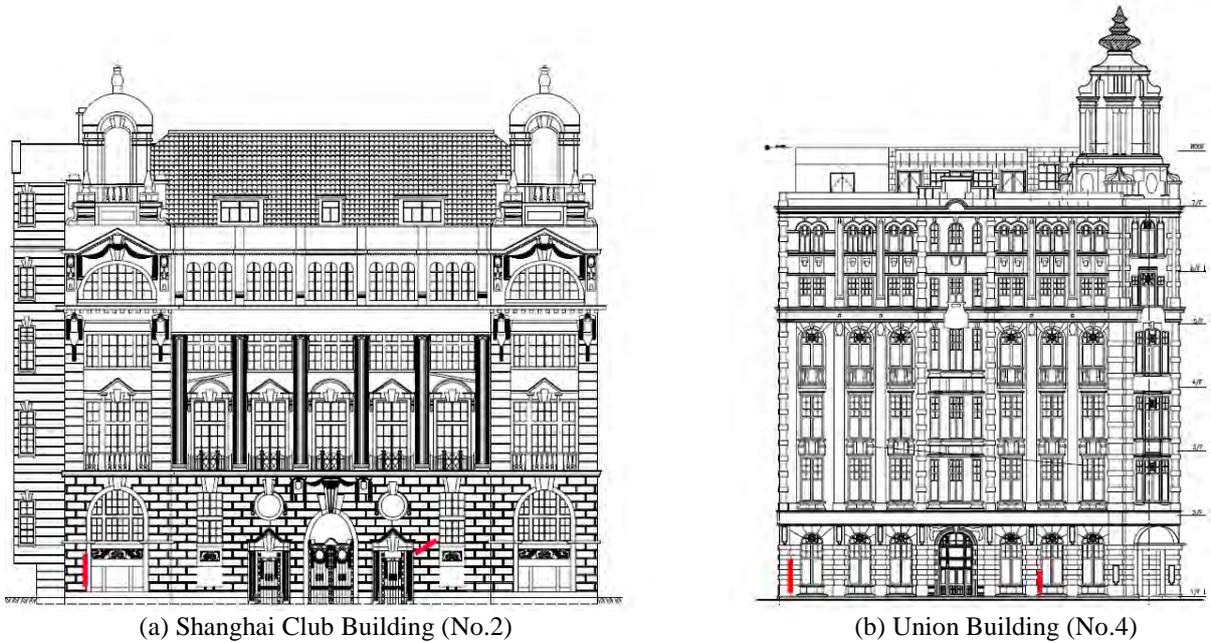
The excavation-induced building damages in the neighboring buildings were primarily in the form of cracking of exterior masonry walls. Periodic detection was performed to monitor the propagation of the building damage throughout the duration of the construction activities. A summary of the typical cracks and the corresponding construction activity is presented in Table 2. The maximum increment of the crack width in the Asia Building was 0.3mm at last, and did not exceed the alarm limit. As for the Shanghai Club Building, new cracks (red line in Figure 9) were found on the east wall, with the crack width ranged between 0.35mm to 0.8mm, after construction. The crack width on the Union Building was bigger than that on the other two buildings due to its larger settlement. Not only the east wall but also the north and

the south wall of the Union Building cracked during the construction. The maximum width of the new cracks was 0.60 mm finally.

Figure 9: New cracks detected on the east walls.
