STRUCTURAL RESTORATION OF ANCIENT BASILICA DE GUADALUPE

José Luis Sánchez Martínez¹, René Serrano Márquez²

Abstract. *The Ancient Basilica de Guadalupe, today Expiatory Temple of King Christ, was built in 1709 by the architect Pedro de Arrieta. Through the years, it has been affected by modifications and has suffered damages that have resulted in a loss of structural strength, and have diminished the architectural qualities that once made it a masterpiece of Mexican Colonial Architecture. In 1994 it was decided to perform a total restoration of the monument to recover the original architectural values, and the structural retrofitting was essential to reach that then. This document describes that retrofitting process.*

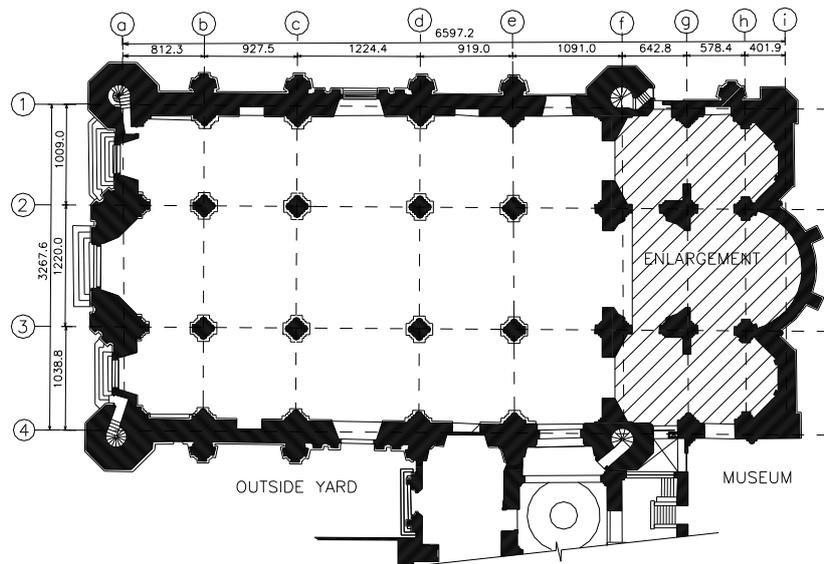
Figure 1: Plan of the Ancient Basílica de Guadalupe with the enlargement made in 1887. (*dimensions in cm)

It was decided to enlarge the Temple, and to this end, two bays were added to the North of the structure, that is, towards the Cerro del Tepeyac. In this way the Sanctuary lost one of its most important virtues: Symmetry.

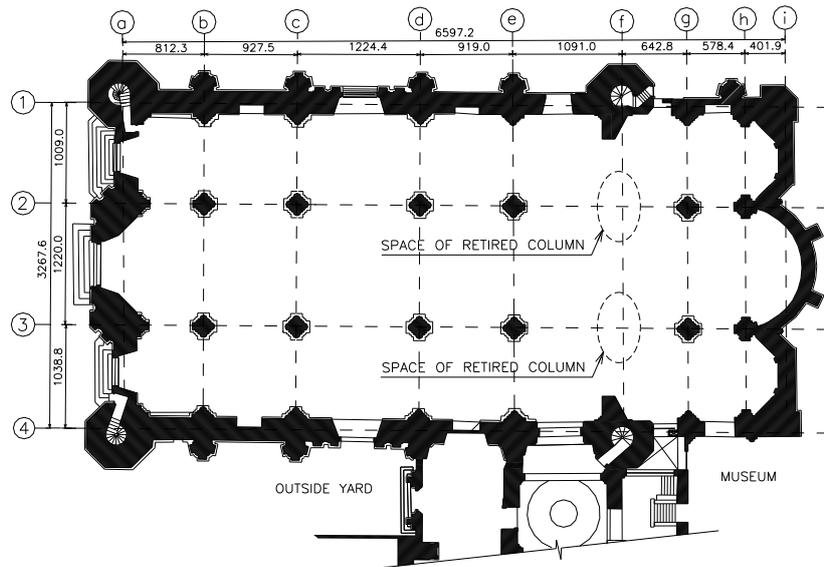
Forty-three years later, in 1930, two of the large columns built in 1887 were removed; and to perform this, without the slightest respect for the monument, there were placed metal trusses supported on columns of the same material which were embedded in the quarry columns, all these on a heavy underground foundation. (Figure 2)

Figure 2: Plan of the Ancient Basílica de Guadalupe after retirement of two columns in 1930.
(*dimensions in cm)

The vaults of the ceiling were hung with tensors from the trusses, giving the Basílica an awful image that lasted for over sixty years.

The metal trusses and tensors that held the ceiling vaults were removed and the vaults were rebuilt with the same geometric characteristics as the original vaults, but using a thin concrete shell.

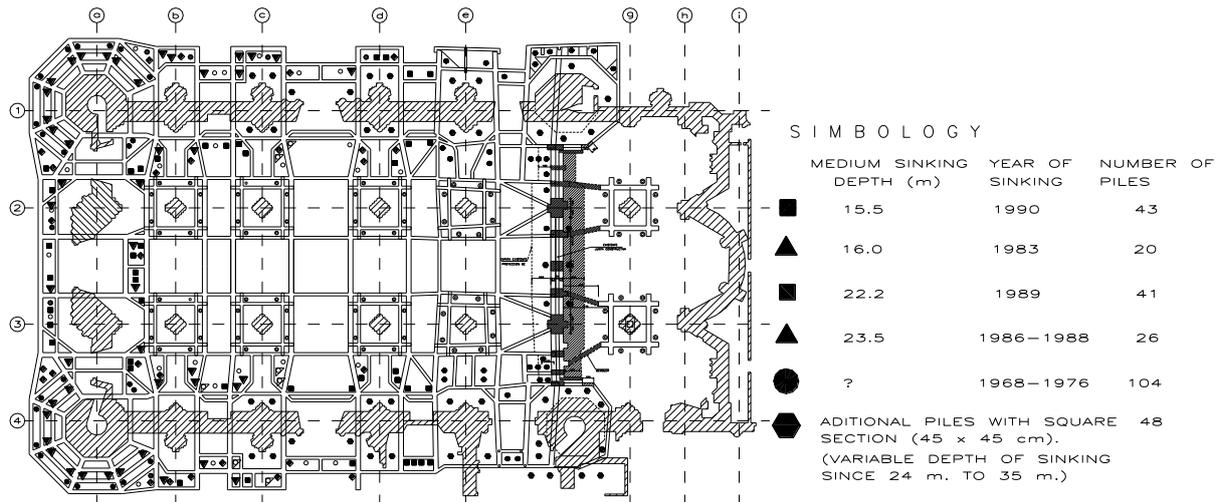
This difference in the depth of the bearing soil under the Basilica has caused extremely important differential subsidence, basically due to the extraction of the underground water which has been particularly intensive since the 1950s.

Figure 3: Foundation retrofitting of the Ancient Basilica de Guadalupe with foundation beams and piles of control.

The continuous sinking of the Basilica caused new interventions on that building, retrofitting its foundations with a series of concrete beams attached to the original stone foundations, and with a large number of control piles [2]. These works, performed after 1965, slowed considerably the deformations that were being produced. (Figure 3)

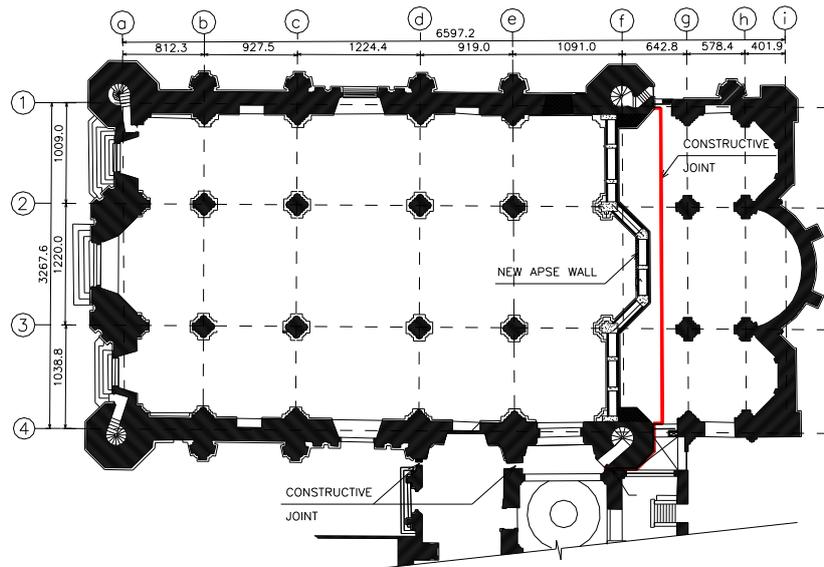
Figure 4: Recovery of the original geometry, new apse wall and constructive joint. (*dimensions in cm)

This sole action, however, was not fully effective, for the building kept having significant subsidence to the South-East. This was evidenced by several cracks on its lateral walls, with the largest virtually matching the addition built in 1887.

Given all this, it was then proposed to divide the building in two parts on each side of said crack which, besides, was very convenient from the point of view of the building's general restoration, and gave place to the extraordinary project that was carried out.

On the walls, vaults and the foundation it was performed a construction joint.

It was constructed a new apse wall with the dimensions of the original, but now built with two brick walls spaced apart and well structured.

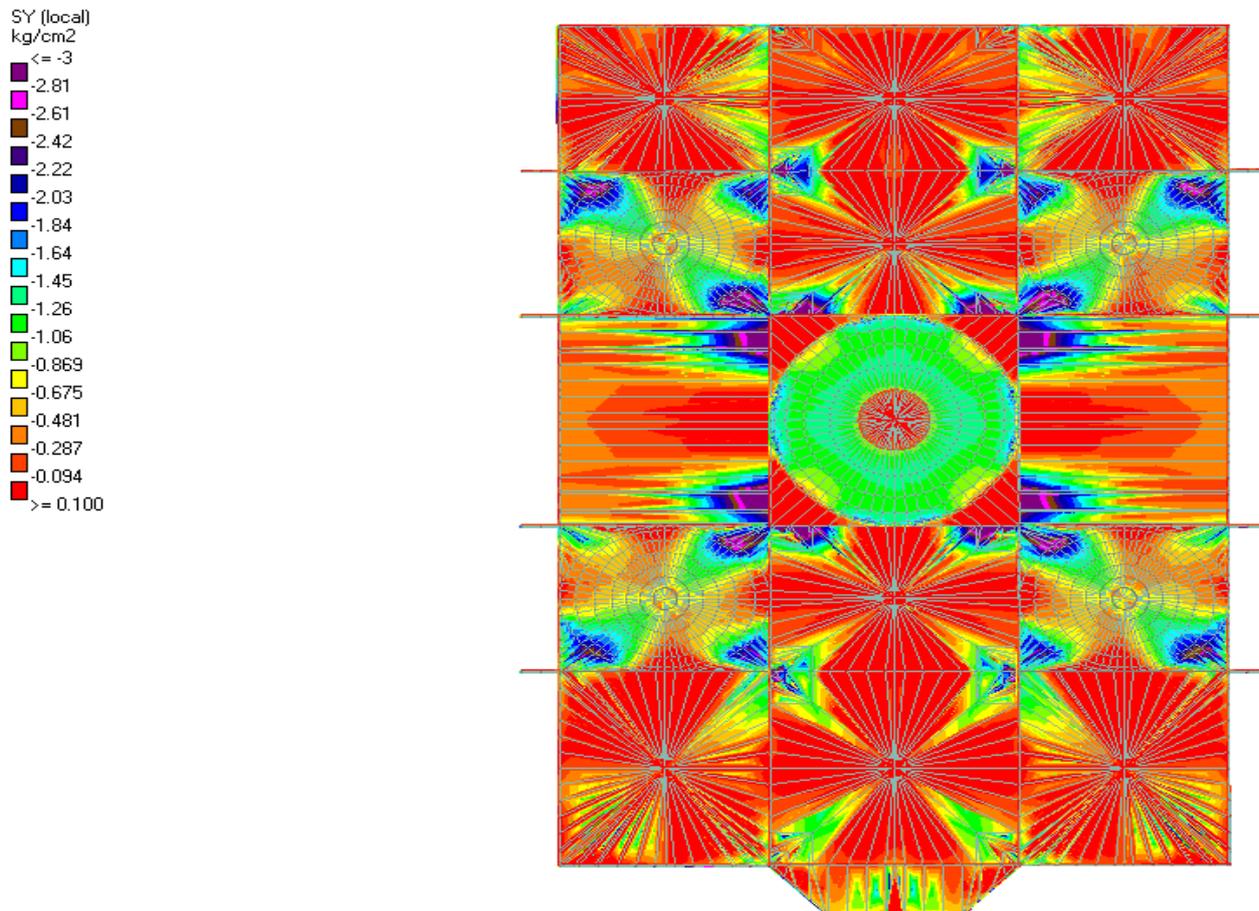
In the most unfavorable conditions, that is, under the action of seismic forces and considering the existing tilt, stresses are essentially compressive and their factored values of about 8.0 kg/cm², which is a considerably a lower value of what the structure's materials can bear. Only in some local areas there are tensile stresses with factored values of about 2.0 kg/cm² in vaults and 1.0 kg/cm² in walls. Both values are acceptable [4], especially considering the great thickness of the vaults and walls allowing the pressures produced by the applied loads to be invariably within the section of masonry. (Figures 6 and Figure 7)

Figure 6: Normal stresses on the roof.

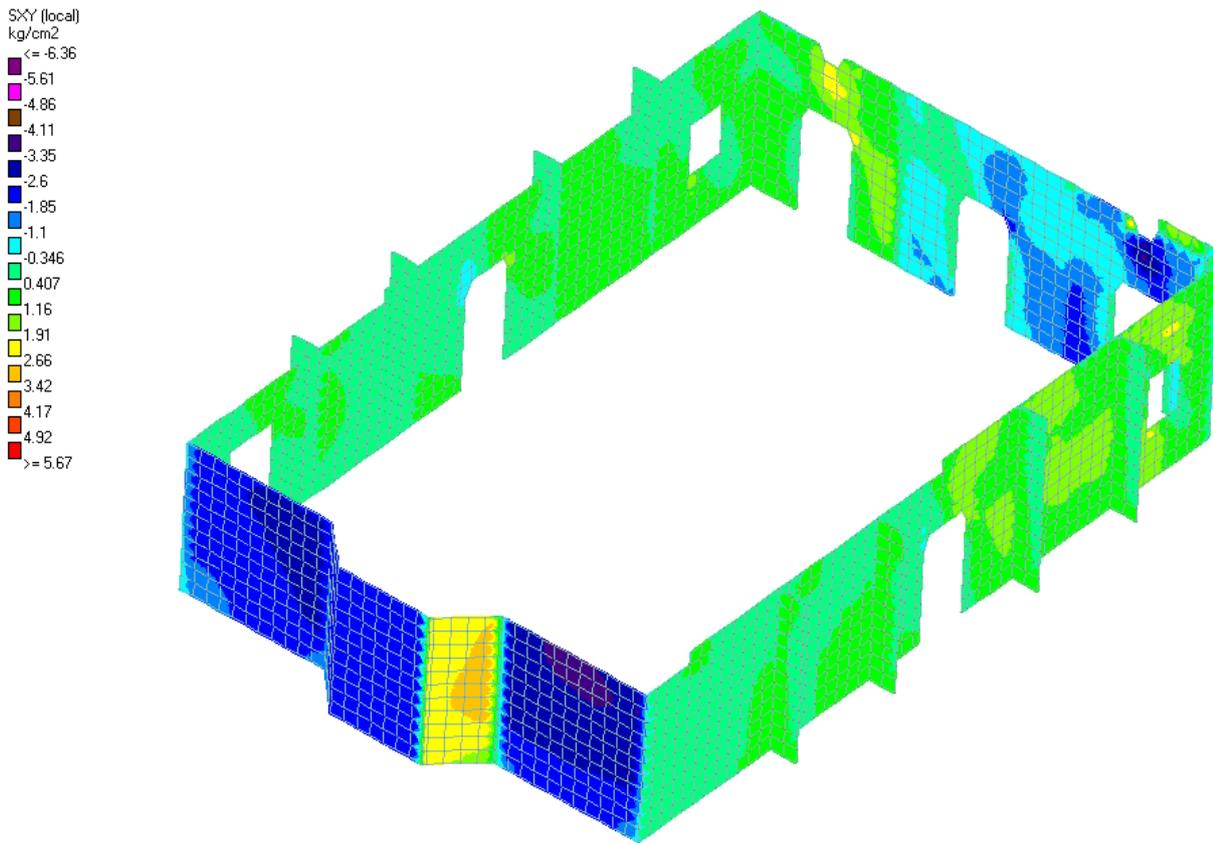
Figure 7: Shear stresses in walls.
