## STRUCTURAL ANALYSIS, CONSERVATION PRINCIPLES AND MONITORING APPLIED TO AN EVANGELICAL CHURCH IN ŻELISZÓW (POLAND)

**Abstract.** *Żeliszów (German: Giersdorf) is a village located in south-western Poland (120 km from Wrocław, 160 km from Dresden). According to many, the evangelical church was designed by the famous German architect Carl Gotthard Langhans in 1796. The church was built in classicistic style in accordance with an elliptical floor plan with exterior masonry walls and a timber construction comprising oval galleries covered with a wooden vault. A neo-gothic tower was added in 1872. The building has been abandoned since 1945. This means that aside from the need for conservation intervention to improve the technical condition of the building, it is also necessary to adapt the church to new uses. The goal of the research reported in this paper was to evaluate the degradation and deformation of the building structure using HDS 3D laser scanning, coupled with destructive, non-destructive and quasi non-destructive testing of the timber structure, brick and stone masonry walls and damp.. The poor technical condition of the church is the result of long-term degradation, natur

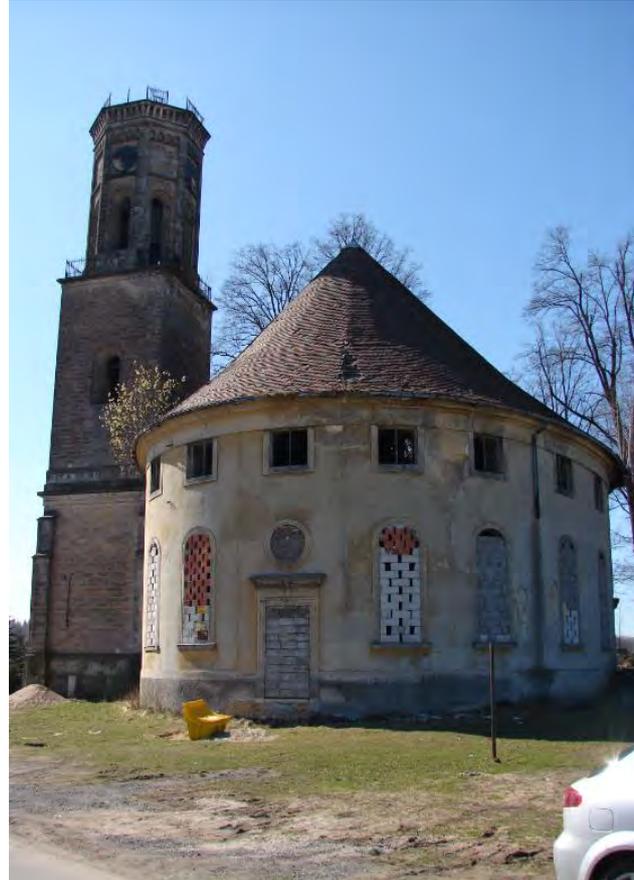
Figure 2: Condition of the church in Żeliszów (2012).

The first important church repairs were carried out in 1835. The roof cover was changed in 1840. The current roof cover made of fish scale-laid plain tiles dates from 1928. The neo-gothic tower was built in 1872. Renovation work in the years 1927-1928 included inter alia, a change of the roof cover. The building has not been used since 1945. It was closed until 1956. The current condition of this valuable heritage building is the result of degradation over the course of many years.

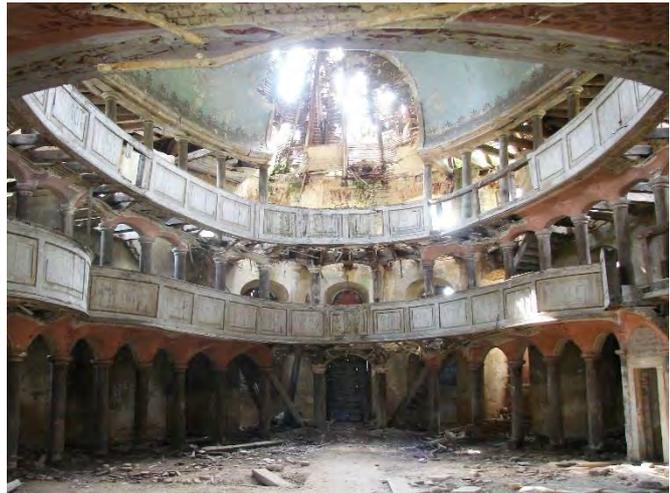
Figure 4: Church interior (2012).

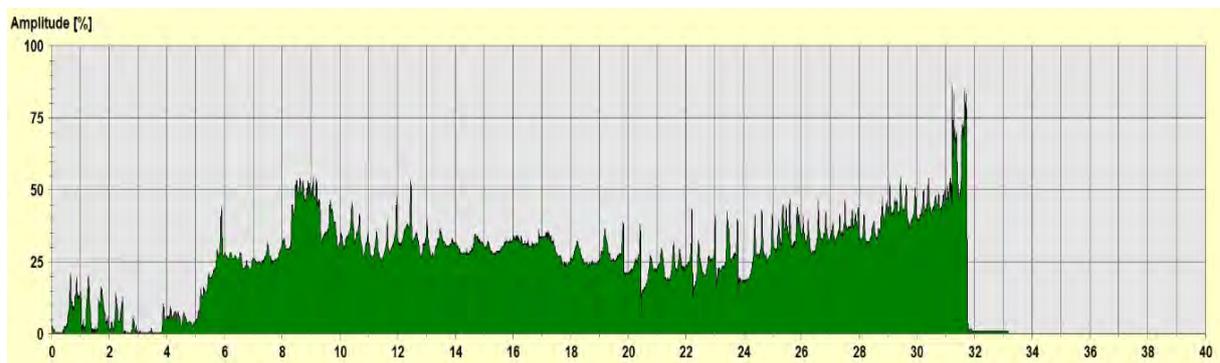
Figure 7: Results of resistograph testing for a gallery pillar.

The test results obtained show that the largest damage is in the surface layers of the wood. The average amplitude of drilling resistance for most of the measurements is in the region of 25-30%. The parameters of the wood tested can be qualified as healthy or average durability. Values of less than 25% in sections longer than 1 cm (reduced durability parameters) were found in elements, which were exposed to atmospheric impacts due to damage of roof cover. Damp elements were found to have been attacked by moulds, which contributed significantly to their damage.

The most unfavourable test result for wood damage in the cross-section of the surface layer was used for the purposes of calculating structural stability – a reduction was assumed of 30% in the dimensions of the cross-section when compared to initial parameters.

Missing elements along with wooden joints need to be restored, whereas damaged and loosened wooden structural elements need to be repaired. The application of toothed wood connectors ('Geka' rings) and screws is recommended as well as restoration of wooden joints by replacing damaged beam and rafter fragments and augmenting degraded cross-sections through insertion of steel rods (based on resistograph testing).

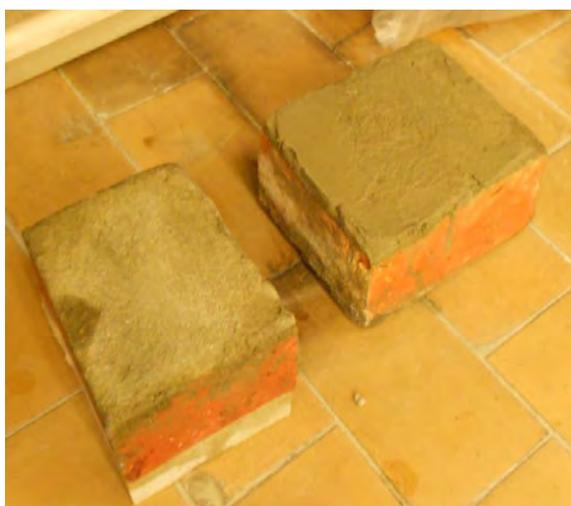
Tests of the compression strength of bricks were carried out in the laboratory of the Building Institute of Wrocław Technical University using a Tecnotest compression-testing device. Bricks obtained from the interior of the church were tested (sample no. 1 – floor, no 2 – cornice, no. 3 – lintel). Samples were sliced cut to a size and the surface for compression testing was smoothed with lime cement. Compression testing was initiated after seven days of sample preparation. The results obtained are presented in Tab. 1. The differences in results for sample no. 2 and sample no. 3 may be the result of differing atmospheric impacts. Damage to roof flashing resulted in soaking of the bricks over many years (no. 2), which affects their mechanical properties.

Figure 8: Samples prepared for compression strength testing.

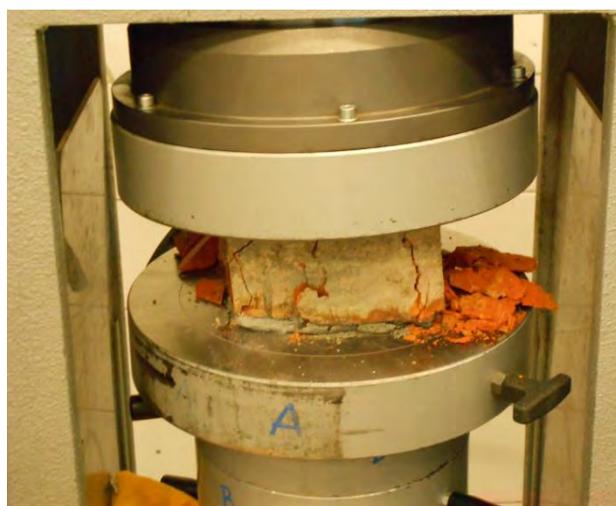
Figure 9: Compression strength testing.

The lowest compression test result for the brick – approx. 13 MPa was used for the purposes of calculating the compression strength of the wall, on the basis of which the compression strength of the wall as a whole was estimated at 1.5 – 1.8 MPa.

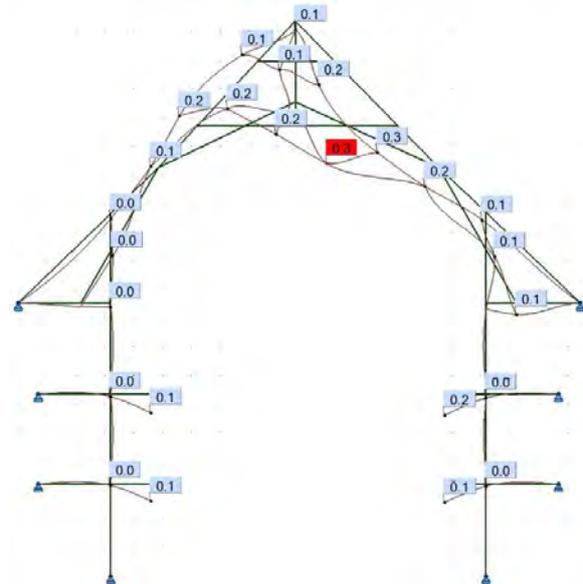
Figure 13: Deformations of a main truss.

Structural stability calculations indicate that the load-carrying capacity of the timber elements is sufficient. Strain of some elements exceeds acceptable levels in situations where the cross-section is reduced by 30%. Although these are not significant, it should be noted that the condition of the rafter framing especially where there is constant damp can experience a more rapid deterioration of durability parameters, and different types of damage can accumulate within a single truss.

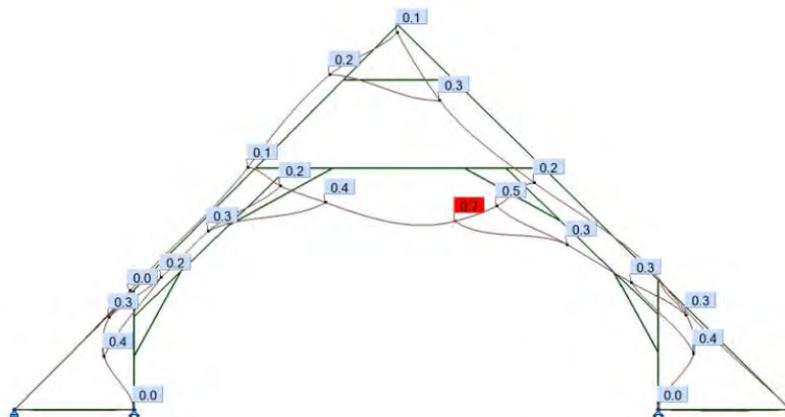
Figure 14: Deformations of a secondary truss.
