ON-SITE INVESTIGATION AND DYNAMIC MONITORING FOR THE POST-EARTHQUAKE ASSESSMENT OF A MASONRY TOWER

Carmelo Gentile¹ and Antonella Saisi²

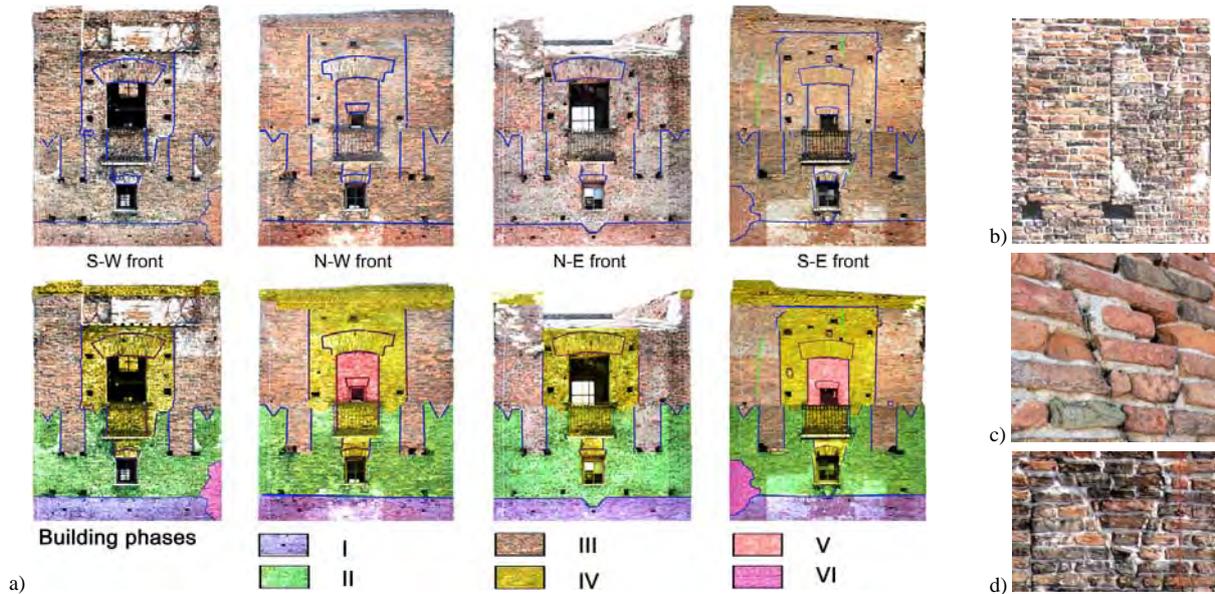
A first hypothesis, based on the surface discontinuity survey, could recognise six main building phases (Fig. 3a): (i) erection of the main building up to about 46.0 m (probably concluded in 1227) and recognisable by the surface workmanship of the scratched bricks (Fig. 4a,b); (ii) subsequent addition, up to the crenellation level (Fig. 3b-d); (iii) adding of 4 corner piers supporting a four side roof; (iv) opening infilling and construction of the windows, crowning and the new roof; (v); repair of the South corner (Fig. 4c-e).

Figure 3: Map of the structural discontinuities and of the supposed building phases (a) and details of the probable merlons embedded in the masonry texture (b-d).

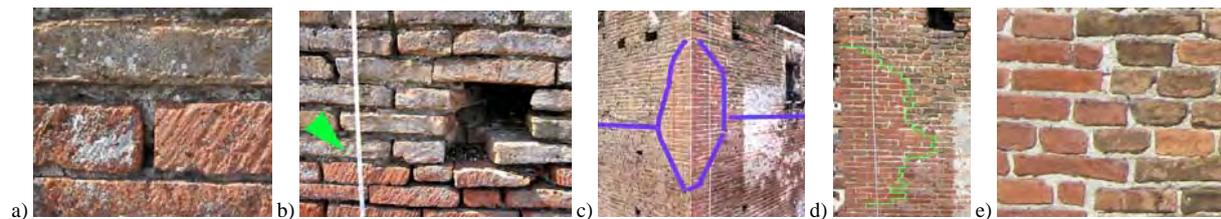
Figure 4: Change of the surface workmanship at about 8.0 m from the top (the bricks of the lower portion are superficially scratched) (a,b) and probable repairs revealed by local changes of the masonry texture (c-e)

On-site survey highlighted two different structural conditions, that were associated to the main part of the building (until the height of about 46 m from the ground level) and to the upper 8 m of the tower, respectively. Excepting the upper part of the tower (i.e. a portion about 8.0 m high, Figs. 2 and 3), visual inspection did not reveal evident structural damage but only superficial decay of the materials (mainly mortar joint erosion, due to the natural ageing and the lack of maintenance). In the lower part of the tower, the corners exhibit rare thin cracks and the masonry section appears of solid bricks and lime mortars. Subsequent pulse sonic tests, double flat jacks and laboratory tests on sampled mortars and bricks confirm the soundness and the compactness of the masonry until the height of about 46.0 m. Results from pulse sonic tests suggest solid brick section, with high velocity values, ranging between 1100 m/s to 1600 m/s. Double flat jack test carried out on the N-E side at about 32.8 m from the ground level revealed that the Young's modulus is larger than 3.00 GPa. Similar information result from the laboratory tests on sampled bricks and mortars. Thermovision inspections applied on several walls of the tower portion embedded in the surrounding palace detected local niches and openings infilled even recently.

On the contrary, in the upper 8.0 m of the tower (Fig. 2 and 4) significant damages were observed, related to the abovementioned detachment of the several construction phases and worsened by the natural decay. More specifically, settlement of the interventions and of the opening infillings coupled with the highly disordered masonry and mortar erosion causes lack of horizontality of the joints of the crowing and the development of cracks as well (Fig. 5). Critical areas are the infillings between the merlons (Figs. 3 and 5), supported only by few

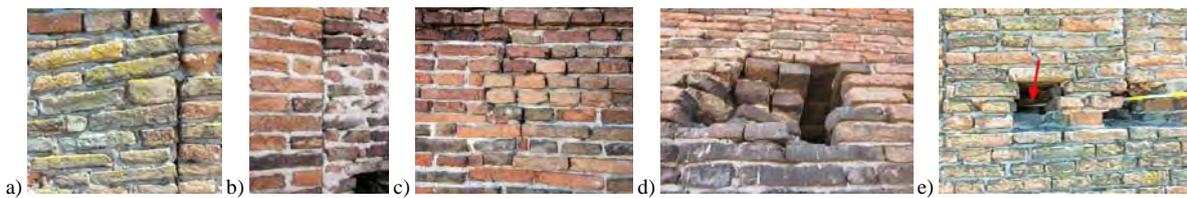
courses of thin masonry due to the unusual layout of the scaffolding holes. The extension of the scaffolding holes beside the base of the infillings weakens the local and overall stability (Fig. 5) so that the prevention of local instability of such masonry portions should be one of the intervention priority on the tower. Moreover, the collected information by the visual inspection allowed to draw up the stratigraphic survey of the fronts. The stratigraphic survey and the accurate mapping of the structural discontinuities allowed to support some concerns on the seismic behaviour of such portions. Because of the lack of effective links except the friction, some unrestrained portions could overturn for the twinned actions of the earthquake and of the roof thrust. Low intensity actions, like after-shocks or far-field earthquakes could slightly move such weakly restrained elements decreasing the adhesion and accentuating the boundaries.

Figure 5: Details of the typical discontinuities on top of the tower (a,b), of the lack of horizontality of the masonry courses (d) and of the infillings between the supposed merlons on the N-W front

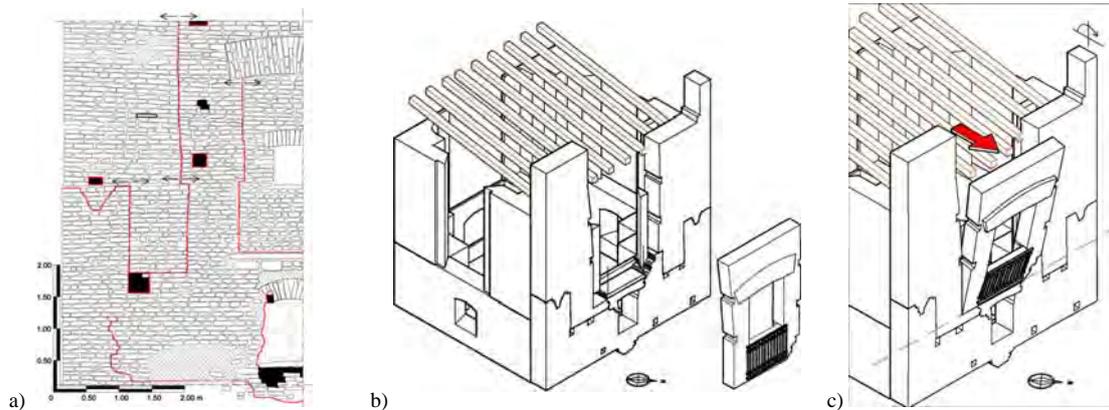
Fig. 6 shows an example of the detailed survey of the masonry textures aimed at recognising the structural discontinuities and the boundaries of the weakly restrained portions. Based on this investigation, the first evaluation of out-of-plane seismic behaviour for each recognised masonry portion not effectively linked was carried out (Fig. 6c). This procedure, implemented according the most recent technical literature and the Italian seismic code, gives an overview of the seismic vulnerability related to the building transformation over time and the effect of local damage. It is important to remark the change of the masonry sections and of the plan layout in the upper part (Levels 3 and 4 in Fig. 2), where the nearly squared plan turns into corner masonry piers and un-toothed infillings. The decrease of resisting section is especially significant for the piers on North and South corners at level 4. In fact, the corner pier at South is partially dismantled, showing an embedded pipe at the edge and the merlon shape. The lack of any mortar encrustation in the merlon surface suggests a weak connection in the other piers at the same level, as well.

Figure 6: (a) Map of the structural discontinuities; (b) identification of the weakly restrained masonry portions and (c) of the possible overturning mechanisms due to seismic actions.

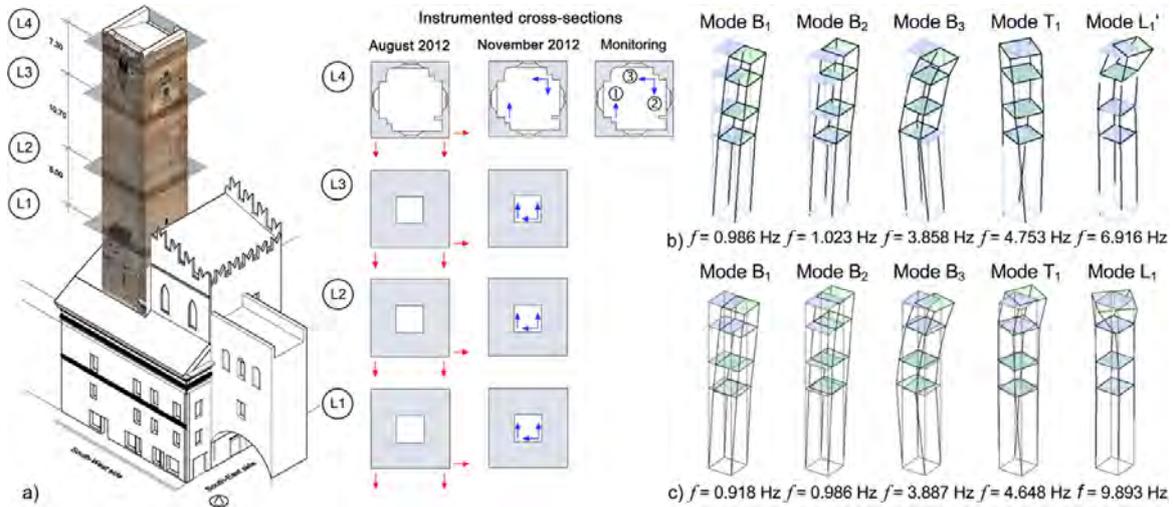
4. the last identified mode is local (L) and only involves deflections of the upper portion of the tower (Fig. 7b). The mode shape looks dominant bending, with significant components along the two main planes of the structure. The presence of this local vibration mode provides further evidence of the structural effect of the change in the masonry quality and morphology observed on top of the tower during the visual inspection. On the other hand, both visual inspection and operational modal analysis confirm the concerns about the seismic vulnerability of the building and explain the fall of small masonry pieces from the upper part of the tower, reported during the earthquake of May 29th 2012.

2. on the contrary, the mode shape T1 (Fig. 7c) now involves both torsion and bending. The identified frequency did not change appreciably with respect to the first dynamic survey, but the mode shape looks significantly different. The torsion component is still dominant in the lower portion of the structure, while the upper part is characterized by dominant bending with significant components along the two main planes of the tower. In other words, after the installation of the wooden roof the deformed shape of mode T1 (Fig. 7c) becomes a sort of superposition of previous modes T1 (Fig. 7b, lower part of the structure) and L1 (Fig. 7b, upper part of the structure). Furthermore, the previous mode L1 was no more detected;

3. the previous local mode L1 (Fig. 7b) has been "replaced" by another local mode, with higher frequency of 9.89 Hz and involving torsion of the upper part of the tower (Fig. 7c). This local mode, not identified in the first AVT, is probably related to the increase of connection between the masonry walls of the upper part of the tower induced by the new covering.

Figure 7: (a) Instrumented cross-sections and sensors layout during the dynamic tests performed on Summer 2012, November 2012 and the dynamic monitoring; (b) vibration modes generally identified during the first AVT (SSI-Data, 31/07/2012, 21:00-22:00) and (c) in the second AVT (SSI-Data, 27/11/2012).

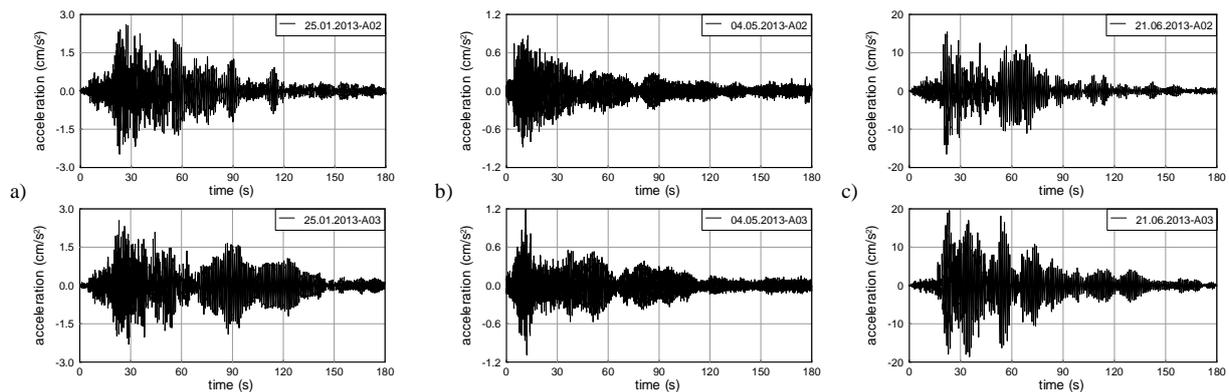
During the examined time period, the monitoring system acquired the tower's response to different earthquakes occurred in the neighbouring regions. Fig. 8 shows examples of the accelerations recorded during some seismic events, with the maximum response exceeding several times the highest level of normally observed ambient vibrations ($0.4\text{-}0.5$ cm/s²). It should be noticed that the strongest seismic event (Fig. 8c, corresponding to the earthquake which hit the Garfagnana area in Tuscany on 21/06/2013) produced significant effects on the *Gabbia Tower*, as it will be discussed in the last part of this section.

Figure 8: Seismic responses recorded on the tower: (a) 25/01/2013, (b) 04/05/2013 and (c) 21/06/2013.

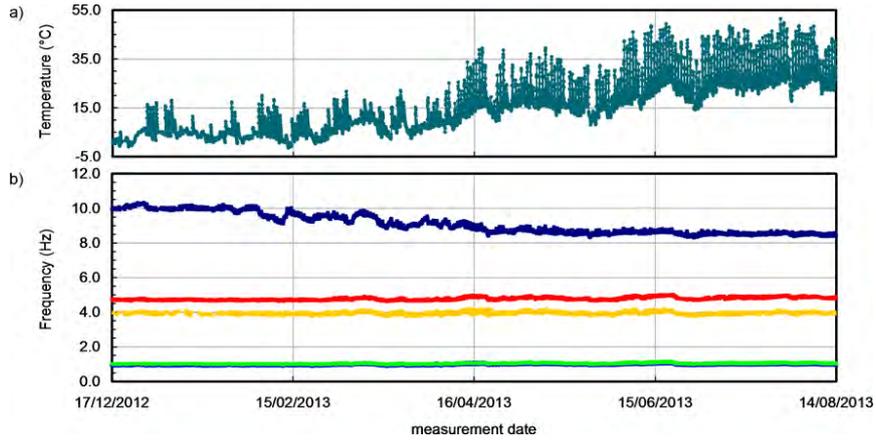
The time evolution of the natural frequency of the upper mode, i.e. the local mode L_1 (Figs 7b,c), deserves some concern because the trend of this frequency is very different from the others (Fig. 10): the modal frequency exhibits more significant fluctuations and clearly decreases in time, from an initial value of about 10.0 Hz to a final value of about 8.5 Hz at the end of the examined time period.

A careful inspection of Fig. 9 reveals that 3 clear drops of the natural frequency took place: (a) between 03/02/2013 and 04/02/2013; (b) between 14/03/2013 and 15/03/2013 and (c) between 13/04/2013 and 15/04/2013. These drops divide the analyzed time period in 4 parts, that are also easily observable by plotting the modal frequency versus the measured outdoor temperature, as shown in Fig. 10. Fig. 10 highlights that the clouds of temperature-frequency points, corresponding to each of the 4 different periods, are characterized by similar slope of the best fit line, whereas the average frequency value significantly decreases. The observed behaviour suggests the progress of a possible damage mechanism, conceivably related to the effect exerted by the wooden roof with increased temperature, and confirms – once more – the poor structural condition and the high seismic vulnerability of the upper part of the tower, highlighting the urgent need for preservation actions to be carried out. As previously pointed out, data sets related to far-field seismic events were recorded on 25/01/2013, 04/05/2013, 19/06/2013 and 21/06/2013. The latter event, corresponding to a significant earthquake occurred in the Garfagnana region, determined acceleration responses (Fig. 8c) on the top of the tower, that were more than 40 times larger than the usual ambient vibration responses

Figure 9: Time evolution of: (a) the outdoor temperature measured on the S-W front; (b) the natural frequencies identified with the SSI-data method.

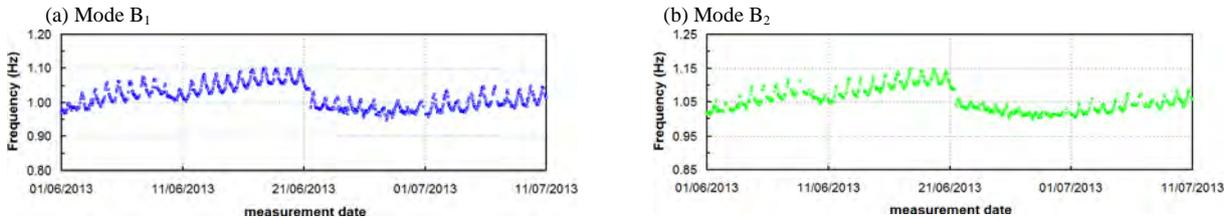
Figure 11: Zoom of the natural frequency of modes B₁ (a) and B₂ (b) in the period between 01/06/2013 and 10/07/2013.

Zooming the time evolution of the natural frequencies of lower modes B₁ and B₂, as shown in Fig. 11, highlights a clear drop of those modal frequencies, corresponding to the occurrence of the seismic event on 21/06/2013. The frequency shift is even more clear by inspecting the

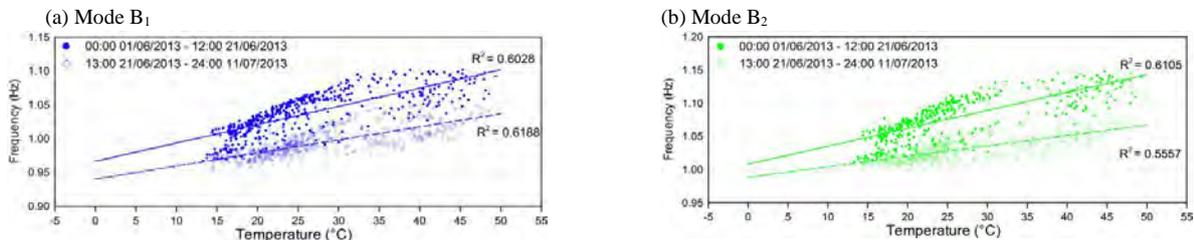
Figure 12: Change in the frequency-temperature correlation induced by the seismic event of 21/06/2013: (a) Mode B₁; (b) Mode B₂.

frequency content of the data recorded in the hour before and after the seismic event, respectively. In order to investigate whether the frequency shifts are permanent or not, the frequency-temperature relationship were inspected, including data collected in the 3 weeks before and after the earthquake. The results of this check are summarized in Fig. 12, where best fit lines have been added as a visualization aid: the regression lines exhibit a remarkable variation after the seismic event, with the range of temperature variation being almost unchanged. Both the variation of the regression lines and the arrangement of the frequency-temperature points before and after the earthquake seem to indicate that the observed slight frequency shift is non reversible.
