## STRUCTURAL AND CONSERVATION SOLUTIONS FOR THE TREATMENT OF THE SEA FRONT WALLS OF OLD AKKO (ACRE), ISRAEL

**Abstract.** *Between the years 2009-2013, the southern sea wall of the Old city of Akko underwent planned rehabilitation and conservation works funded by the Old Akko Development Company. The southern section of the wall, measuring some 300 m long with an average height of 8 m, was severely damaged by years of marine erosion and flaws in the ancient structural foundation techniques that were comprised of materials unsuited to a marine environment. Moreover, stabilization and rehabilitation attempts carried out in the 1930's of the 20<sup>th</sup> century also caused irreparable damage to the wall's foundations. The ancient city and its walls are subject to statutory limitations and considerations, as it has been declared an antiquity site by the Israel Antiquities Authority and a world heritage site by UNESCO, and is also a modern bustling town. In addition to these limitations, there are implementation restrictions for construction inside an ancient port, lacking the option to carry out works in an underwater environment. These limitations required creative thinking and

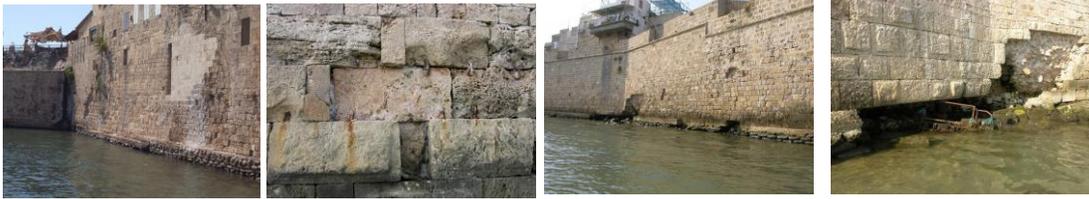
- The foundations of the sea walls were extremely deteriorated and the structural intervention in the years 1940-1970 didn't stabilize their condition.[Fig. 1a, 1b, 1c, 1d].

- There were missing stones and large gaps in the lower part of the wall at water level, large cracks and buckling, possible detachments of the exterior stone leaf, with space between it and the interior core, missing mortar between stones and missing pointing,

- There have been all over the wall exposed rusting iron pins between stones.
- On top of the aforementioned, there were damages caused by plant roots creeping between cracks and stones, as well as various inserted elements, such as iron and steel elements or leaking sewer-pipes or gutters or iron..

Fig. 1a, 1b, 1c,1d Part of the engineering failures of the sea wall

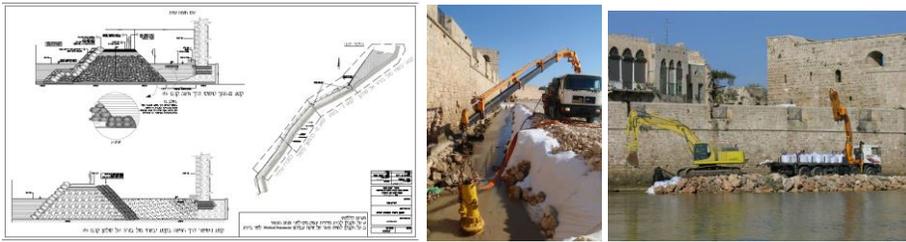
Fig. 2a, 2b, 2c The temporary rampart

A temporary rampart was constructed parallel to the wall at a distance of 6m, to create a dam which would allow drying the land in front of the wall. The rampart served also as a road for the

mechanical vehicles and conveying equipment. [Fig.2a,2b,2c]. The rampart was built with an inner pyramidal shaped section piled with a double layer of large synthetic sacks, filled with natural clay sediments. Each layer of bags was separated from the upper one with a double layer of geotechnical cloth. The exterior layer of the rampart was built with large boulders placed on the bank facing the sea to act as a barrier against the sea waves. Crushed kurkar gravel was spread over the upper side of the rampart, creating a large 4 m wide. The cross-section of the rampart was a pyramid with a 30-45° slope; its foot 4 m from the wall, some 2 meters above sea level. In the next strips, the base of the rampart was removed to a distance of 6 m from the base of the wall.

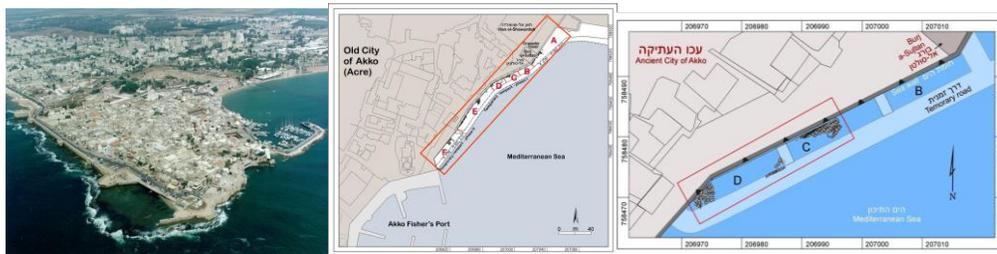
Fig 3a, 3b, 3c Old Akko and the section of the treated section and its "working pools"

The area between the rampart and the seawall was divided into 6 separate "working pools" (areas A-F; Fig.3a, 3b, 3c) and the seawater was pumped out of each 2 pools in turn, enabling contemporaneous archaeological excavation and conservation work. Excavation trenches were dug alternately, with the "stich and un-stich" or "cuci scuci" method, until the completion of the sequence strip along the wall. During the clearing and cleaning process, huge amounts of building debris and garbage was removed to a sorting site; chiseled stones were separated from the field stones and debris, and were returned to the wall to be used in the reconstruction process. The foot of the wall was excavated down to the bedrock and temporary reinforcement scaffolding was erected.

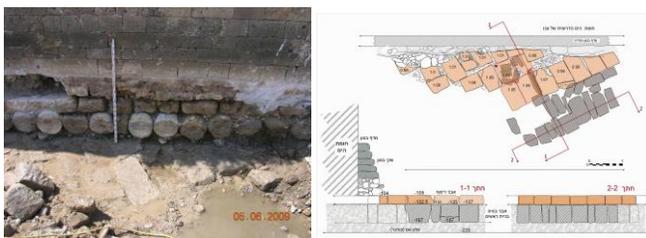
Nearby the southern edge of the Ottoman pyramid-form foundation an impressive floor was exposed built of stone slabs each measuring 0.8x0.4x0.15 m. The length of the exposed floor area is some 30m and it continues both northwest underneath the wall and southeast under the temporary dam. The stone slabs were placed on a layer of cut kurkar stones arranged in the header technique. A test pit was dug under the floor revealing a sealed layer of sludge that characterizes the bottom of a harbor; containing numerous Hellenistic finds (3th-1st cent. BCE), attesting to the fact that the platform was built during the Hellenistic period and probably functioned as a docking platform. While constructing the wall during the Ottoman period, a line of columns was placed on part of the Hellenistic floor as the foundation for the wall. This shows that the Ottomans were aware of the Hellenistic floor and used it as a foundation for the wall (Fig.4, 4a, 10). The existence of the quay was also known during the British Mandate as is apparent from a Mandate map based on Marino Sanudo's 14th cent CE map (Makhouly and Johns 1946, [7]: ).

Fig. 4, 4a, Foundation of type C.

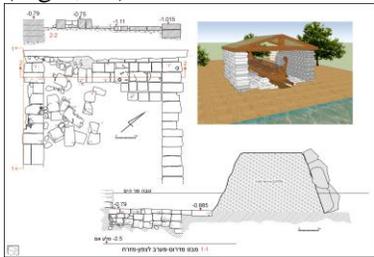
A rectangular structure 5 m long and 8 m wide with an east-west orientation that continues underneath the Ottoman building, as well as seaward continuation underneath the temporary battery. The structure is built of two thick walls made of large cut kurkar stone slabs that were laid in the header technique (Phoenician style) and in between them is a stone paved floor some 6 m wide with a slight seaward slope.(Fig 6,14 )

Fig. 6 Foundation type G

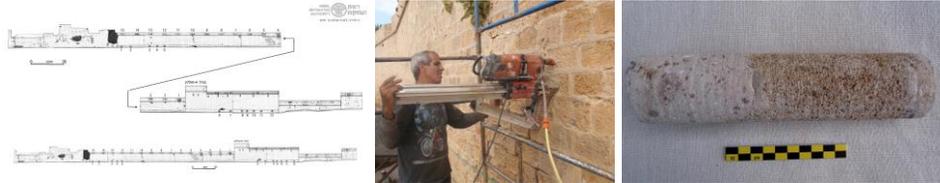
Fig. 16 a, 16b, 16c Drilling of "cores" in the sea walls

Drillings no. 3, 4, 7 penetrated into the cavity of a structure, probably a vault. It is not yet clear whether the vault is whole or rubble of a collapsed vault. It seems as if the drillings penetrated through the foundation courses of the wall that were built with chiseled kurkar-stone 1 m thick and filled with field stones and aggregate.

Drillings no. 5 and 6 were undertaken at a height of 7 m above sea level, from two sides of a crack that was seen in the wall underneath the "balustraria". The drilling revealed that the width of the outer stone layer is 1 m and behind it there is a muddy filling aggregate. Analyses of the array of vaults revealed that the drillings penetrated into a wall supporting a roofed vault built for the canon's platform.

Drilling no.8 was undertaken at the southern seawall of the Burj-el-Sultan tower. The drilling revealed that the wall was constructed of chiseled kurkar stone 1m wide and behind it 2 m' of aggregate filling containing small stones. Behind the aggregate filling is a cavity and small stones. Examination inside the Burj-el-Sultan tower two story vaulted rooms revealed that the lower vault was used as a water reservoir.
