## COLLAPSE AND REBUILDING OF A MEDIEVAL CITY WALL – AN ASSESSMENT OF THE STRUCTURE AND MATERIAL

**Abstract.** *In February 2012, a part of the medieval city wall of Visby collapsed. The wall was constructed in several stages in the 13th and 14th centuries. It was decided that the collapsed part of the wall should be rebuilt. To determine a procedure for the rebuilding and to secure a safe work site, it was necessary to define the construction and structural behaviour of the wall. Furthermore, the cause of the collapse needed to be identified, in order to assess and predict the risk of future damage to other parts of the wall. An investigation into the construction of the wall was carried out through archival research and on-site examinations. Laser scanning made it possible to describe and study the geometry of the wall and the damage in detail, and a structural analysis was carried out. The results show that the wall was built in two stages, making its construction complicated. The structural analysis indicates that there is a concentration of forces to the outer masonry leaf of the lower part of the wall. The collapse was most likely triggered by freezing of the water contained

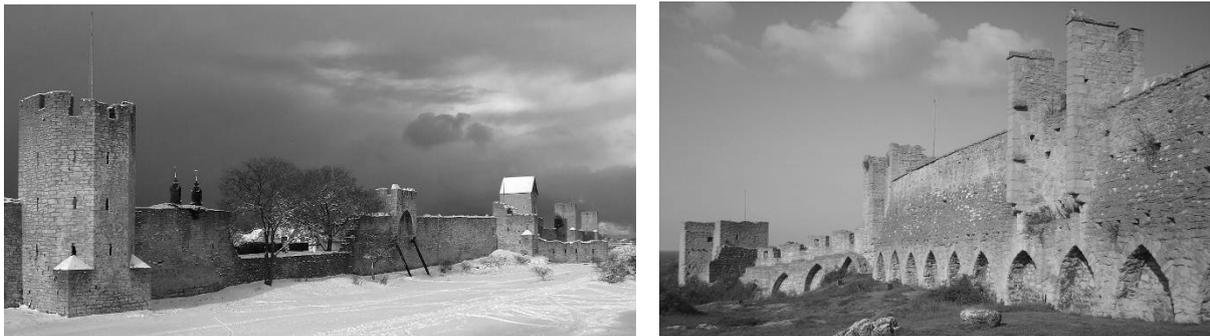
Figure 1: Visby City Wall seen from the outside and the inside. The smaller wall towers ride on top of the wall. Old collapses as well as different kinds of reinforcing structures can be seen in many places.

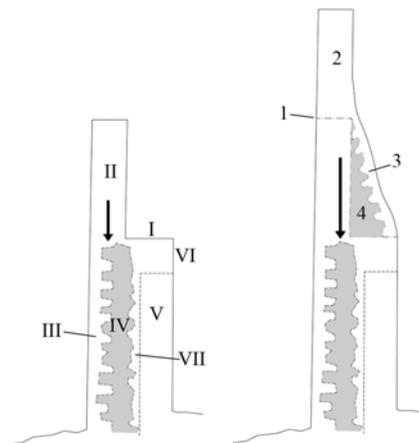
The original land wall was about six metres high and had a parapet with crenellations and a rampart walk on top of an arcade on the inside; see Figure 2. The contour of that wall can still be seen within the stonework of the current wall [8]. The wall has a thin outer leaf of

bonded masonry, about 25-50 cm thick, and an arcade of pointed masonry arches, approximately 70 cm thick, on the inside. In between, there is a loose rubble core of stones varying in size and clay mortar. Except from the upper, thinner part of the wall, there are no through stones and a limited number of stones that bind the outer leaves to the core. The outer leaf and the arcade were built with lime mortar. The parapet wall was also built with lime mortar as a homogeneous wall, about 75 cm thick. Since the thickness of the parapet wall is greater than the outer leaf of the lower part of the wall, it stands partly on the core and partly on the outer leaf masonry.

When the wall was heightened by 2-4 metres, the parapet wall was used as an outer leaf and a bottleneck-shaped addition was built on the rampart walk, with an upwardly narrowing core of smaller stones and lime pressed against the parapet wall. Since the parapet wall was reused as an outer leaf, no binding stones exist in that part. The top part above the former parapet wall was built as a homogeneous solid wall.

Figure 2: Simplified sections of the land wall. The section to the left shows the land wall before it was heightened and the section to the right shows it after the heightening and the structure today. The arrows show the eccentric loading of the outer leaf. I) Rampart walk. II) Parapet. III) Outer masonry leaf. IV) Core with clay mortar and no bond. V) Openings of inside arches. VI) Top of inside arches. VII) Thin masonry leaf inside arches. 1) The height of the original wall (left image). 2) Heightening of the wall in solid masonry. 3) Masonry leaf of bottleneck-shaped masonry. 4) Upper core inside former parapet wall.

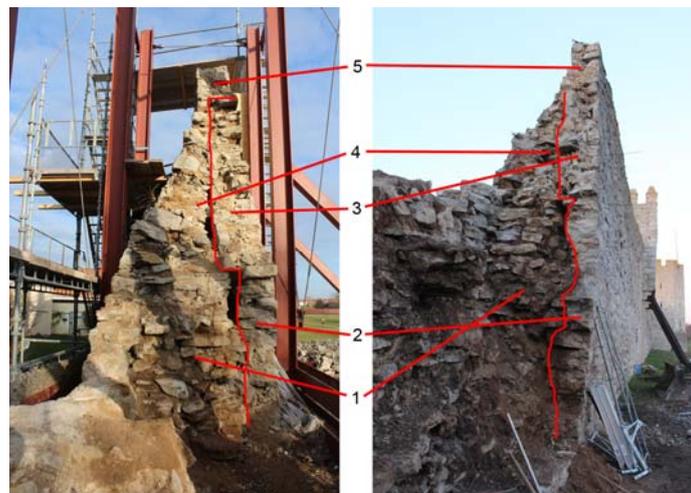
Figure 3: Two photos showing the same part of the wall at two different stages of dismantling of the collapsed part. 1) Lower core with clay mortar and no bond. 2) Thin outer masonry leaf. 3) Former parapet, now outer leaf of the middle part of the wall. 4) Upper core inside the parapet wall. 5) Top with solid masonry.

The collapse had exposed several weaknesses in the structure of the wall clearly. A recurring problem, described in various records, is cavities in the core and between the core and the outer leaf. At several locations this has led to bulges in the outer masonry leaf. This problem was very evident at the northern side of the collapsed part, where large cavities between the outer masonry leaf and the core became visible; see Figure 3.

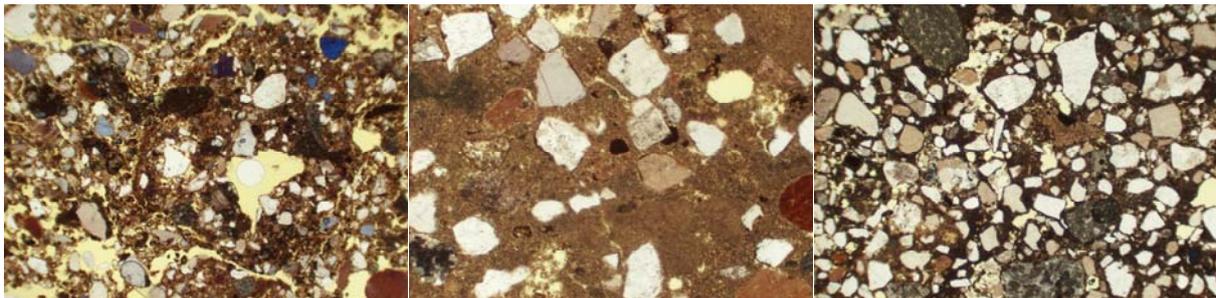
Figure 4: The first sample represents the clay mortar used in the wall core beneath the rampart walk. It is a clay soil type containing sand, resulting in a rather fat clay mortar. The second sample represents the type of fat lime mortar used in the first building phase of the wall, in the two leaves and in the compact masonry above the level of the rampart walk. This is a very fat lime mortar where the amount of lime is greater than the amount of sand. The third sample represents the type of lime mortar used in the second building phase. The yellow colour shows the pore system, the brown colour shows the binder and the other particles show minerals in the sand. The width of each thin section is equivalent to 4.5 mm of the sample.

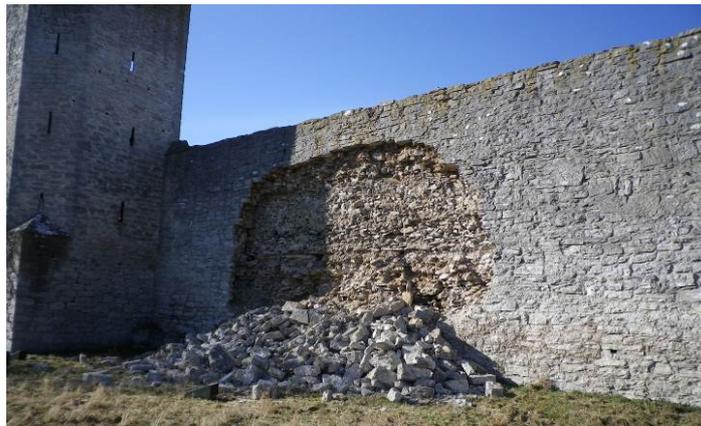
The collapse in 2012 resulted in the falling down of approximately 90 m<sup>2</sup> of the outer masonry leaf. The upper part of the wall, consisting of solid masonry, did not collapse and remained as an arch above the damaged part; see Figure 5.

The collapse was most likely triggered by freezing of the contained water. The combination of high stress levels in the outer masonry leaf, due to the construction of the wall, with a loose core, thin outer masonry leaf, insufficient binding stones and weak adhesion in the bedding lime mortar in the lower part of the wall, led to a domino effect, causing the extent of the collapse.

Figure 5: Visby City Wall in 26th of February 2012, a couple of days after the collapse.

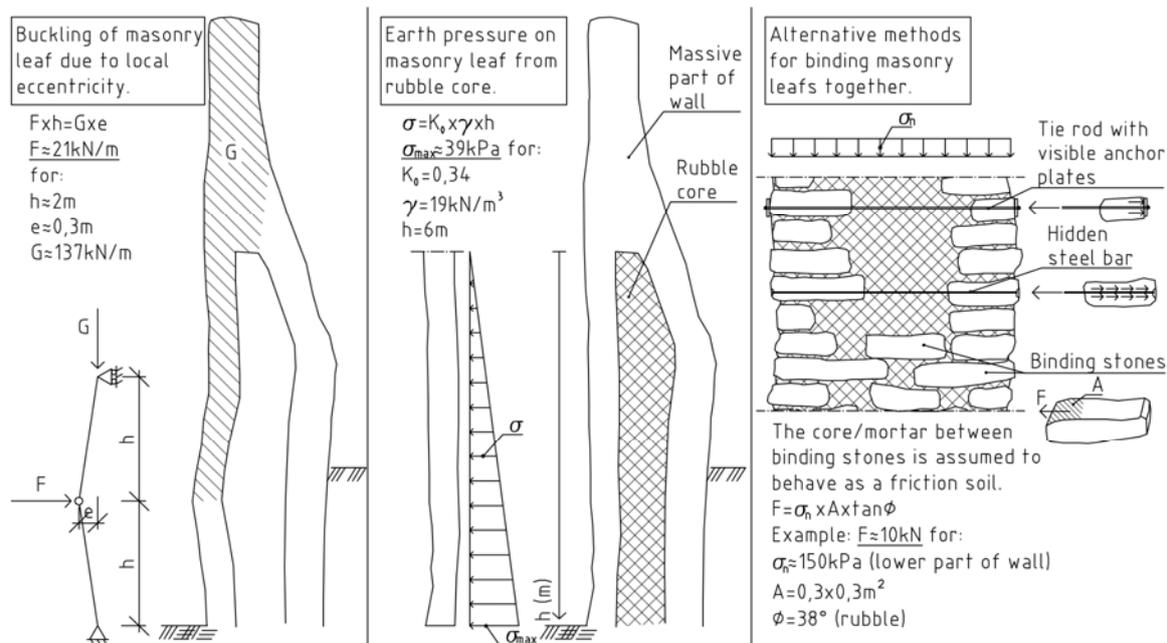
the number of binding stones needed, two hypothetical load cases were used: local buckling of the outer masonry leaf and earth pressure from the core [16]. Both load cases give rise to forces of approximately the same magnitude; see Figure 6. These load cases are based on a wall structure in bad condition, in contrast to the rebuilt part, and can therefore be presumed to have a satisfactory factor of safety.

Figure 6: The hypothetical load cases used to design the number and placing of binding stones for the rebuilt part and reinforcing bars in the adjacent parts of the wall.

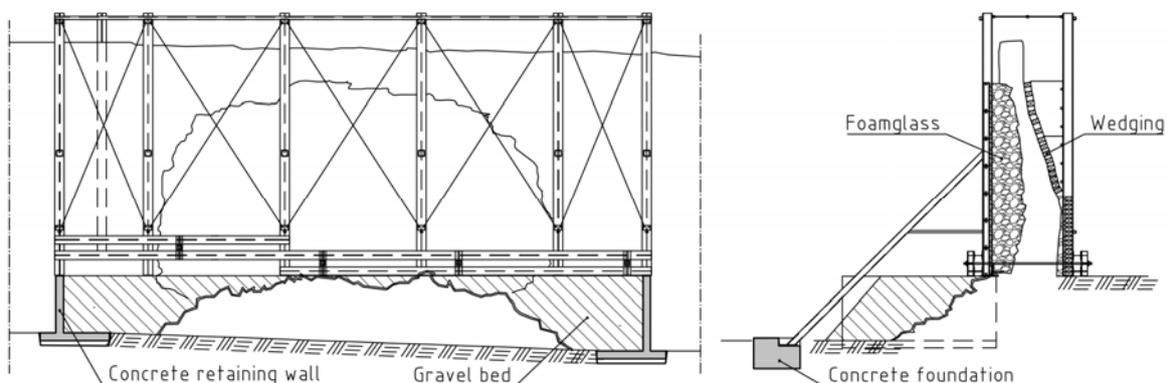
Figure 7: Drawings for the temporary supporting steel structure with counter-filling and wedging.

The concept of the temporary structure was to restrain the wall from further collapse by counter-filling a formwork at the outside and placing wedges between the inside of the wall and the steel structure. The counter-fill on the outside created a passive pressure that was larger than the worst case of active pressure from a collapsing wall. Granulated foam glass was used as the filling material, as it is both light-weight and has high strength. The steel structure was held together at the top and through four holes drilled in the wall at the bottom. The structure also stabilised the adjacent walls on both sides of the collapse site; see Figure 7.

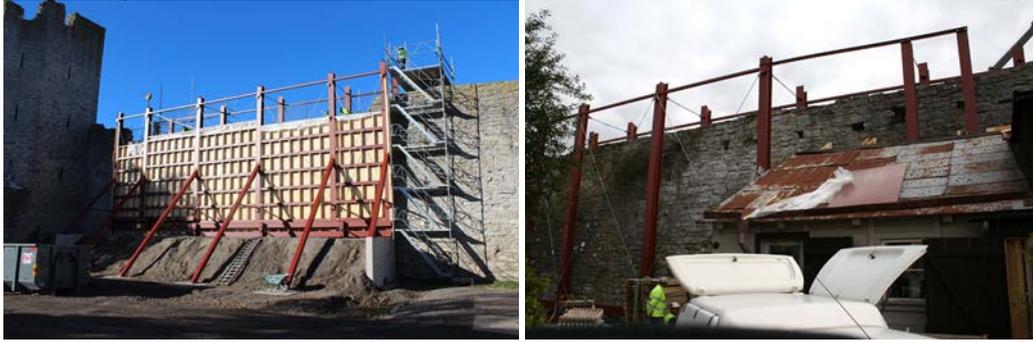
Figure 8: The temporary supporting steel structure, viewed from the outside during dismantling of the wall (left), and from the inside during erection (right).

Since the ground level is about two metres higher on the inside of the wall and there was a pile of stone rubble on the outside, a new ground level had to be created for the temporary steel structure on the outside, through the use of concrete retaining walls and gravel. The steel structure also had to be adapted to fit in between the wall and the building close to the wall on the inside; see Figure 8.
