## RE-STRENGTHENING 20<sup>th</sup> CENTURY ARCHITECTURAL HERITAGE: A CASE STUDY OF BRISBANE CITY HALL RESTORATION

Arturo Cruz

Queensland University of Technology (QUT)  
2 George St, Brisbane QLD, Australia  
[arturo.cruz@qut.edu.au](mailto:arturo.cruz@qut.edu.au)

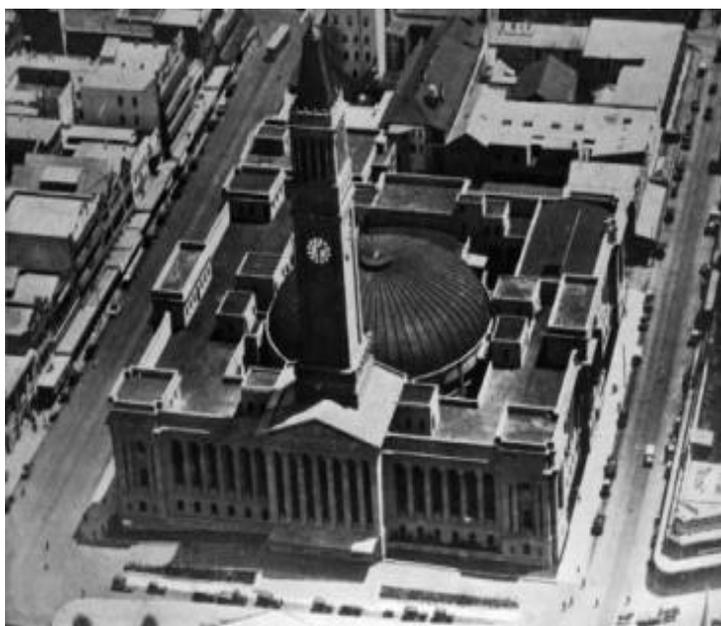
Several problems and their related causes were identified and documented. One major problem was the ingress of water to the basement of the building due to the leak coming from the roof. It was claimed that there was a subsequent differential settlement of the foundation where the water was ponding[3]. A photograph taken a year after Brisbane City Hall opened in 1930, shows the original flat roof (See Figure 2). That physical condition of being flat where water

Figure 2 Photograph showing the original condition of the concrete flat roof (Source: Brisbane City Council)

could easily be trapped would be susceptible to maintenance problems. It was recently discovered that the roof was leaking badly due to the limitations of the waterproofing system. The major contractor's (ABI Group) project manager, Rod Boxall, explained that they had a problem installing a watertight seal on the surface of the flat roof. The floor surface of the rooftop was exposed and it revealed that bitumen membrane was used in the past to protect the floors below from water ingress. The bitumen membrane that was used for waterproofing was originally from Northern Europe where they have a cooler climate. This technology was used 60 to 70 years ago and was not tested against the Queensland climate. Once the

membrane was subjected to the harsh climate of Queensland, it became relatively brittle.

Cracks also appeared in the concrete as structural movement occurred. From the weakest point, the water found its way below the barrier until it reached the steel reinforcement of the structure. It was quite evident that previous repairs were just cosmetic and lacked thorough problem analysis that could have led to a substantial solution. As a result, the structure that was added to the roof was demolished because of the leak that was causing serious damage.

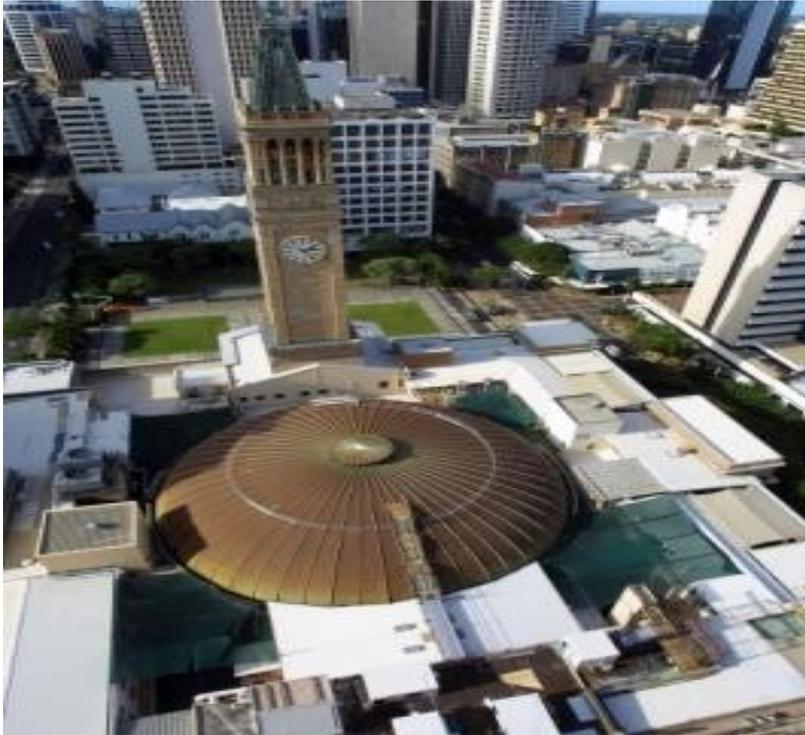
Figure 4 Photograph showing the roof with items that were added over the years (Source: Brisbane City Council)

As mentioned earlier the failure of the original waterproofing membrane on the roof allowed water to seep into the building. The concrete was porous in places so the water was able to penetrate through the concrete roof. It came into contact with the reinforcement which eventually corroded. As the steel expanded it caused chunks of concrete to spall and break away, exposing the full surface of the reinforcement and eventually undermined its strength and integrity as a structural material.

Over the years several items in the roof such as the kindergarten school, air-conditioning systems and equipment were added that

eventually led to further maintenance problems (See Figure 4).

To mitigate the cause of the problem, it was decided to completely strip back the concrete and apply a new liquid membrane to make sure that there would be no chance of any future water leakage; the roof would be covered by another layer of waterproofing membrane for additional protection [3].

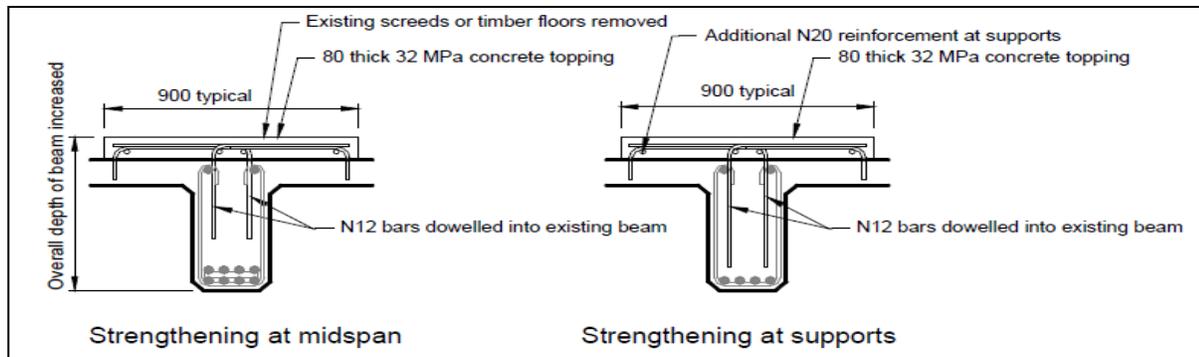
Figure 6 Overlay strengthening details (Source: Cartwright, 2011)

The Aurecon Group devised two methods of strengthening. The first one, an innovative approach, was the provision of an overlay on top of the existing beams and girders. The idea was to increase the strength of the beams by adding additional bending and shear reinforcement in a concrete overlay along the affected length of the beam. The additional steel reinforcement is drilled and epoxied vertically into the existing beams underneath (See Figure 6 & 7).

This technique increases the effective depth of the beam at mid-span resulting in a greater rigidity of member that would furthermore decrease the deflection. The vertical dowel bars were drilled into the beams to resist the horizontal shear force between the new and old concrete.

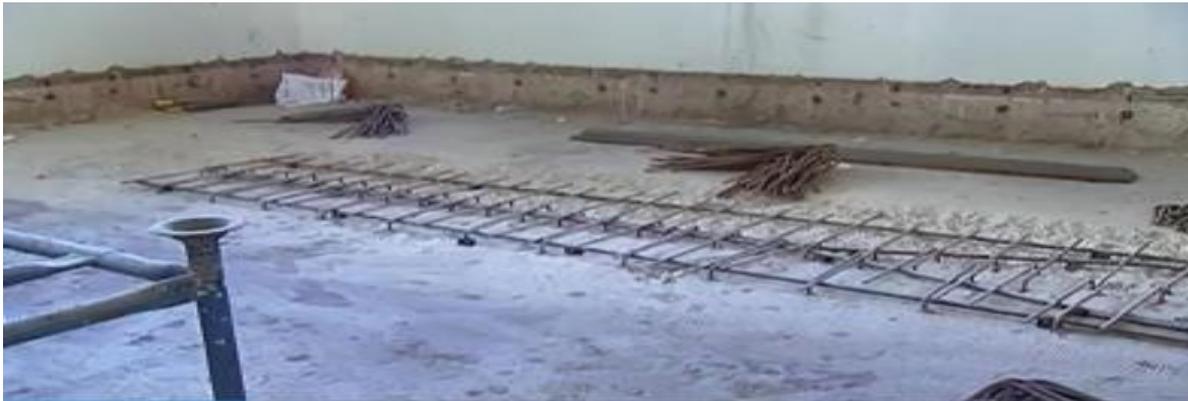
Figure 7 Photograph showing reinforcement drilled and epoxied vertically into the existing beams underneath (Source: The Soul of Brisbane)

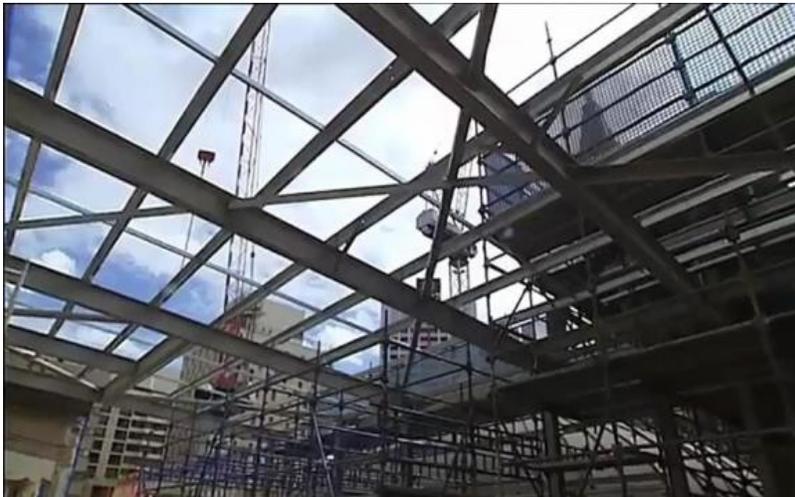
Figure 8 New steel structures designed to restrain the existing high stone parapets (Source: A. Cruz)

When the City Hall was constructed, earthquake loads were not considered as significant for buildings in Brisbane. Recent expert analysis indicated that the frame on its own lacked sufficient bracing strength. Currently there is a building requirement contained in Structural design actions [8] and Strengthening existing buildings for earthquake [10]. The latter code recommends that the horizontal seismic load applied to the existing structure is reduced to 33% of that used in

At roof level, the use of a steel structure for the new Museum of Brisbane is intended to restrain the existing high stone parapets (See Figure 8). It was also indicated that additional works would be carried out on the clock tower to ensure that the balustrades and finials are adequately restrained [3].

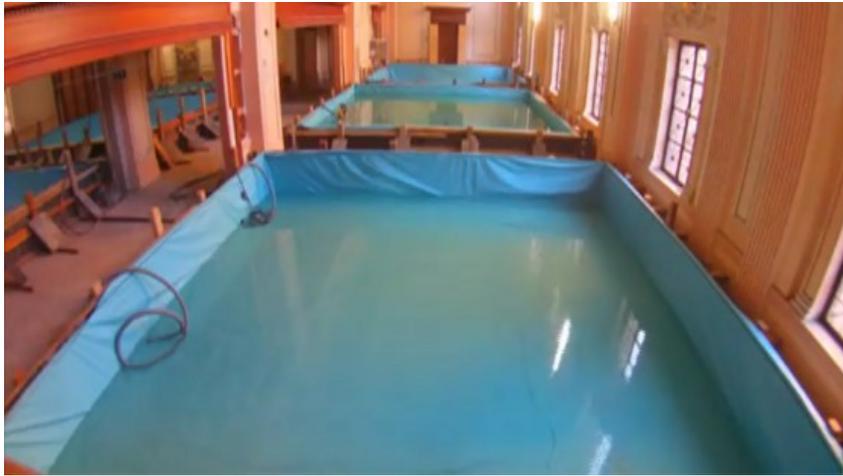
Figure 9 Water tank filled with water to test beam deflection when subjected to load (Source: The Soul of Brisbane)

Full scale load testing (as shown in Figure 9) was carried out to check if the strengthening had been done correctly between the 26<sup>th</sup> May and the 8<sup>th</sup> June 2011. The test was carried out on level one in the north quadrant of the building (the Balmoral and Oak Table rooms). The objective was to test the typical strengthening works installed on the beams and girders. The soffit of the girders and beams were inspected for existing cracks.

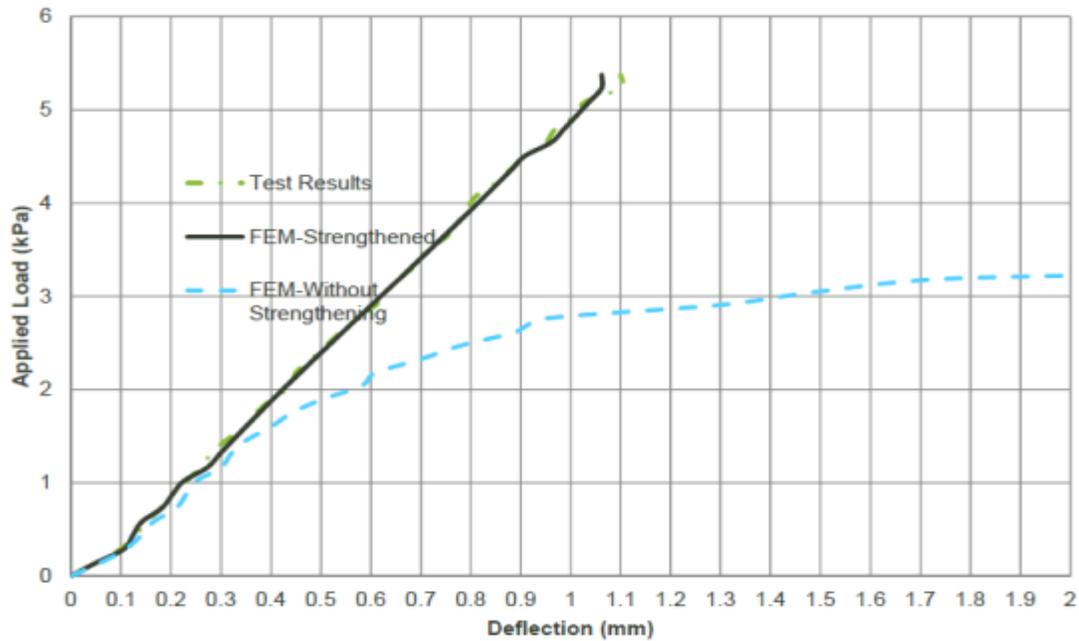
Figure 11 Comparison of the load test with the theoretical analysis (Source: Aurecon)

The results of the load test are summarised in Figure 11, which shows the deflection against the applied load for the onsite strengthened girders, along with the theoretical results for both strengthened and un-strengthened girders (both modelled using finite-element analysis).

With a 3.0 kPa imposed floor load, the deflection of the strengthened girder was similar (approximately 0.6 mm) for both the theoretical analysis and the load test. This was a significant improvement over the theoretical analysis of the un-strengthened girder, which had a higher rate of deflection, and which had failed at approximately 3.2 kPa. The measured deflections were well

within the generally accepted limiting value of span / 500 (for beams where the line of sight is along the soffit).

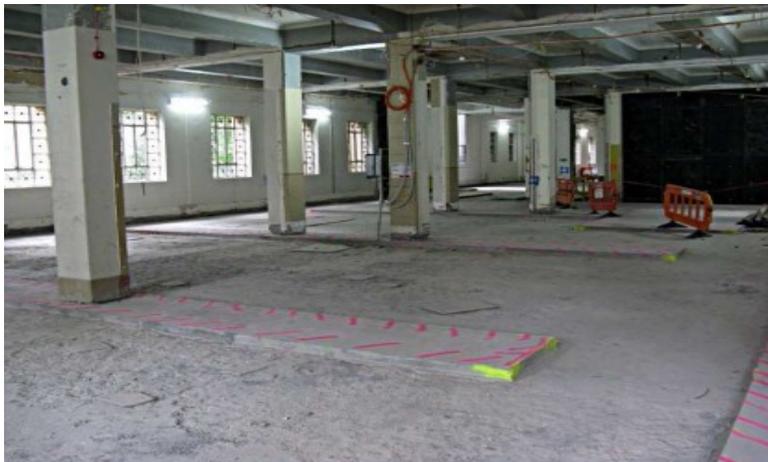
Figure 12 Completed overlays of beams and girders (Source: A Cruz)

A visual inspection of the beams and girders after the tests revealed only fine cracking in the tension zones. This is to be expected in reinforced concrete members where the cement structure has to crack in order for the reinforcement to be effective in tension. As a result of the load test a permanent deflection in the

girders of approximately 0.05 mm was recorded.
