## INVESTIGATION OF THE MASONRY PILLARS OF A MODERNIST BUILDING OF HOSPITAL DE SANT PAU, BARCELONA

**Abstract.** *The methodology employed and the results obtained from an experimental campaign to determine the compressive strength of a masonry pillar extracted from an early 20<sup>th</sup> century building are presented. The samples of the pillar were extracted from a structure located in the Hospital de Sant Pau modernist complex. The pillars analyzed are characterized by a circular section of a diameter of 60 cm, and are composed of clay bricks and, instead of the more common lime based mortars, Portland cement as a binder. The pillars show a complex interior morphology including an outer layer of regular masonry in combination with an internal core composed of an irregular mix of mortar and brick portions. The material, geometrical and structural typology of the pillars investigated are fairly representative of the pillars encountered throughout the hospital complex, therefore making the determination of its capacity of wide interest for the structural study of several adjacent buildings.*

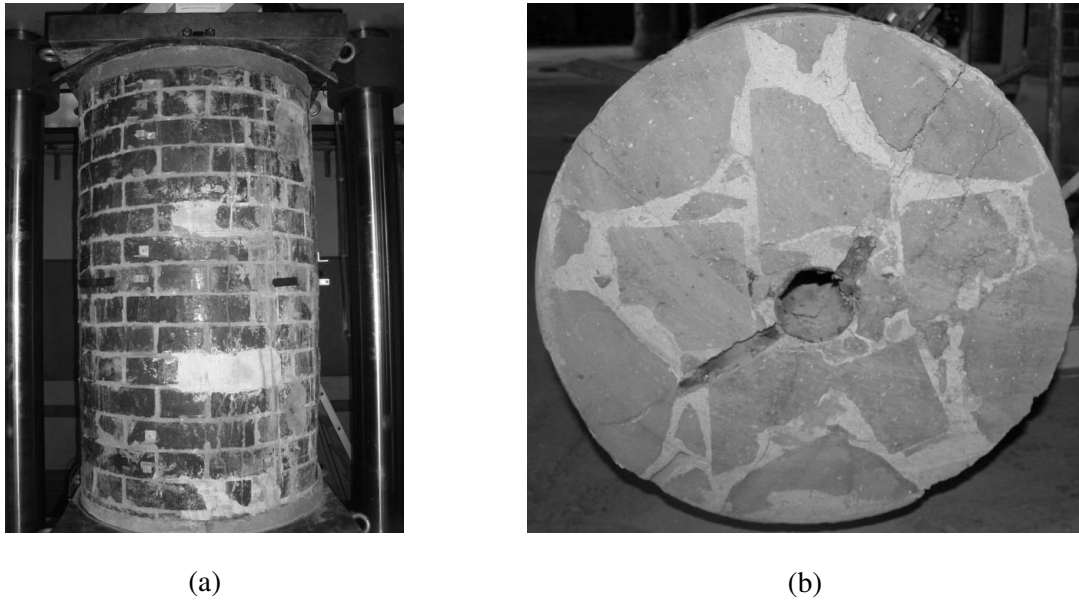
Several distinct damage patterns are visible in the exterior, the most prevalent of which is a set of three large vertical cracks extending to nearly the entire height of the pillar. Several smaller vertical cracks are also present. A large spalling area is also visible near the base which spans several courses in height and a few centimeters in depth. The supports of previously installed timber elements are also visible, having left voids several centimeters in depth.

Figure 1: (a) External and (b) cross sectional geometry of the pillar.

While the exterior structure presents complete regularity, inspection of the cross sections, made visible by the diamond thread cuts, revealed a somewhat irregular internal structure, in which the “header” bricks are but a few centimeters thick. The “stretcher” bricks have more regular internal dimensions. The infill of the pillar is composed of 5 bricks of moderate dimensions and smaller brick fragments resembling a rubble masonry structure. The mortar, however, appears well compacted, although several voids were found. The center of the pillar is vertically traversed by a drainage pipe with an external diameter of 90 mm. The pipe appeared heavily corroded. The large vertical cracks can be seen to extend to the center of the pillar (Figure 1b).

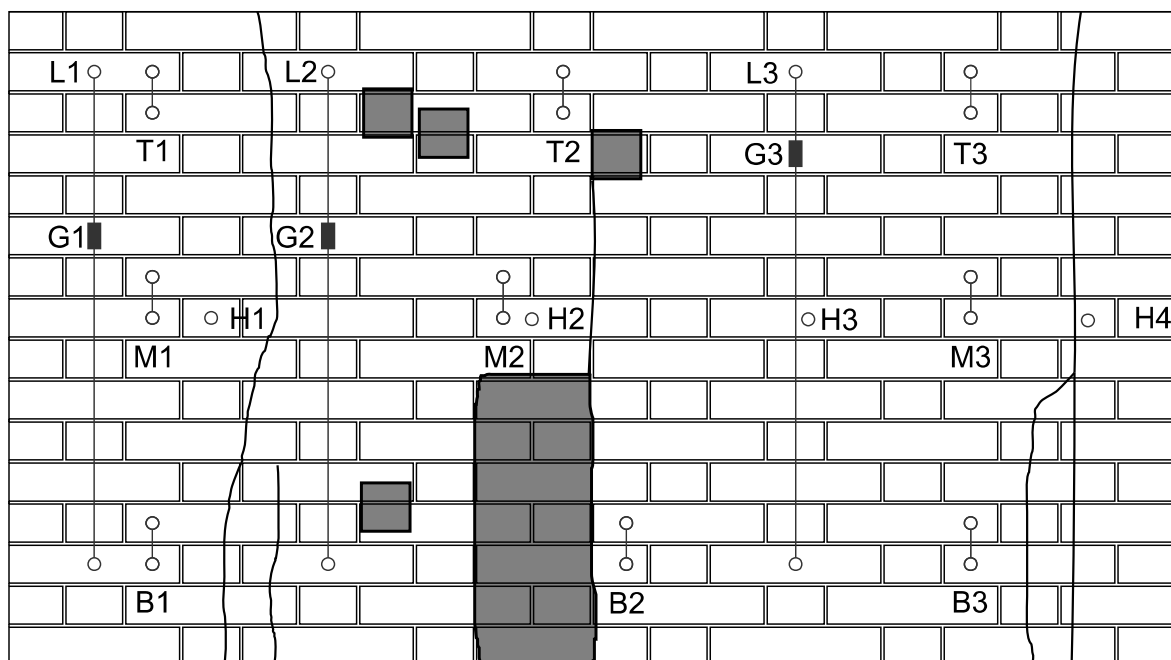
The arrangement of the instruments is shown in Figure 2, along with the existing damage documented through visual inspection. The distribution of the large vertical cracks and the location of the spalling area divide the pillar in three uneven segments: one part consisting of roughly half the pillar and two parts consisting of roughly a quarter of the pillar each. This fact, along with the superficial damage, dictated the arrangement of the instrumentation.

Figure 2: Existing superficial damage and instrument placement. L: large vertical transducers, H: small horizontal transducers, T, M & B: small vertical transducers at the top, middle and bottom, G: strain gauges.

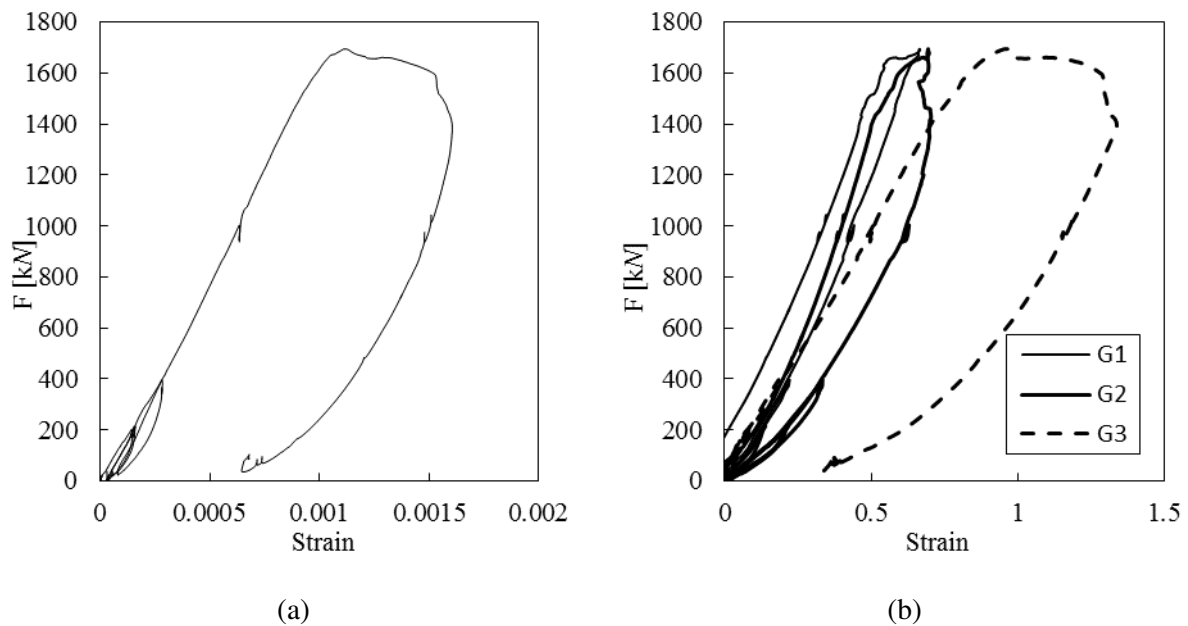
The peak force attained was  $1694 \text{ kN}$ , corresponding to  $5.6 \text{ MPa}$  of compressive stress. The elastic modulus of the pillar at 50% of the maximum load was  $6075 \text{ MPa}$ . Throughout the application of the load and before the attainment of the maximum force, the variation of the elastic modulus was very small, owing to the good compaction of the concrete used in the joints. The force-axial strain response curve, the strain having been calculated from the displacement measured at the large vertical transducers, is presented in Figure 3a.

Figure 3: Force-axial strain curves: (a) transducers and (b) strain gauges.

Figure 3b illustrates the strain measurements from gauges G1, G2 and G3. According to these readings, the elastic modulus of the bricks is equal to  $7320 \text{ MPa}$ . Given the irregular structure of the pillar and the very short measurement length, it is not certain that the stress in the brick is equal to the average vertical stress at the pillar. Therefore, this value can only be considered as a rough indication of the elastic modulus of the bricks.

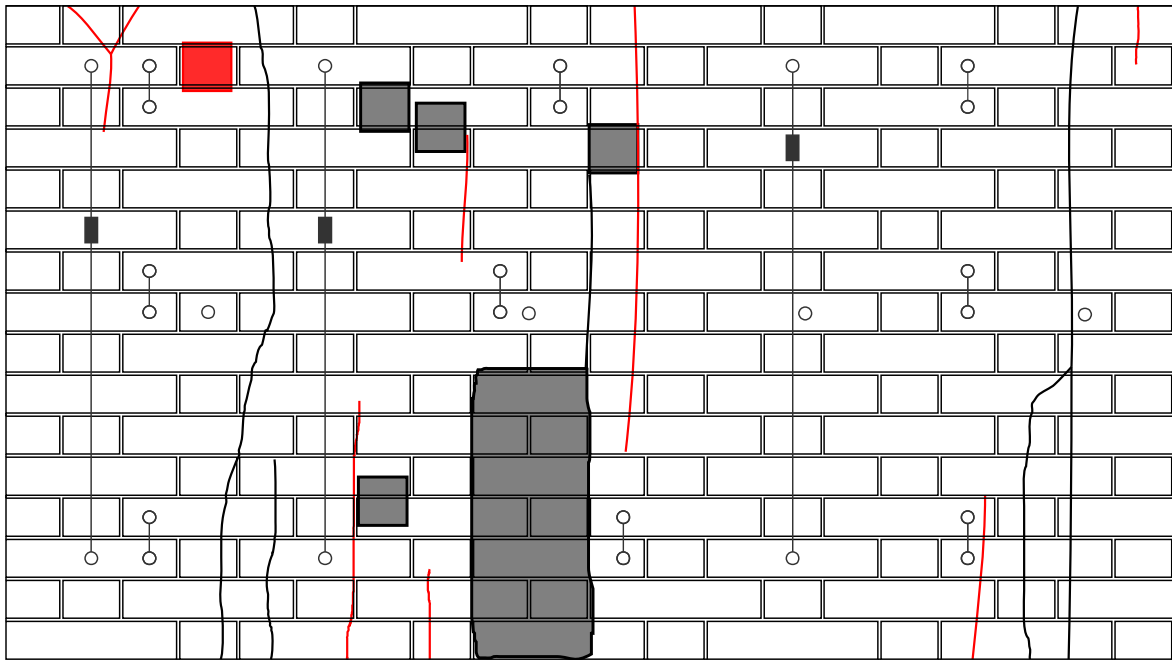
The progression of damage was visually monitored during the test. At a load of  $1000 \text{ kN}$  the large preexisting vertical cracks had expanded into the concrete caps and new vertical

cracks had appeared on the surface. It is assumed that the preexisting cracks exhibited further opening. Near the maximum load, limited superficial spalling of bricks was registered, while the already large spalling area near the base had degraded, but not significantly.

Localized damage in the joints, such as vertical cracks in the head joints or crushed mortar in the bed joints was not noticed at close visual inspection. Furthermore, superficial damage in the bricks was mostly limited to “header” bricks, which are only a few centimeters thick at most points. Crushed material was not found to have fallen from the pillar in any significant amount from either the bricks or the joints. No cracks or other damage appears to have originated from the pins used for the anchoring of the measurement instruments. The concrete caps also did not appear to bear significant damage except near the edges. Removal of the concrete caps also revealed that no localized damage had been caused near the load surfaces.

This global failure appears to have developed mostly along the preexisting vertical cracks and resulted in separation of the three pillar segments. The new damage identified at the end of the test, along with the preexisting damage, is shown in Figure 4. It is clearly indicated that most new vertical cracks originated near the anchor points of the old timber elements. These too extended to the concrete caps. No evidence of crushing damage was discovered in neither the bricks nor the joints and new vertical cracks were limiter in number and expanse.

Figure 4: Preexisting (black) and new (red) damage at the end of the test.

It is therefore understood that the noticeable preexisting damage possibly has a strong effect on the compressive capacity of the pillars. Irregularities or voids in the interior of the pillar may also have caused this lower than expected capacity. Therefore, the repair, strengthening or replacement of pillars of this typology in the building investigated may be

necessary at least in those cases where similar damage patterns are encountered: large vertical cracks extending well into the interior of the pillars.

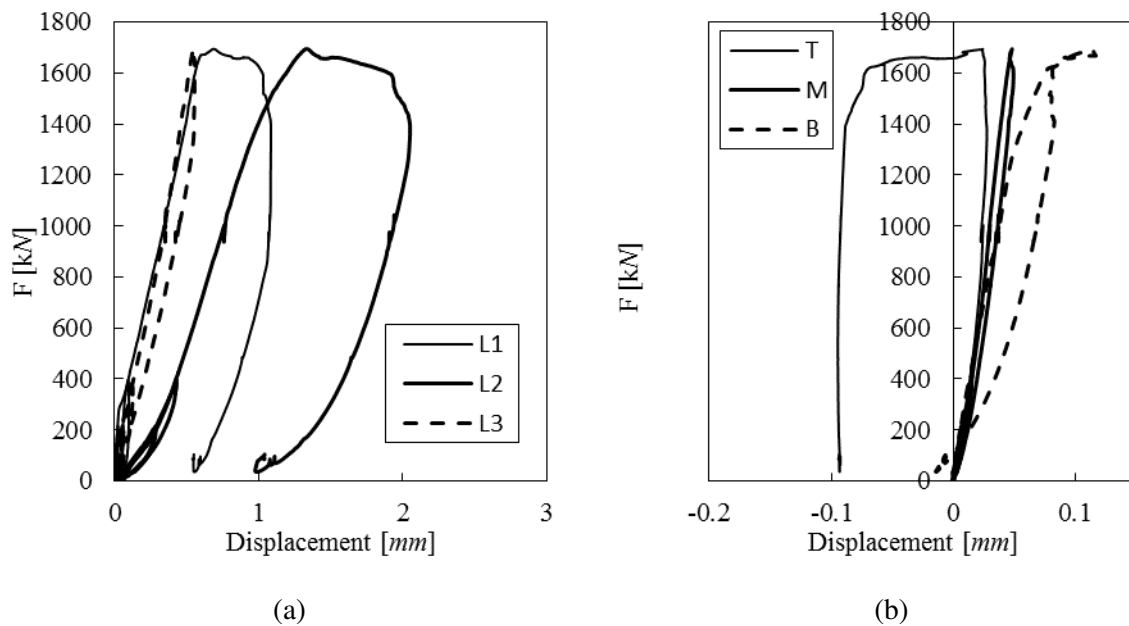
Whereas global axial stiffness, defined as the average stiffness derived from the large vertical transducers, was steady until failure, different values of stiffness were registered in each of the three masonry segments. Transducer L2 in particular showed a much smaller stiffness than L1 and L3, especially for low loads and for loads near failure, as can be seen in Figure 5. The L2 transducer was placed near the large spalling area which may account for this behavior. Another discrepancy was found in the behavior registered at different heights by the small vertical transducers, which is also illustrated in Figure 5. The bottom transducers recorded a clearly nonlinear response near the peak, the middle transducers recorded an almost elastic unloading after the peak, as did top transducers following a sudden expansion after the unloading process started. At 50% of the maximum load the top transducers registered a stiffness of 13511 MPa, the middle transducers 9196 MPa and the bottom transducers 6111 MPa.

However, the transducers at each level did not register the same stiffness, especially at the top part, where the maximum stiffness was  $20252 \text{ MPa}$  and the minimum was  $7883 \text{ MPa}$  at T3 and T1 positions respectively. The variation was much smaller for the other two levels.

Figure 5: (a) Force-displacement curves: (a) L1, L2 and L3 transducers and (b) average of top, middle and bottom transducers.

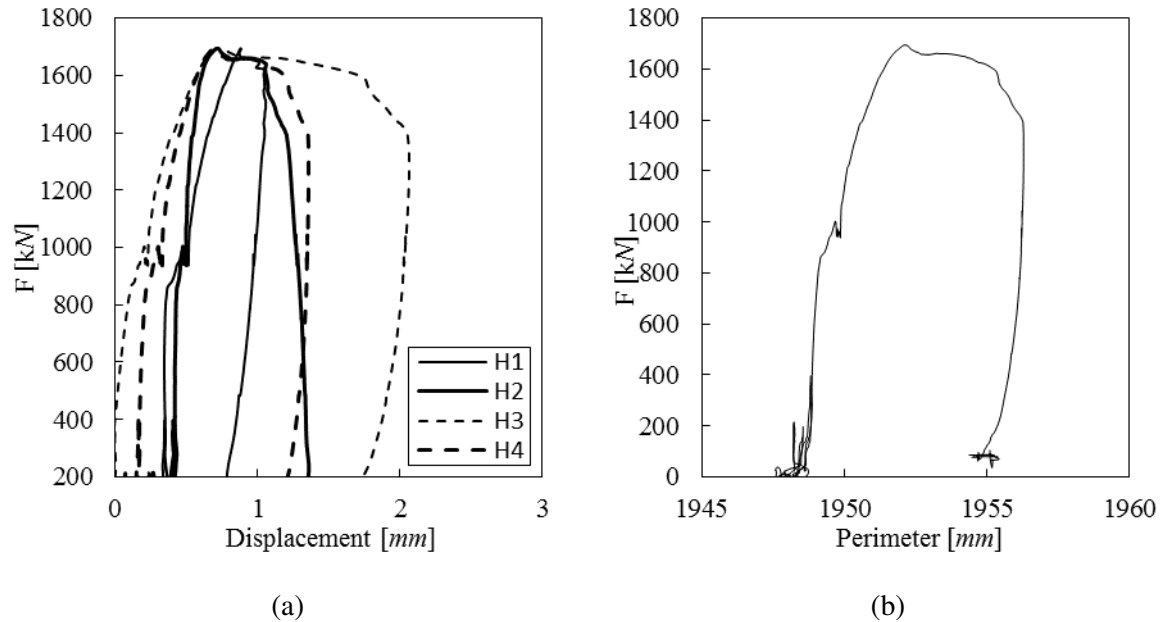
Horizontal expansion was uneven in the two directions set by transducers H1-H3 and H2-H4. Generally, the displacements were much larger in the H1-H3 direction. Considering the total radial expansion as the average produced by the two directions, the Poisson's ratio of the pillar reaches the value of 0.50 before 50% of the maximum load. The initial ratio for a load level of  $300 \text{ kN}$  is 0.22. The measurements of the horizontal transducers, along with the evolution of the diameter of the pillar at the height of measurement, are illustrated in Figure 6.

Figure 6: (a) Horizontal transducer readings and (b) mid height perimeter.
