SEISMIC ASSESSMENT OF THE ST. PETER APOSTLE CHURCH OF ANDAHUAYLILLAS IN CUSCO, PERU

Sarilyn R. Ivancic¹, Carolina Briceño², Rui Marques²,
Rafael Aguilar², Renato Perucchio¹, Julio Vargas²

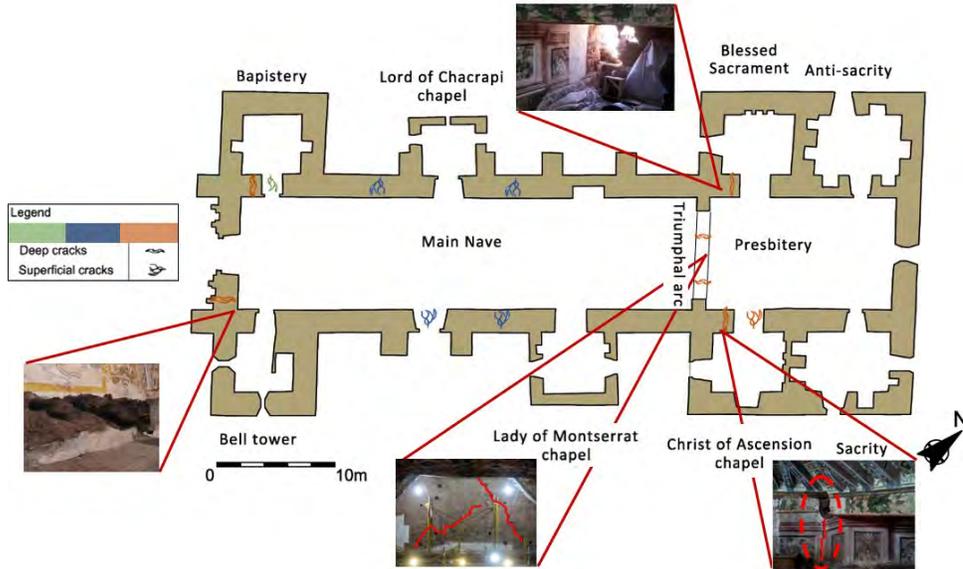
The church has undergone conservation works, especially in the last 50 years, which have negatively affected the monitoring of structural behavior by hiding the deeper damage of the church [6]. Deep cracks in walls of the presbiterium and the chapels, and in the triumphal arch have been identified. A map with the major damage occurrences in the church is presented in Figure 2. For example, a large opening is observed in the south wall next to the triumphal arch and diagonal deep cracks are identified in the tympanum above the triumphal arch, possibly due to delayed effects associated to self-weight load.

Figure 2: Mapping of the major pathologies observed in the church.

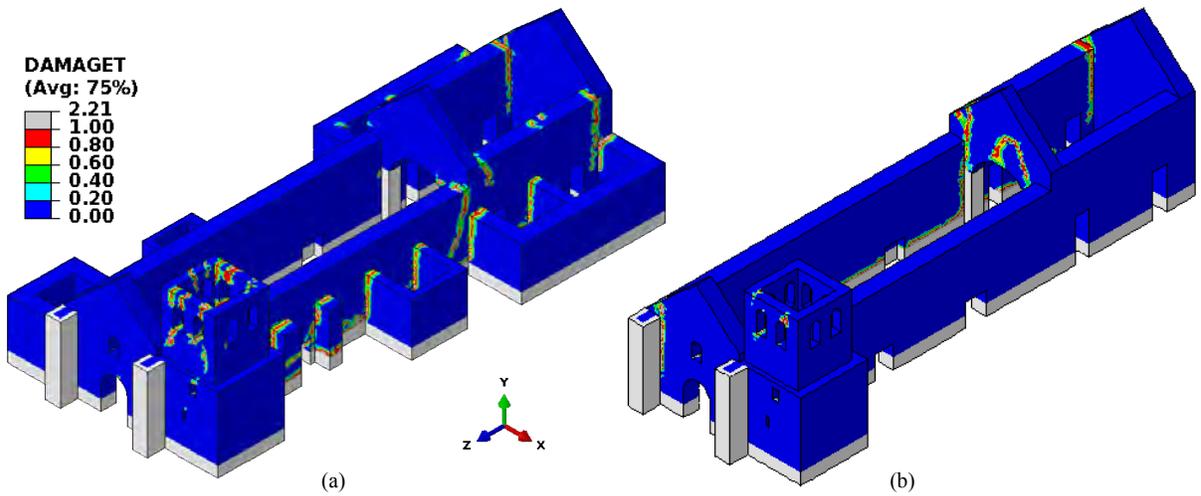
The contour plot in Figure 8(a) maps the tensile cracking in terms of a damage parameter, where 0 means that no damage has developed while 1 indicates that the material is completely damaged. The displacement in the south side of the church inevitably causes tensile damage to develop in the wall connections between the side rooms and the nave and presbitery walls. The buttresses are also separating from the wall. In contrast, the buttresses and room walls located on the northern side restrain the displacement of the nave wall. In addition, three other areas develop tensile damage: the northwest corner of the bell tower, the west and east ends of the southern nave wall and the northeast corner of the presbitery. The triumphal arch which separates the nave and the presbitery presents low damage throughout the pushover analysis.

An additional pushover analysis was performed on a reduced model of the church in which the side rooms and nave buttressing were removed in an effort to determine how the structural response changes when these lateral stiffening mechanisms are not present. As expected, Figure 8(b) shows that this model develops tensile damage earlier in the pushover loading process when compared to the full model of the church. The damage on the northern nave wall is consistent with an overturning mechanism as separation is occurring between the adobe wall and the stone base. The triumphal arch is showing tensile damage at the crown of the arch. Additionally, the north presbitery wall is damaged near the triumphal arch and the back wall of the church. A comparison of the results in Figure 8, shows that the buttressing and sides rooms attached to the nave and presbitery play a

critical role in stiffening laterally the main structure of the church. While the separation of the side rooms from their respective walls in Figure 8(a) does not seem to produce catastrophic damage to the church, the overturning mechanism seen in Figure 8(b) could potentially cause the structural collapse of the building.

Figure 8: (a) Tensile damage development in the full model at 0.25g. (b) Tensile damage development in the reduced model at 0.14g.
