REHABILITATION OF THE MAISON DU FORT: ADOPTING TRADITIONAL TECHNIQUES FOR SEISMIC RETROFITTING

Stephen J. Kelley¹, Owen A Rosenboom², and Terrence F. Paret²

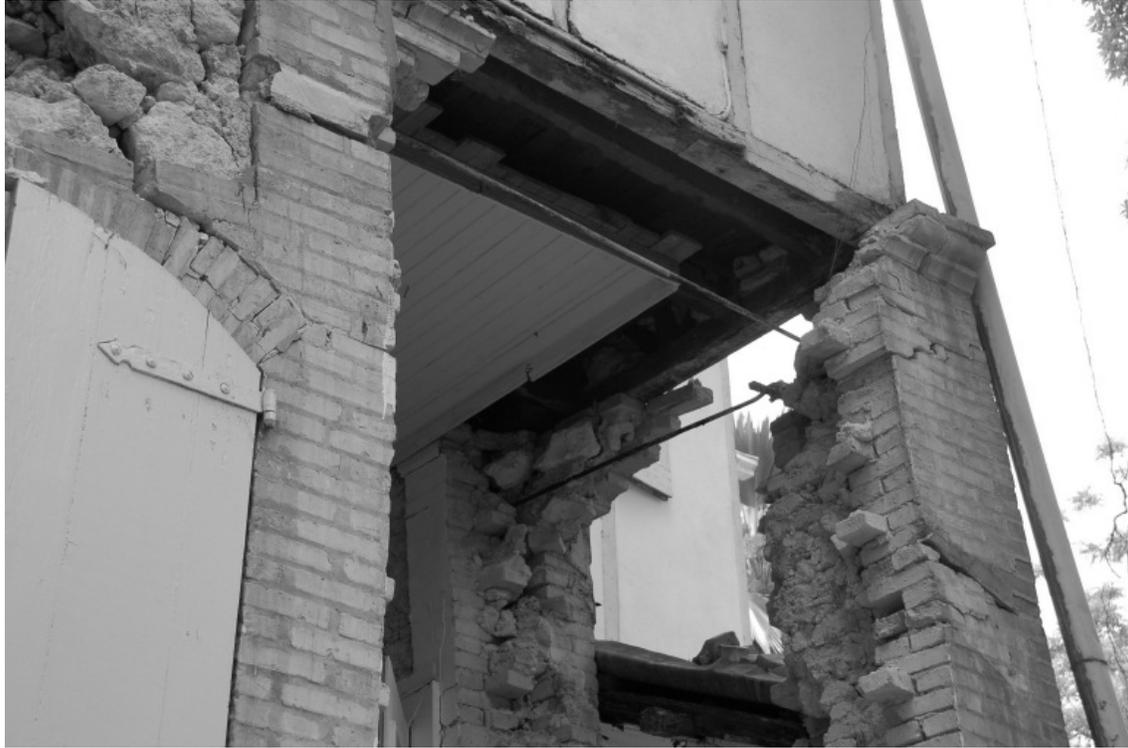
Figure 2. View of Maison Dufort after 2010 earthquake showing bearing walls constructed of clay-brick masonry and limestone rubble infill. The metal rods now exposed appear to have kept the corner pillar in place during the earthquake.

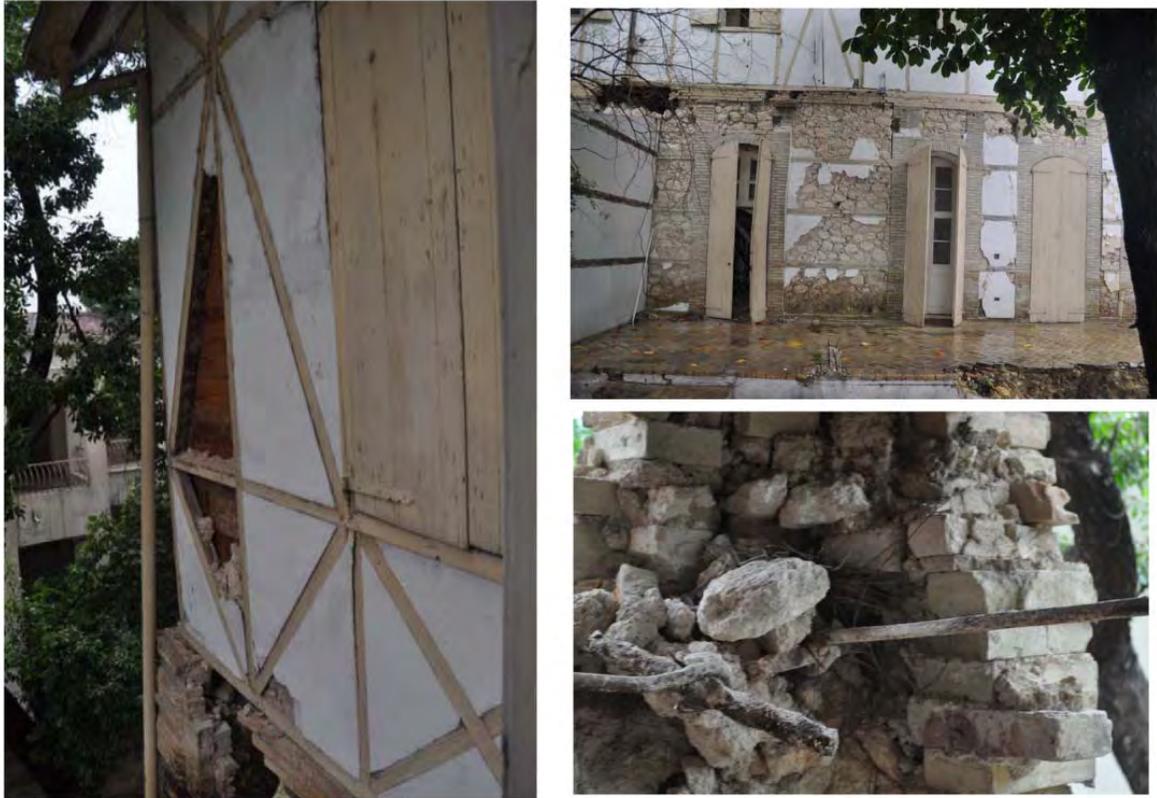
Based on historical records, the ground motion during the 2010 earthquake was the largest shaking felt by the Maison Dufort since its construction. Even though the duration of the 2010 earthquake was only 15 seconds, the shaking led to significant degradation of the masonry bearing walls, on some elevations near total loss of infill panels (figure 3).

Figure 3. Earthquake damage to Maison Dufort, clockwise from left: 1) Damage to colombage in one corner location, 2) long rear wall of house showing masonry bearing walls, 3) wall intersection showing iron “chains” with square rod anchors.

Several aspects of the original construction, however, led to the wholesale shedding of masonry and rubble during the 15 second earthquake. In addition to the low mortar strength, the walls were also inhibited by the lack of ability to transfer vertical shear between the two different “wythes” -- interior and exterior -- that were connected with a rubble filled collar joint. Two aspects of the construction promoted differential movements between the wythes during ground shaking: the colombage sill plate being supported by the exterior wythe, and the iron chain embedded in the collar joint. Even with these mechanisms, it is possible that if the joists were not connected to the colombage the building could have partially collapsed, and without the iron chain the damage to the walls would have been more severe.

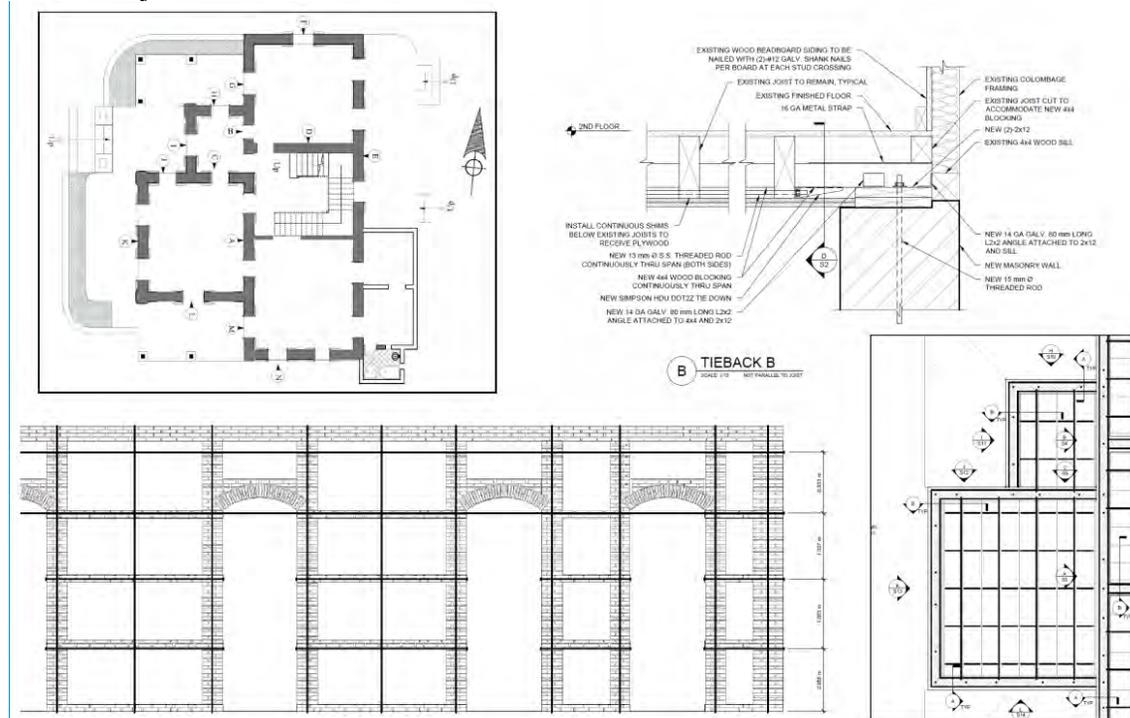
The layout of the masonry bearing walls at the ground floor is shown in Figure 4, along with the joist spanning direction. Many of the bearing walls shown have flanges at wall intersections, which can significantly boost the in-plane and out-of-plane resistance. But it is also clear that the fewer number of walls in the east-west direction will impart higher demands on the walls in this direction. Therefore, in a general sense, the masonry wall piers that performed worse in the earthquake were situated in the east-west direction and also situated parallel to the joists.

Figure 4. Drawings of rehabilitation of Maison Dufort, clockwise from upper left: 1) Ground floor plan showing wall layout, 2) typical floor-wall detail, 3) partial plan of diaphragm tie rod layout, 4) horizontal and vertical wall tie layout.

The chosen seismic retrofit (Figure 4) can be described as durable (stainless steel) and developing the natural strength of the masonry while offering confinement. The system is perceivable from the exterior but the retrofit is by and large within the walls and not intrusive to the overall composition of the Maison Dufort.
