The cathedral of SS. Massimo and Giorgio (L'Aquila, Italy): consideration on damage and retrofitting criteria after the earthquake of April 6th, 2009

Marta Brancaleoni¹

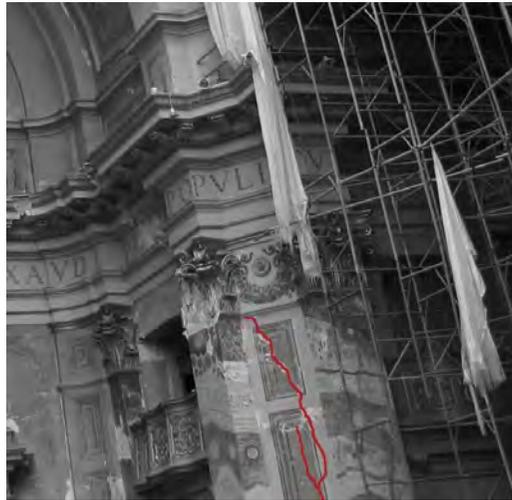
The pillars of the main nave, that support the false ceiling made with *camera canna*, present cracks with vertical development visible along the height of the pillar, as well as at the base with spalling and/or fall of the elements of the plasters, especially the parts that compose the corner. All elements indicate that the damage is to be associated with excessive vertical load. The described damage occurs in a diffuse way, but in a very different extent in distinct areas. The three pillars remaining in the area of the presbytery are extremely damaged, in particular towards the apse, while the same

signals are present to a much lesser extent, although well detectable, in the pillars of the nave, with further regression less evident, but noticeable as one moves away from the presbytery.

Figure 7 – Vertical cracks on the transept pillar.

In light of what has been shown up to this point, this chapter will identify the principal reflections for future conservation project, even though they do not represent guidelines. The main nave, as said before, show significant damages on the pillars that sustained the vault, the vault itself, the decorative apparatus and the plastering. The first intervention proposed has the aim of strengthening the masonry walls with injections and/or creeping of mortars, compatible with existing ones⁶, or with like for like replacement. The second type of interventions must increase the compression strength of the walls. The most adequate intervention is the contentment of the walls trough the installation of high- strength stain steel restraints strap: This straps are possible to be install on complex forms and at the same time they offered a high level of contentment made more effective by the pretension when applied on the walls. Another important aspect is the ductility offered by the characteristic of the contentment and the high - intrinsic of the material operate on the walls without bond. Furthermore this kind of materials offered a high level of durability, and most important for conservation intervention, the strips are completely removable, because the installation does not require the use of resin or binder. The most effective interventions for the *camera a canna* system is the use of extradados bands in fibre- reinforced composite materials, especially the one made in linen or hemp that could be applied using mortar instead of resin. After the survey, the elements (*centine, tambocci, paconcelli, cantinelle, and stuoiato*) composing the vault should be replaced. The presbytery's area is the one most affected by the earthquake: For the collapsed pillars the suggestion is to rebuild them with elements and building techniques capable to increase the mechanical properties both of the materials and mortar. For the pillars that are still in place, the interventions is similar to the one described for the main nave. The core of the pendentives should be depleted, after that should be strengthen and waterproofed. The string- course in the area of the transept and the one in the area of the apse should be removed and substituted with a cornice or a steel tie bar, with the double purpose of reinforced the structure and bears the canvas of the paintings. In alternative it should be substituted with reinforced masonry band, connected to the existing walls, in which to place tie bar made from steel anchor plate or pattern plate. Similar kinds of interventions should be realized on the not- collapsed masonry walls of the apse, with the insertions of tie bars or strips on the middle high between the top and the spring of the masonry. The intervention should achieve an increase of the compression strength of the walls to avoid the opening of new crackles.

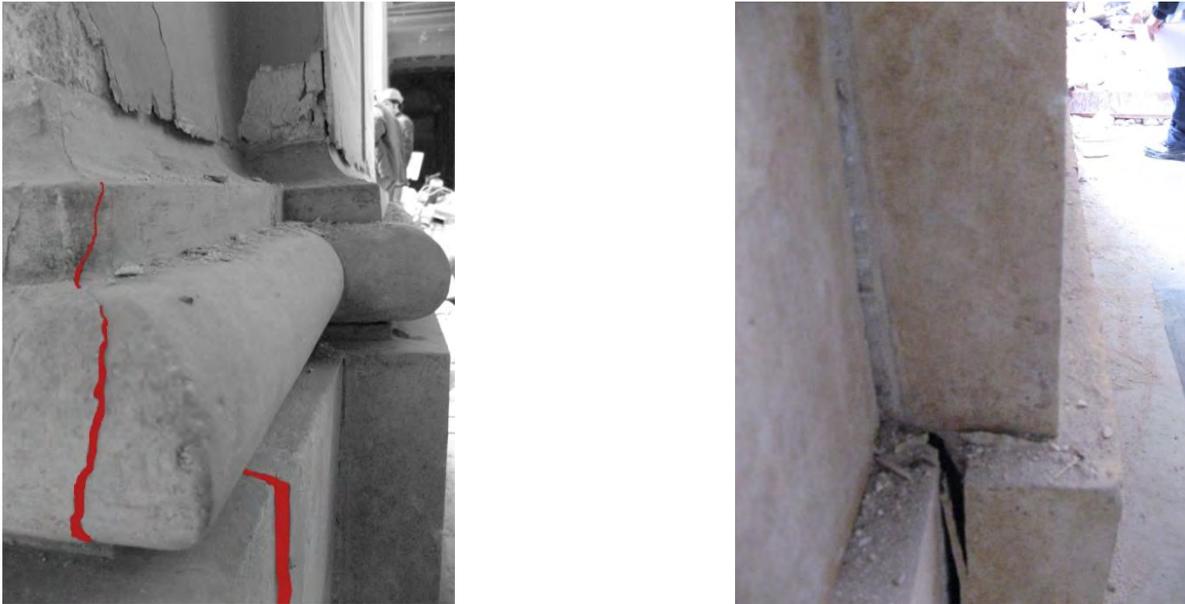
The evidence is that the pillars suffered from increase of vertical, in addition to horizontal, seismic action⁵. This increase is particularly relevant for the pillars of the transept that bear the pendentive of the fake dome. The masonry of these pillars does not have an ordinary setting and the mortar presents poor grading of the aggregate and an inadequate tooling. The mortar usually used for masonry joints can be classified on the basis of the binding materials: lime mortar, gypsum mortar and cement mortar. Lime mortar can be found in the original brickwork and at large in all the work done before the XIX century. Gypsum mortar and cement mortar can be found in the most recent structural strengthening. The quantity of mortar per masonry unit is not enough to guarantee a proper connection between the stones, one of the reasons for the damage occurred to the structure during the seismic events. Similar behaviors can be found in several of the masonry buildings in L'Aquila. It is easy to understand how one of the main load-bearing elements of the fabric reached the ultimate compression strength and collapsed: The collapsing of the pillar caused consequently the collapse both of the roof elements and the wall next to it.

Figure 8, 9 – Vertical cracks on the transept pillar.

The remaining pillars of the transept undergone unloading, when the roof collapsed, and hence remained standing, although showing significant damage.

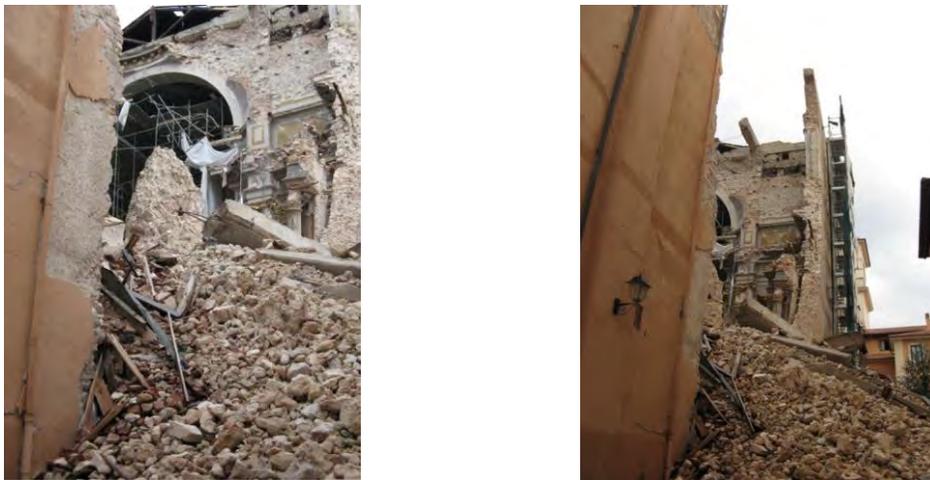
The pillars of the main nave show the same type of damage but to a lesser extent and did not approach collapse, due to the lower loads of masonry and roof they carry. In no case compression instability phenomena were observed, despite of the slenderness that is considerable for a masonry column. Compression damage was observed in columns and joints also in studies on modern reinforced concrete buildings, effect attributed to the vertical seismic action and corresponding response of the structures.

Figure 10, 11 – Collapsed masonry.

The wooden roof covering the main nave should be investigated to evaluate the substitution of the elements of the roof truss. The reconstruction of the collapsed elements should be done with materials and buildings techniques similar to the existing ones with purpose of achieve resistance to bending on the horizontal axe.

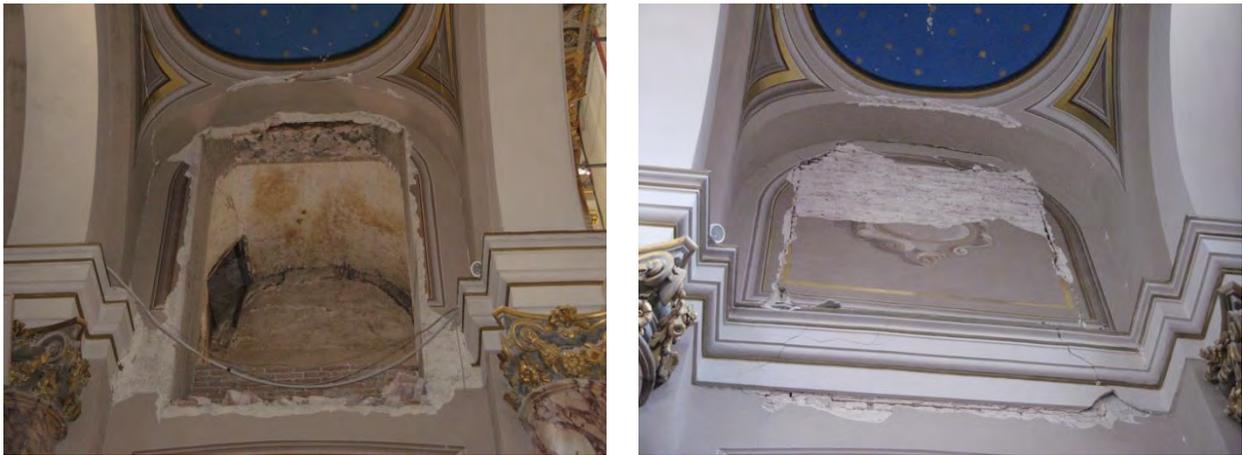
The remaining parts of the church, although not collapsed, show significant damage, distributed in non uniform levels. Even the side chapels present crackings. On the left side of the nave, in correspondence to the altars in the side chapels, it failed the infill wall within openings that over the centuries have been closed. These closures are probably related to the elevation of the building in late XVI century and the following reconstruction after the earthquake of 1703. The fall of plaster occurred in all spaces.

Figure 12, 13 - Collapsed infill walls in the lateral chapels of the left side nave.

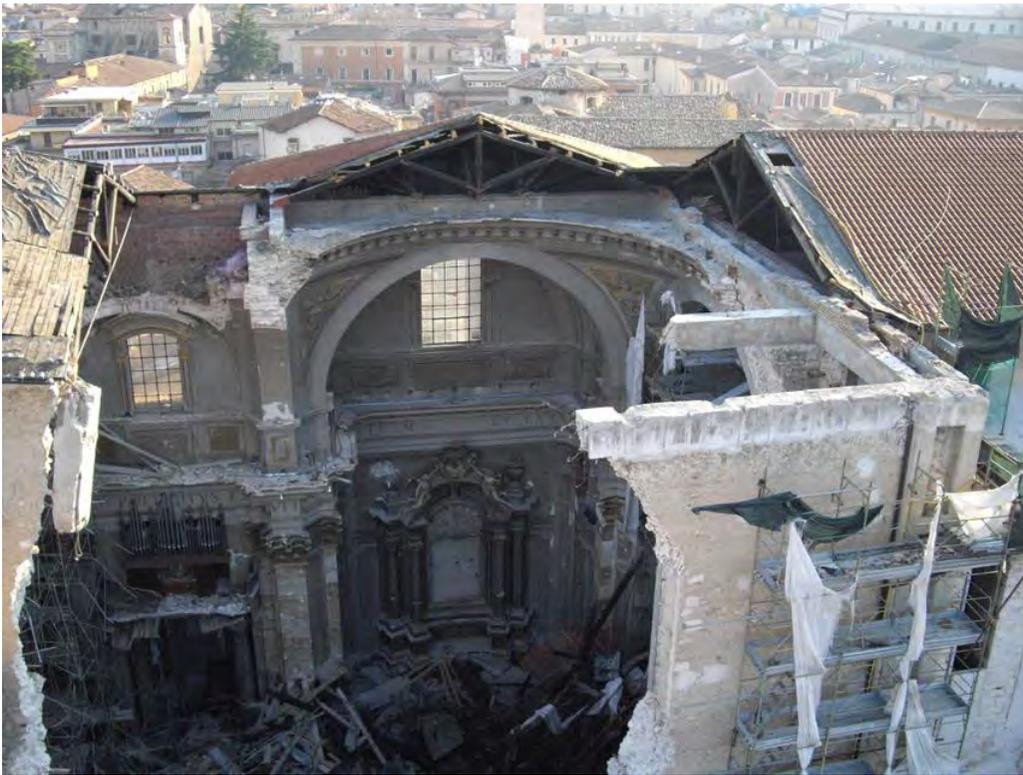
Figure 14 - R.c. string-courses framing the transept opening.

Observed behavior is threefold, regarding respectively the string-courses in the collapsed area, the second the double shaft pillars and last the summit string-courses of the perimeter walls. In the first case the patent ineffectiveness in preventing collapse should be not addressed in a negative manner: as the very term states, a “stringer” is aimed at carrying tensile forces, like an internal “rope”, present in certain areas of the masonry structures texture, e.g. connecting wall tops to each other. Here the collapse is due to the lack of a vertical bearing element, the transept pillar that reached its limit load capacity, on which the contribution of a stringer is nihil. Nor one should think that a role was played by the weight of such r.c. elements: simple quantitative evaluations show how minor is the relevance of this additional load with respect to those induced by the masonry itself and in particular by the massive pendentives surrounding the transept.

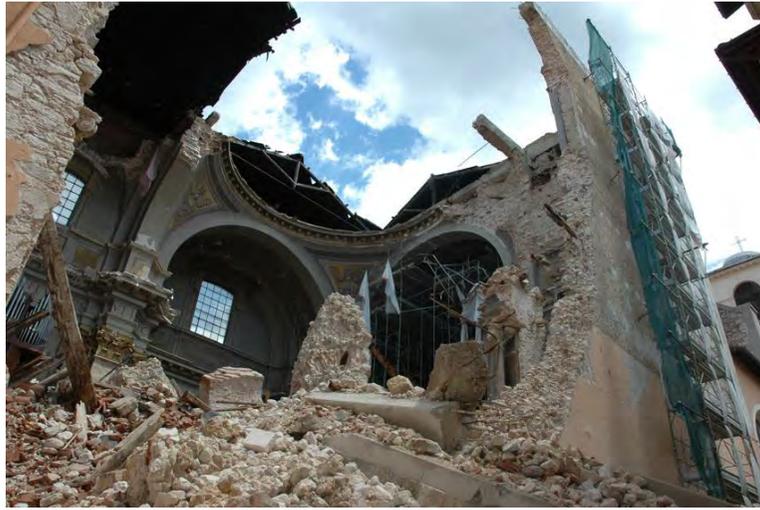
Figure 15 - R.c. string-courses in the area of the collapsed left side wall.

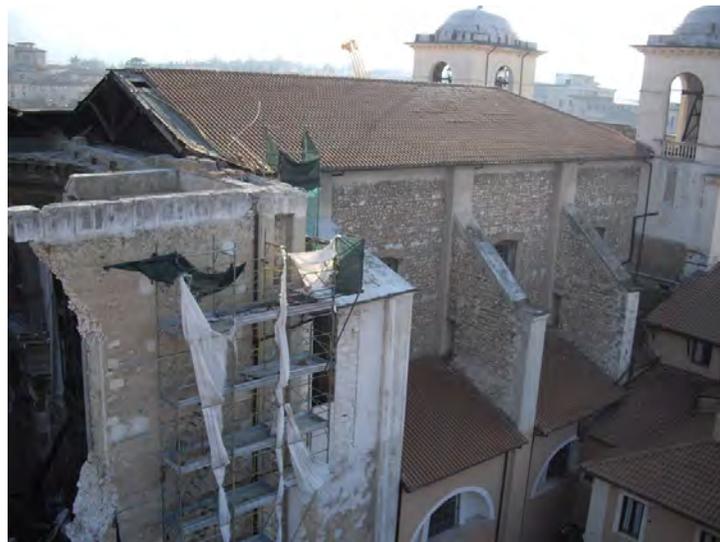
In the case of the double shaft columns the rationale underlying such strengthening is not completely clear. One may think them to be aimed at increasing the vertical bearing capacity of the walls or, more probably, at increasing the out of plane bearing capacity of the same. If no certainty can be stated about the objectives, it is a fact that these works, badly conceived and manufactured, are addressed to an element that revealed not to be the weakest. Again, on the whole a strengthening that revealed to be of minor or no influence in the collapse mechanism, either positively or negatively.

Figure 16 - Double shaft columns, left side wall.

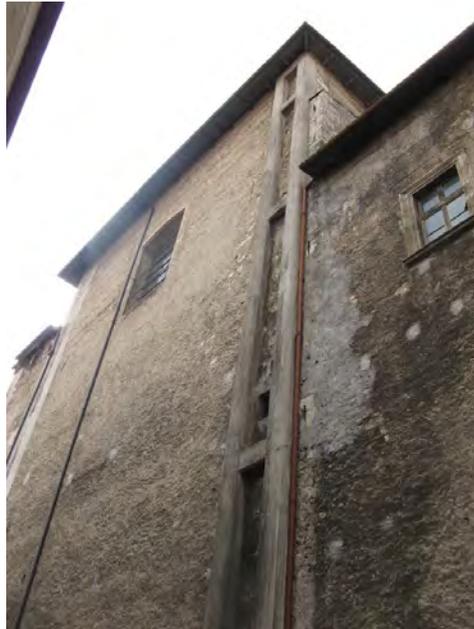
Figure 17 - Double shaft columns, left side wall.

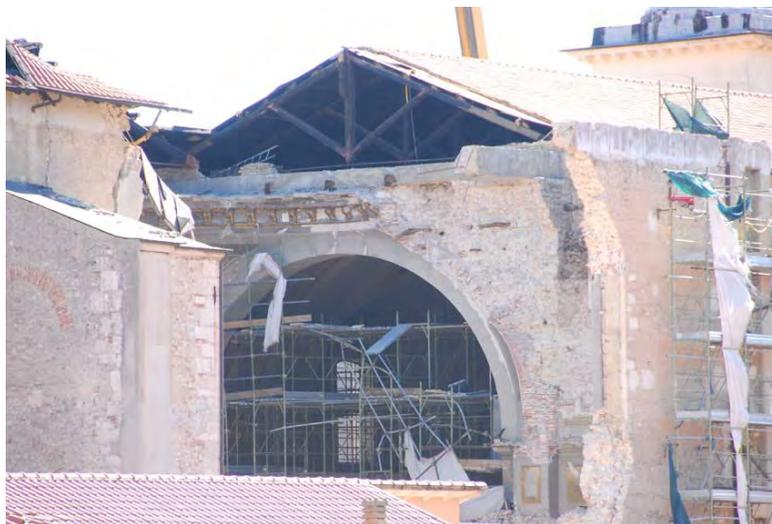
Last, the evaluation of the behavior of the summit string-courses of the perimeter walls. Here one can safely state that they did play a positive role, made clear by the well visible, thin and diffuse cracks they show in the perpendicular direction with respect to the string axis, present throughout the building and more evident in the apse. Unmistakable sign of having undergone significant tensile force that the masonry structure would have been unable to withstand. This allowed the vertical cracks in the walls of the apse to remain limited and to close in the upper levels, closet to the course. It was hence developed an effective tie function that has most probably prevented the complete apse collapse.

Figure 18 - Summit string-courses, transept.
