ASSESSMENT AND RESTORATION OF HERITAGE AND HISTORIC STRUCTURES AFFECTED BY THE BHUJ, INDIA EARTHQUAKE OF 2001

Author: Satwant Rihal¹, Rajni Patwa²

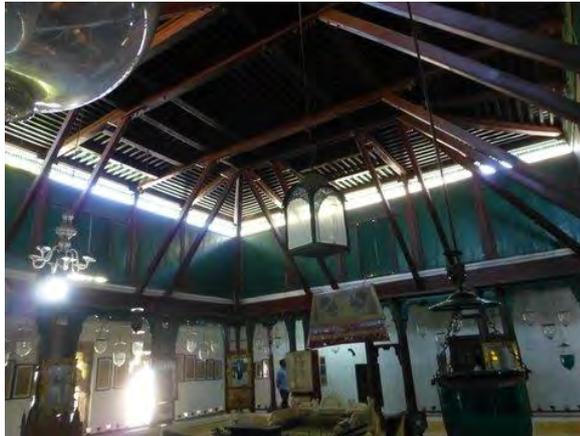
It consists of an array of interior timber columns extending about 3.2 meters above the top of the exterior walls and the walkway roof slab, to support a timber truss system carrying a flat roof over the central part of the Fuvara Mahal as shown in Figure 2.

Figure 2: Fuvara Mahal, timber truss system and clerestory

The truss configuration with vertical sides with large openings form a clerestory. This unusual roof truss configuration appears more like a knee-brace type lateral bracing system for the upper part of the roof structure, as there are no horizontal ties defining the truss system, even though partial horizontal restraint is provided by the roof slabs spanning the perimeter walkway, acting as a perimeter ring beam. The wooden trusses use bolted metal-strap connections, which suggests that they possibly represent repairs carried out after one of the earlier earthquakes e.g. the 1819 Gujarat earthquake.

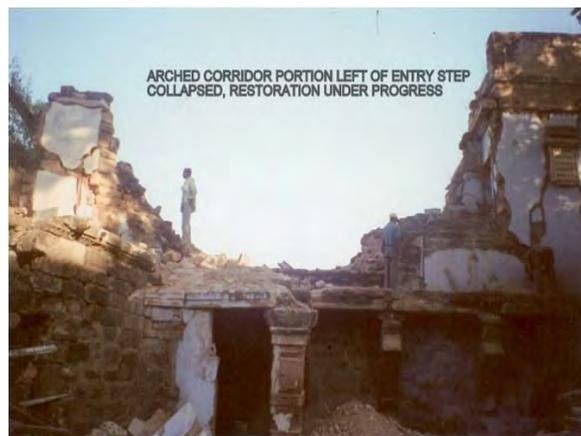
The arched corridor and the stone columns on the west side of the entry steps to the Ayna Mahal had collapsed during the 2001 Bhuj earthquake, as shown in Figure 3.

Figure 3: Ayna Mahal, collapsed arched corridor west of entry steps, restoration in progress.

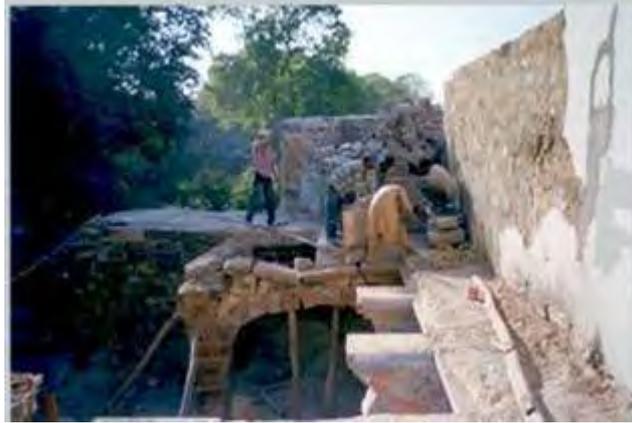
Figure 4: Ayna Mahal, arched corridor restoration in progress.

The repair work started with the restoration of these stone columns and the corridor arches as shown in Figure 4.

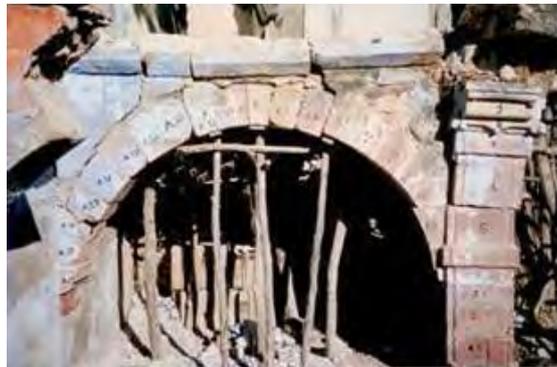
The distortion and damage of a typical corridor stone arch, including the numbering of the stone pieces making up the arch, and the temporary shoring used during the restoration process is shown in Figure 5.

Figure 5: Ayna Mahal, arched corridor restoration in progress. Showing distortion of corridor arch and numbering of stones making up the arch.

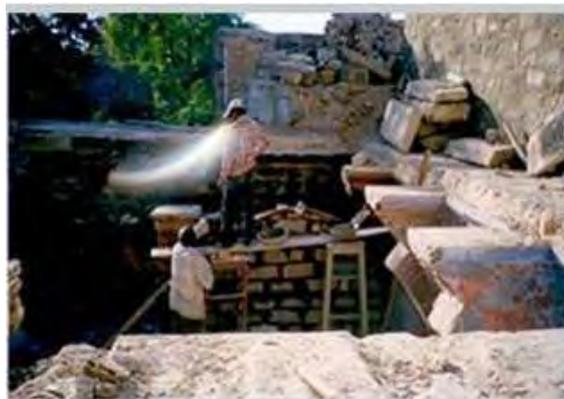
Figure 6: Ayna Mahal, arched corridor restoration in progress

The process of restoration of the corridor arch including the temporary masonry work for shaping the corridor arches being restored, is presented in Figure 6.

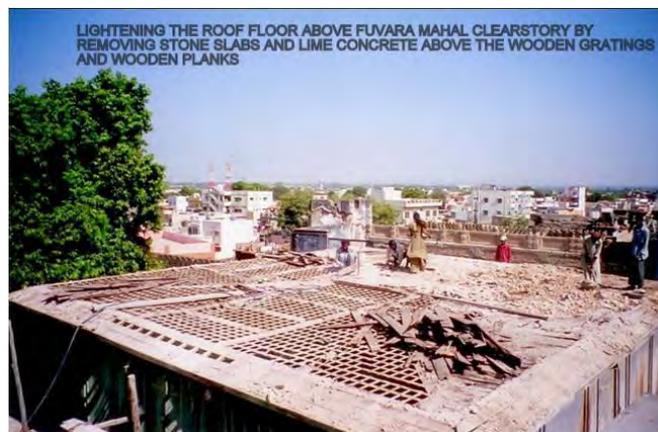
It appears that one of the main causes of the observed damage and failures in this whole complex was the effect of very heavy roofs and floors; possible amplification of ground motions toward the upper parts of buildings resulting in very large inertial forces that the existing lateral force resisting systems could not resist. An innovative solution to help reduce the dead weight of the floors and roof system, was developed and implemented by the project architect. It consisted of replacing the stone slabs and overlay of thick lime concrete (total thickness of 304.8 mm); with 50.8 mm thick thermocol sheets and topped with 30.8 mm thick IPS floor (Indian Pattern Stone) cement plaster floor finish. During this restoration process the stone slabs and the lime concrete over the wooden gratings and wooden planks, were removed as shown in Figure 7.

Figure 7: Lightening of roof / floor above Fuvara Mahal clerestory by removing stone slabs and lime concrete above the wooden grating and planks.

This innovative solution was able to achieve a 60-70% reduction in the dead weight of the floor / roof framing system, in the restoration process, and thus help reduce the earthquake forces that the structure will have to resist during future earthquakes.

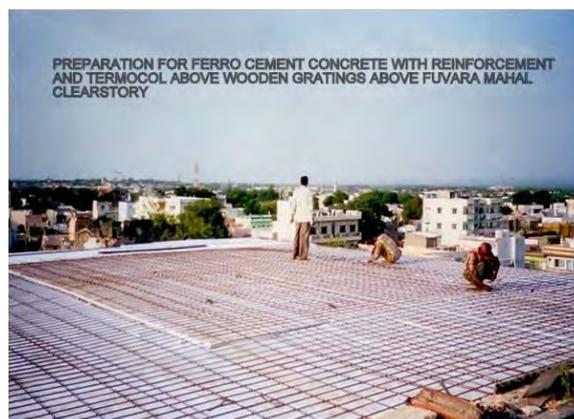
Figure 8: Lightening of roof / floor above Fuvara Mahal clerestory by removing stone slabs and lime concrete above the wooden grating and planks.

The preparation for the new layer of ferrocement, and thermocol sheets above the wooden grating is as presented in Figure 8.

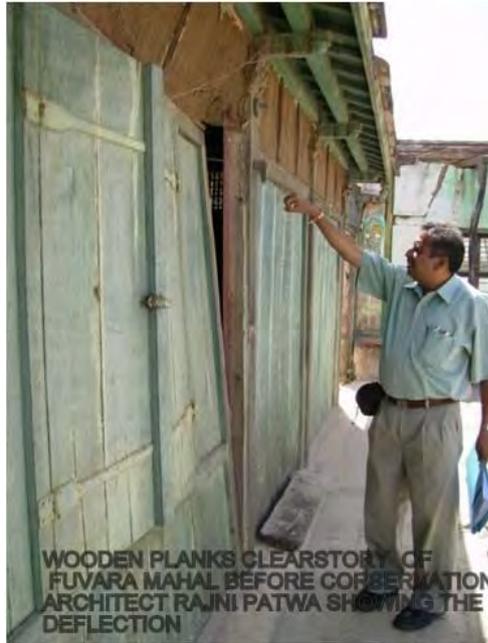
The clerestory portion of Fuvara Mahal suffered extensive damage during the 2001 Bhuj earthquake. This part of Fuvara Mahal underwent significant distortion possibly due to torsional response, as shown in Figure 9.

Figure 9: Fuvara Mahal, distortion of clerestory portion

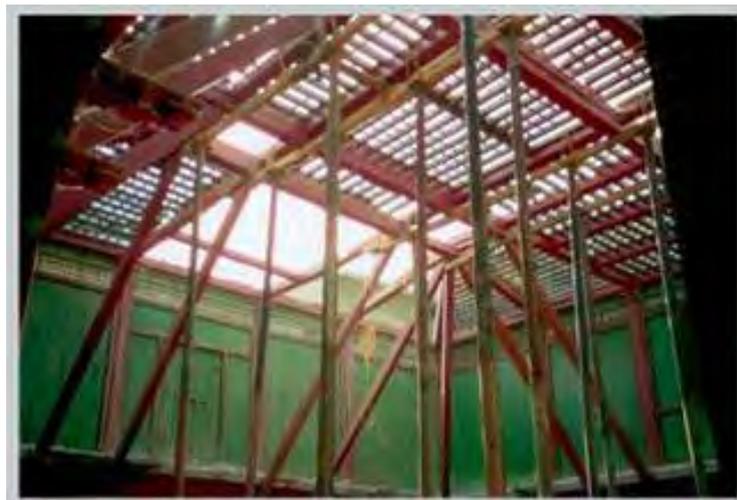
Figure 10: Fuvara Mahal Clerestory Ceiling, restoration of buckled truss members in progress.

The restoration process of the Fuvara Mahal clerestory ceiling and replacement of damaged wood members is as shown in Figure 10 and Figure 11

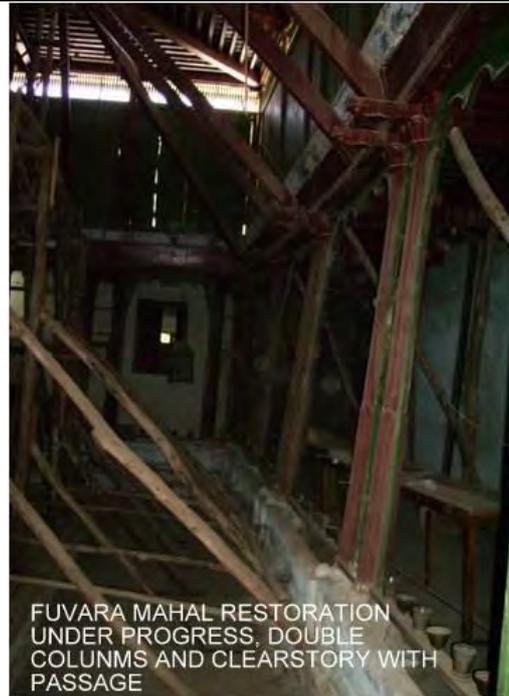
Figure 11: Fuvara Mahal Clerestory Ceiling, restoration in progress

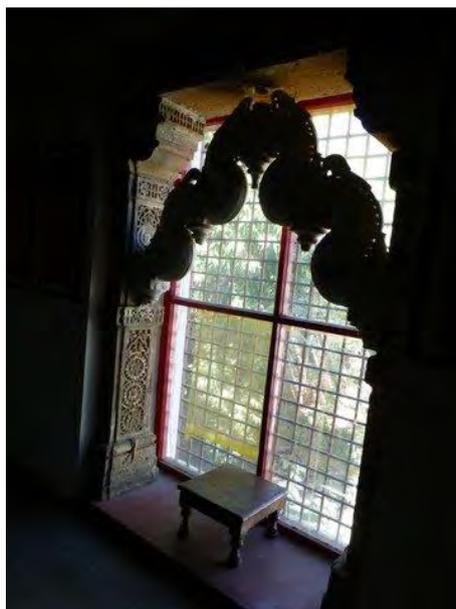
Figure 12: Fuvara Mahal, discovered arches after restoration

During the process of repair and restoration of Fuvara Mahal, beautiful arches were discovered in the north façade of Fuvara Mahal. They were found to be embedded inside the masonry walls. The design team decided to incorporate the beautiful decorative arches as part of the finished window openings as shown in Figure 12. The restoration of the discovered arches in progress is presented in Figure 13.

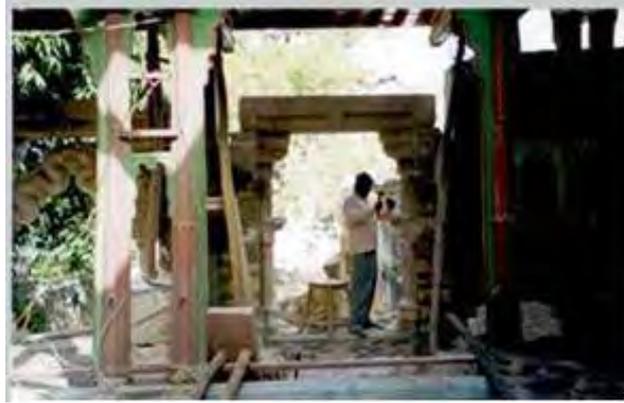
Figure 13: Fuvara Mahal North Façade, discovered arches under restoration

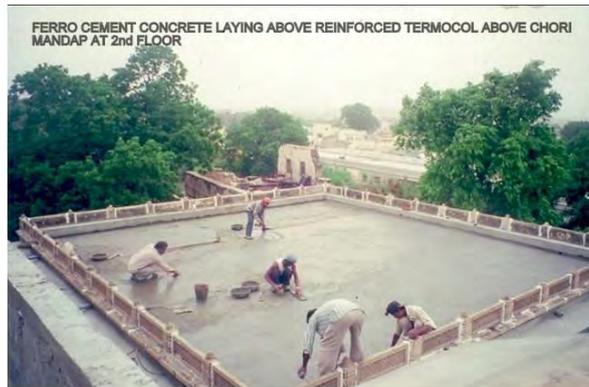
Figure 14: Ferrocement Concrete, overlay on thermocol sheets above Chori Mandap second floor.

The process of laying ferrocement concrete over thermocol sheets above Chori Mandap at second floor as presented in Figure 14. A view of Darbar hall structure and roof after restoration is presented in Figure 15.

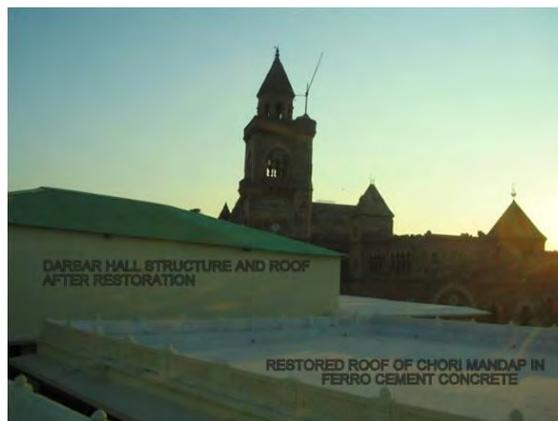
Figure 15: Darbar Hall structure and roof after restoration. Chori Mandap restored roof with ferrocement overlay.

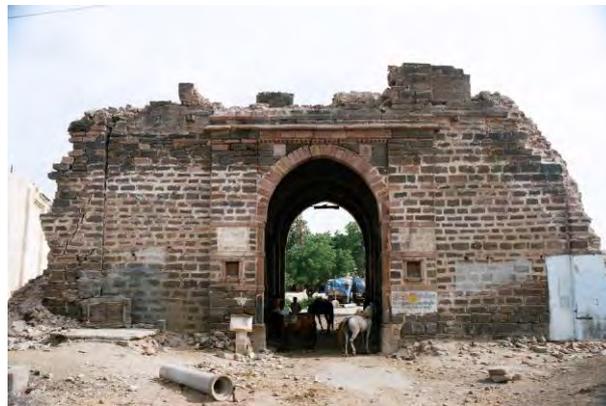
Figure 16: Old City Sarpat Gate, damaged condition before restoration

The damage consisted of collapse of the stone masonry work on each side of the arched gate; and the parapet and spandrels above the arch; displacement of supporting columns; and shifting of the gateway arch segments. This type of damage was possibly caused by very heavy self-weight of masonry and earth-fill above the arched gates; and amplification of ground accelerations resulting in very large seismic forces on the stone

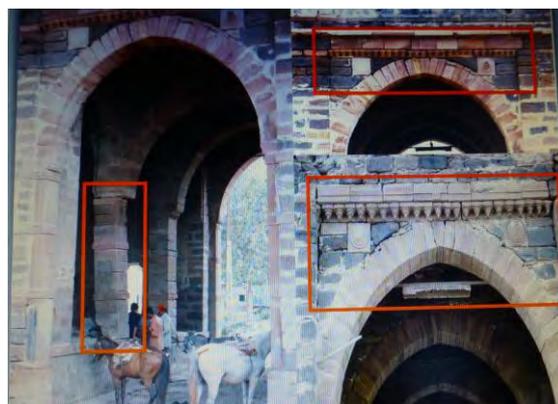
Figure 17: Old City Sarpat Gate, condition before restoration showing displaced column and shifted arch segments.

masonry arched gates. The arches in the arched gates did not collapse, but did show clear signs of yielding, with some of the arch stones being noticeably displaced from their normal positions as shown in Figure 17.

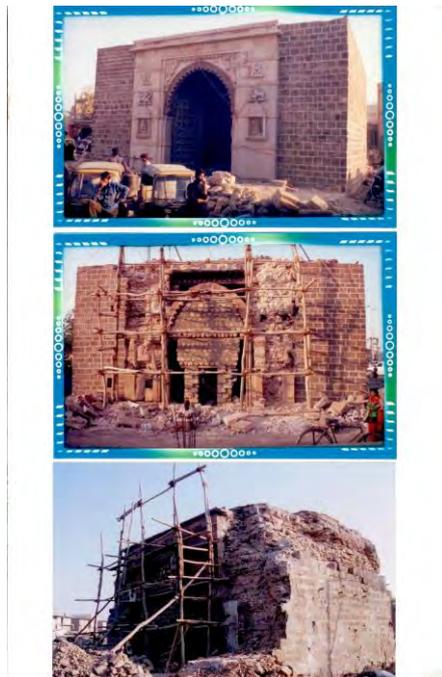
Figure 18: Old City Bhid Gate, restoration of arched gate in progress - Bottom two pictures

The general process of restoration of the historic Bhid Gate is shown in Figure 18, including scaffolding, and false masonry work to shape and support the arched gate while the restoration work is in progress. A view of the old city Bhid Gate after restoration is shown in the top picture in Figure 18.
