THE GUADALUPE AQUEDUCT: HISTORICAL MONUMENT AT RISK

Abstract. *Based on data obtained directly on the site, the current conditions of the Guadalupe Aqueduct are described. The aqueduct was constructed from 1743 to 1751 to carry water to the Guadalupe Sanctuary along approximately 10 km (6.7 miles). According with original descriptions the length of the aqueduct was 12 900 varas (10 700 m), in the first section, water runs through a shallow or underground channel; however, the main portion was elevated supported by 2287 arches. As part of this paper a resent survey was done, which shows that the first part is no longer exist, and only 1584 arches remain of which 887 are in good conservation condition, 369 are moderately damaged and 328 have severe damage o dilapidated. The results are compared with the information reported in other sources, mainly a book by Manuel Romero de Terreros written in 1949. Despite rehabilitation programs carried out so far, the deterioration of this National Monument is evident and far more advanced than that reported in past years. For instance from the year the aqueduct was completed in 1751 to 1949 the structure lost about 5% of its volume, in only 63

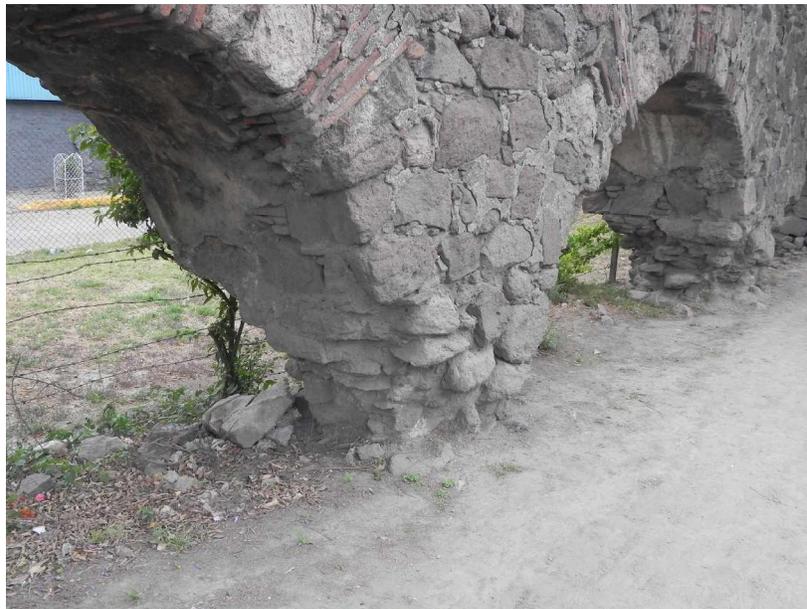
Despite rehabilitation programs carried out so far [5], the deterioration of this National Monument is evident and far more advanced than that reported in past years. The existing reminders are: a) arches: 1584 of different dimensions, of this total 887 are in acceptable state of conservation, 369 with moderate damage, an the rest, that is 328, are severe damaged or ruinous, see Figure 1.

Figure 1. Photography showing severe deterioration at the base of some arches, location near the former Los Remedios River. (by the authors, November 2012)

1. Arches and buttresses with severe damage need first of all a re-foundation which can be attained with micro-piles or soil substitution with fluid refill. Once the stability of the foundation is ensured mortar injection of cracks and reposition of weak mortar and stones are required.
2. Arches with severe cracks and deviations need to be replaced previous scaffolding.
3. The part exposed to earth pressure due to road embankments need to be protected with reinforced concrete retaining walls.

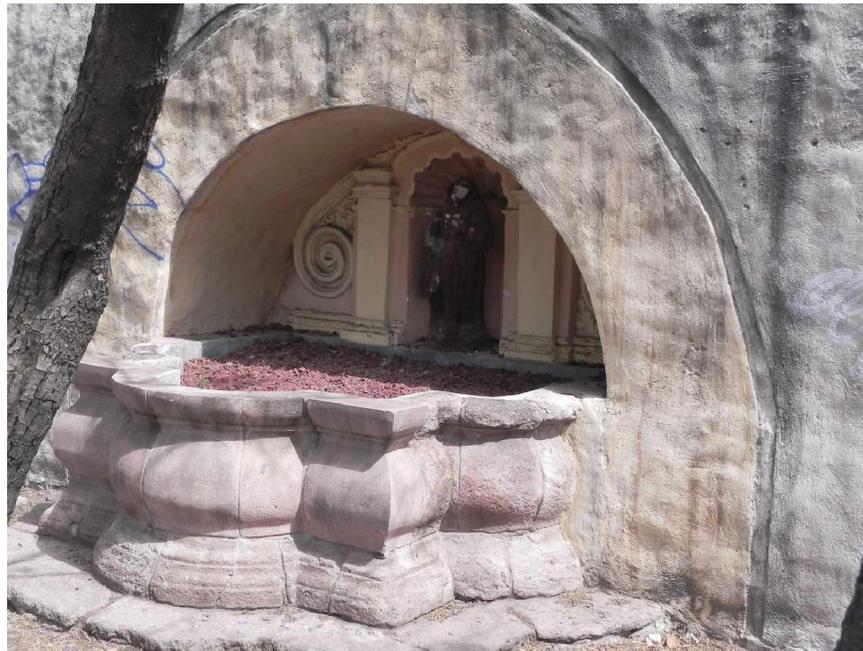
Figure 2. Photography showing San Francisco Fountain near the village of Santa Isabel Tola (by the authors, November 2012)

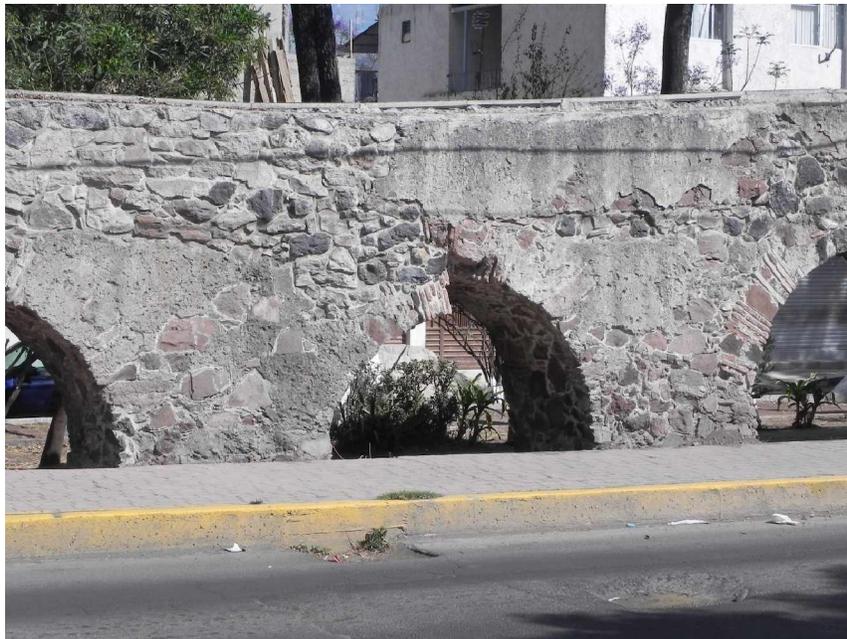
At upper part of the archery, the arches were constructed with poor quality masonry with non labored stone and bricks in complete pieces or broken, with lime and sand mortar joints of good consistency. Other parts are made of irregular stones jointed with very poor mortar or mud. The parts that exhibits more consistency it is observed that good quality stones were used, some of them carved, and mortar of strong consistency. In relation with the foundation, only was possible to observe its shape in a few cases were excavations were made to form depressed pedestrian passages. The original foundation was only 0.30 to 0.50 m in deep, made with slab stones of appreciable dimensions with joints of lime and sand mortar or mud. It is evident that the low deep of the foundation propitiated that several trams of the aqueduct suffer sinking and deformations. This is a problem that continues because all the zones of antique lakes of the so call Valley of Mexico are not stable.

During the colonial period the constructors follow empirical rules from roman constructors [6]. The slender ratio is defined as the ratio of the clear span to the deep of the voussoirs which for better results was recommended to be between 10 and 20. A slender ratio less than 10 is a robust arch with a structural behavior as a wall. A slender ratio of more than 20 means a very slender arch that can fail suddenly. In the case of the analyzed aqueduct the slender ratio is 5 or less, only a few arches with 12. For this reason the arches of the Guadalupe Aqueduct are, in its majority, robust and the observed failures of some of the arches are not due to loads but to the settlements of the foundation and intentional harm [7], see Figure 3. The rule to establish the depth of the foundation was a tenth of the high at firm soil and a fifth of the high at soft soil. In the present case, the dept of the foundation should be, according with this rule, at least one meter, which was not accomplishes as was mentioned later. This is the main reason why most parts of the aqueduct are instable. It is concluded that from the beginning the structural conception was not correct; because in one hand arches are overdesigned, but in the other the foundation is scared.

Figure 3. Photography showing a failed arch due to settlements (by the authors, November 2012)

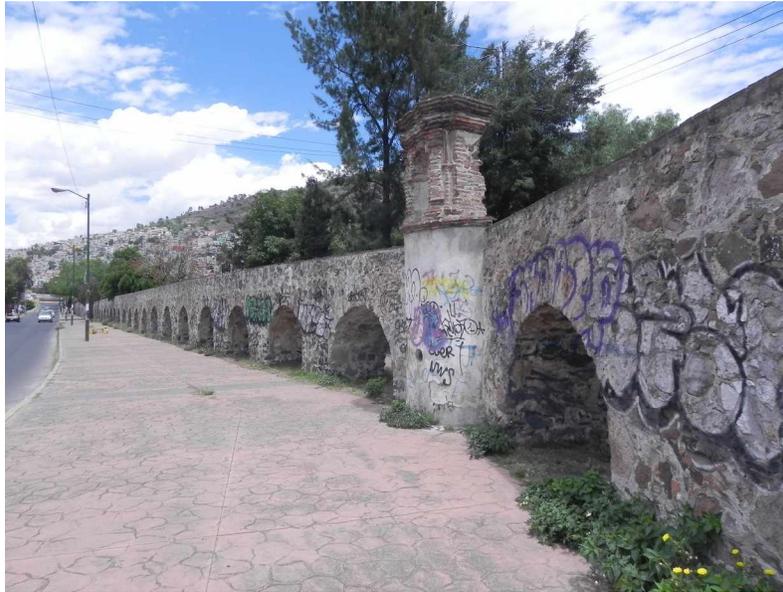
Tree facts are pointed out: a) because of the grow of the city the aqueduct is now located within the urban area, b) the aqueduct have a social value as an historical monument, and c) the aqueduct form a part of the landscape and may be a factor of social integration in the zone, see Figure 4.

Figure 4. Photography showing a view of the Guadalupe Aqueduct at Ticomán (by the authors, November 2012)

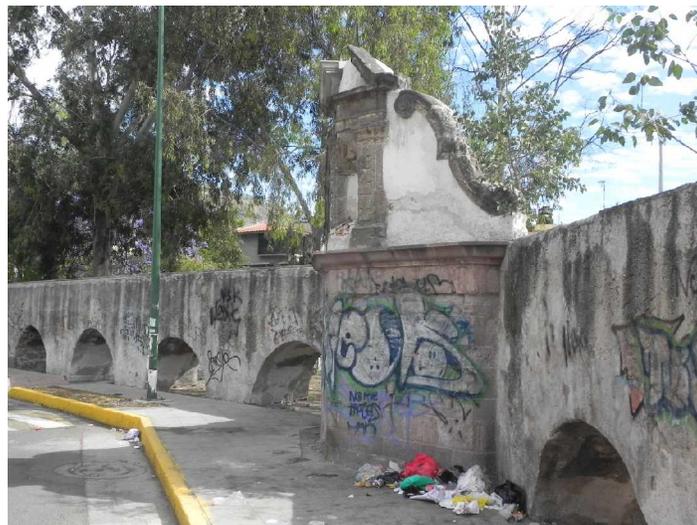
In each of the mentioned cases, including the Guadalupe Aqueduct, is common the abandonment and misuse including intentional damage by some people, see Figure 5. Other problem is graffiti which is difficult to solve because political and social aspects are involved. In order to gain better results it is necessary to involve the residents and visitors by means of cultural activities as well of historical tourism, for instance cultural contests as photography, panting and other techniques including in some parts street art. An other possibility that may be positive is to work in agreement with the involved official instances, the residents and institutions of higher education, working in multidisciplinary teams, mainly architecture, civil engineering, urbanism and other social sciences, to elaborate compressive studies and proposals for the integrated rescue and reutilization with the participation and compromise of all the parts involved.

Figure 5. Photography showing a water box and part of the aqueduct, damage and abandonment are apparent (by the authors, November 2012)
