## DAMP PROOFING OF HERITAGE BUILDINGS LOCATED IN HISTORICAL TOWN CENTRES

**Keywords:** Heritage buildings, protection against moisture, damp-proofing, non-destructive tests.

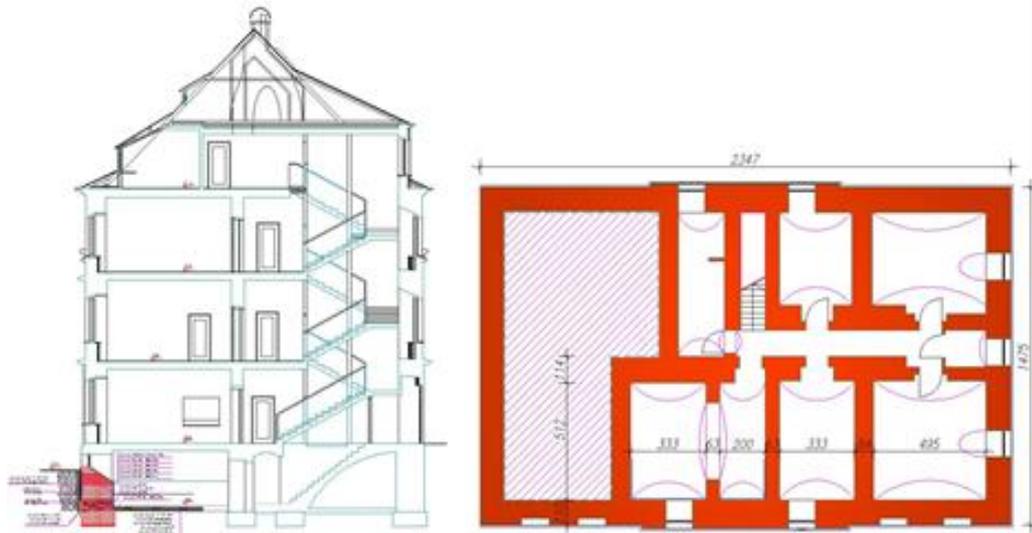
A comprehensive analysis of building structures found out that they were built on foundations and substructures of older buildings. The evidence for this relates to the use of different materials, different cross-sections and structural systems. (fig. 1) [1].

Figure 1: Cross-section of a building and floor-plan of its cellars (parts with and without cellar marked).

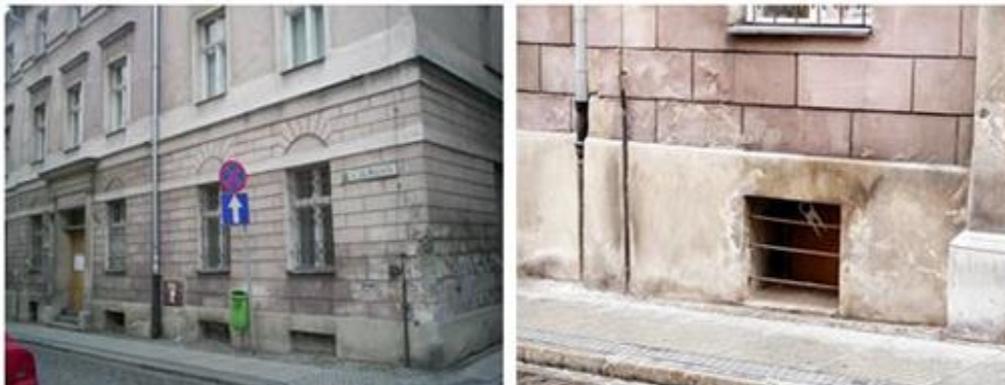
Figure 2: Views of the façade of one of the buildings analysed.

External and internal walls of the buildings were built with full bricks and lime mortar. The arrangement of load bearing walls is mixed (longitudinal and transversal). Cellar walls were found to be very damp. Numerous salt precipitation concentrations were visible. In places, the dampness of external cellar walls has reached full absorbability (22%) extending to the top of the wall. The moisture in the fragments of walls shown in fig. 2 and 3 is not the result of long-

term capillary rise of water from ground level. The damage was caused by precipitation water from adjacent land areas and in part by choked and leaky rainwater drainage systems.

As the buildings are located in a densely built up and serviced area, the decision was made to introduce complete and systematic damp-proofing protection with renovation plasters on most internal surfaces of cellar walls. Renovation plasters allow unrestrained evaporation of moisture contained inside the wall and gradual elimination of salts. After three years, the technical condition of walls was deemed to be satisfactory which demonstrates the effectiveness of the method adopted.

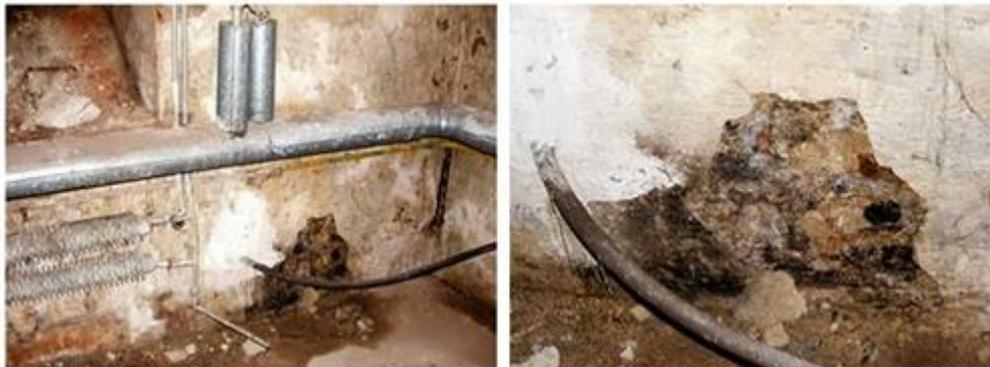
Figure 3: Internal walls of the building.

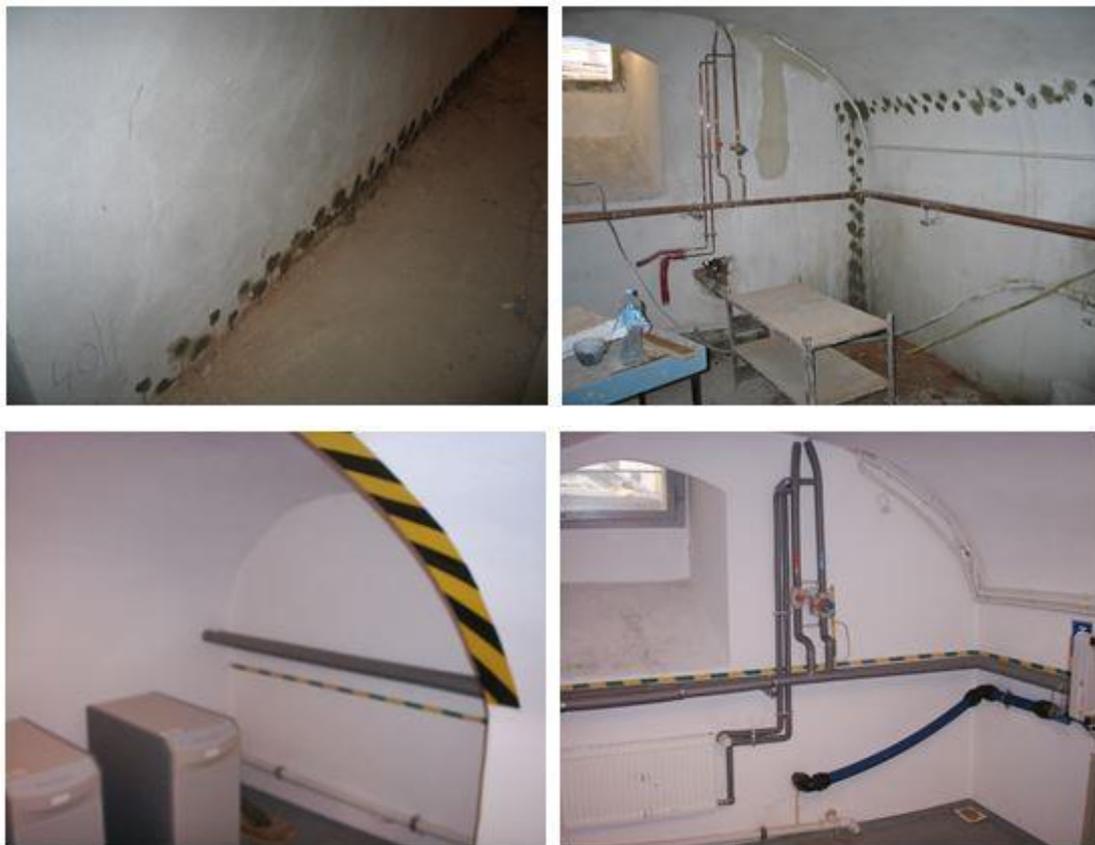
The effectiveness of the comprehensive damp-proofing method introduced was analysed by comparing the original condition of the building to its condition after seven years (2007 – 2014). The condition of the walls was assessed using a thermographic camera. The effectiveness of restoration work is evidenced also by the visual appearance of walls as presented in fig. 4.

Figure 4: Internal surfaces of cellar walls – during the introduction of damp-proofing in 2007 (above) and after seven years in 2014 (below).

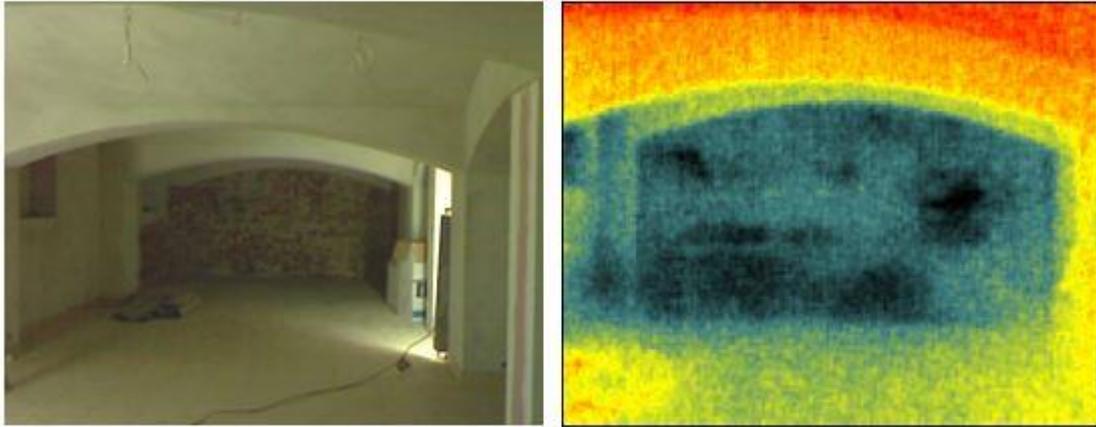
Figure 5: Internal surface of the end wall of the cellar in 2010 (on the left), thermographic image of the wall showing areas of high moisture (on the right).

No damp-proofing was introduced in the case shown in figs. 5 – 7. The building remained in its original state. The only intervention involved digging out a channel along the end wall and installation of a draining system, which together with the channel collected rainwater from the roof with transfer to the municipal rainwater drainage system. The technical condition of the cellar has improved significantly. No modern methods of damp-proofing protection were introduced. So called chemical building materials did not have to be used because traditional methods were deemed to be sufficient on the basis of the analysis and observations carried out in the building, which ruled out the possibility of ground water penetrating its substructure.

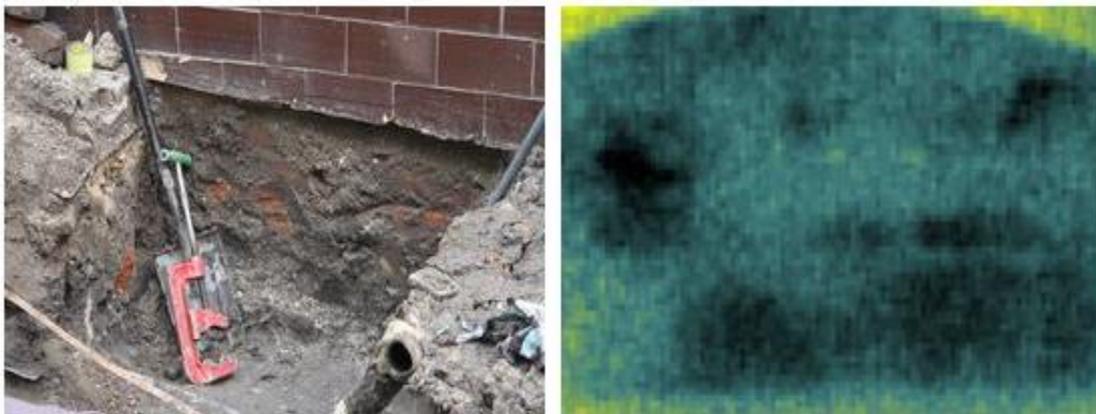
Figure 6: Internal surface of the end wall of the cellar shown in Fig. 5: the wall uncovered for installation of a draining system (on the left), thermographic image of damp (on the right).

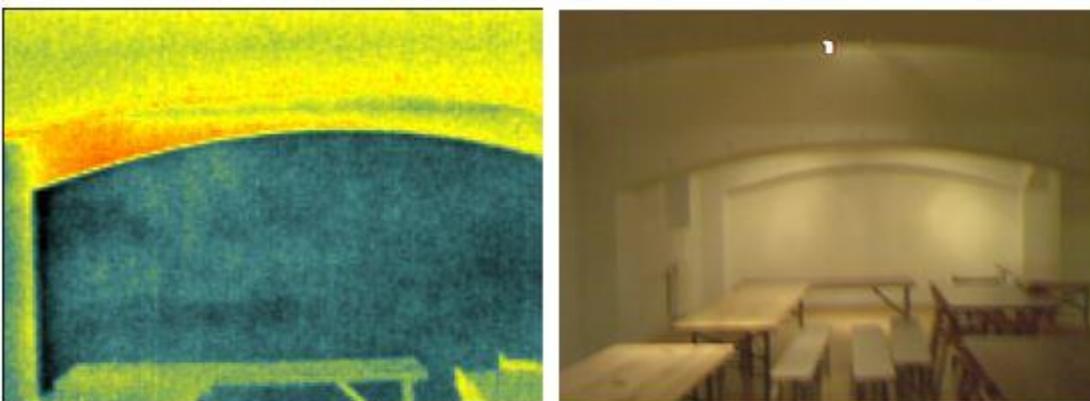
Figure 7: The building's cellar seven years after the damp-proofing work: thermographic image of the wall with no damp focal spots (on the left), view of the inside of the cellar with the end wall (on the right).
