DIAGNOSIS AND STRUCTURAL REHABILITATION OF A XVI CENTURY STONE MASONRY ARCH BRIDGE

Abraham R. Sánchez Ramírez¹ and Roberto Meli²

Keywords: Historical construction, stone masonry, seismic safety, damage evaluation, structural rehabilitation.

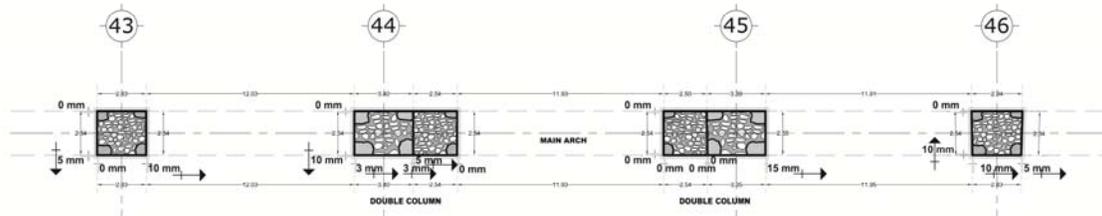
Some results of the geometric and topographical surveys that were carried out for the master plan of rehabilitation of the aqueduct are of interest to assess the quality of the execution of the work. It was found that the maximum deviation of the dimensions of the sides of column sections from their average value do not exceed 10 mm. Out of plumb of column faces never exceed 15 mm, nor 1/1000 of the column height. In many cases, tilting of opposite faces

of a column is in different directions, thus indicating that is due to small inaccuracies in the construction and not to a rotation at the column base (Figure 6). A remarkable regularity is found in the slope of the channel bottom, as well as in the vertical and horizontal alignments of the columns.

Figure 6: Measured out of plumb of the column faces.

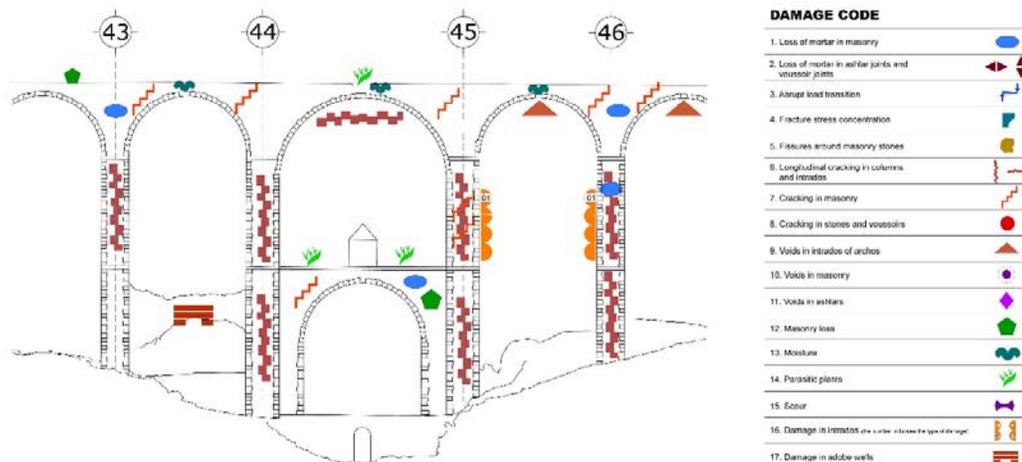
Columns, arches and channel were thoroughly inspected to obtain a comprehensive assessment of the structural damage. Six main types of damage were identified. Damage types throughout the bridge were recorded as shown in Figure 7 for the central area. Each type of damage is described below, along with comments about its origin and significance.

Figure 7: Types of damage recorded in the central part of bridge.

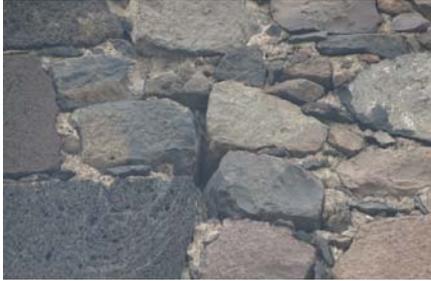
Loss of mortar in raw masonry. Different zones of the aqueduct show a partial loss of the mortar used as a binder in raw masonry. In most of the observed sites, mortar loss was only superficial; however, there are some parts where the problem is exacerbated and the lack of mortar is such that some of the stones have fallen, leaving cavities of remarkable size (Figure 8). These cavities reduce the structural capacity of the masonry work and accelerate its deteri-

Figure 8: Loss of mortar in raw masonry.

General rehabilitation of masonry. This concept includes various actions aiming at restoring the integrity of the masonry work. It includes removing the parasitic flora; replacing the mortar that has been lost in the joints between ashlar and between stones of the raw masonry; replenish the stones that have fell or are broken; and perform consolidation grouting to fill cavities and internal cracks in the masonry.

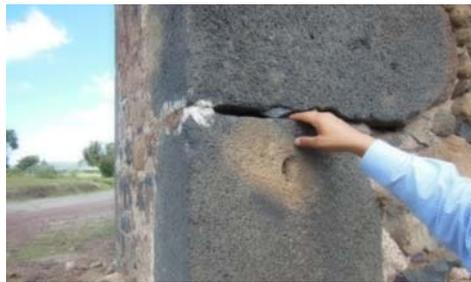
oration. Similar effects are produced by the mortar loss in horizontal joints between the corner ashlar of the shaft of the columns (Figure 9) or between the voussoirs of the arches.

Figure 9: Loss of mortar in horizontal joints between ashlar stones (notice stone wedges placed to level corner ashlar stones).

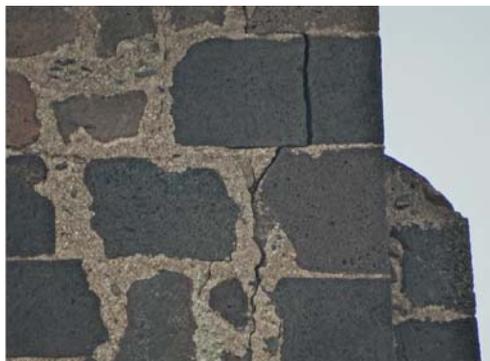
Fracture of ashlar stones. Breaking of ashlar stones is caused by stress concentrations (Figure 10) occurring mainly after a mortar loss in horizontal joints between column ashlar stones. Under these conditions, the load transfer from the upper to the lower stones no longer occurs through the entire mortar joint, but exclusively through several small stone wedges that the builders had placed to align and level the corner stones of the columns (Figure 9). These stress concentrations in the small areas covered by the wedge stones, in most cases only give rise to chipping of the stone edges, but, in some cases, the whole stone is fractured.

Figure 10: Cracking of raw masonry, affecting a corner ashlar.

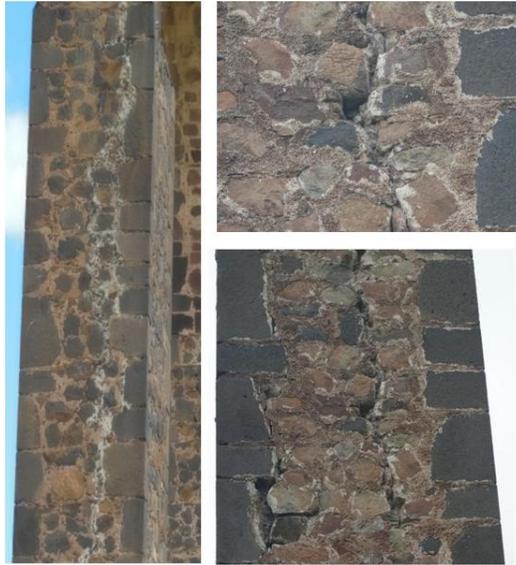
Separation of the corner ashlar from the raw masonry. Extended cracks were found at the boundary between column ashlar stones or arch voussoirs and the raw masonry (Figure 11). The problem is attributed, on the one hand, to the stones lacking of protruding teeth to anchor them to the raw masonry and, as will be discussed below, to the great difference in stiffness between stone ashlar stones and raw masonry. This gives rise to high compressive stresses in the

corner stones, which, eventually, separate from the inner raw masonry get to work as four isolated columns, that, because of their greater stiffness take most of the gravity load and tend to separate from the rest of the shaft and bend outwards. A similar situation occurs in the arches, between voussoirs and raw masonry (Figure 12). The vertical cracking of the columns is the most widespread and most worrying problem. There is evidence that several of these cracks had been repaired in the past by grout injections; nevertheless, most of them are now opened again, indicating that this solution was insufficient.

Figure 11: Vertical crack separating corner ashlar from the raw masonry. (It can be noted that the crack had been repaired in the past and is now open again).

The separation of ashlar stones from the raw masonry is attributed to the loss of bond between the two parties. In columns, the four corners are much stiffer than the central part of the section. This situation causes the gravity loads be concentrated in the corner stones, which, therefore, tend to bend outwards and to separate from the core of the section. The slenderness of the corner elements increases their tendency to bend out of the plane of the bridge. Something similar to that described for columns, occurs in the arches due to the absence of an ef-

Confinement of columns. To restore the composite action of the corner ashlar and the inner raw masonry, four stainless steel angles will be placed at the column corners and interconnected through eight bars of the same material (Figure 22a). These bars are provided with threads and nuts on the ends, so the device can be tightened to confine the column section avoid the development of vertical cracks in the columns. These confining devices will be mainly placed at the upper end of the columns to restrain the opening due to the eccentric thrust of the arch, as well as at the column base where stresses due to gravity and lateral loads are maximum. They constitute a reversible intervention, which can be removed by loosening the nuts (Figure 23).

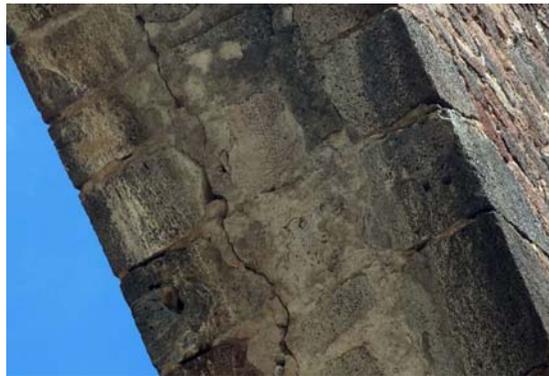
Figure 12: Typical cracking at the intrados of an arch, due to separation of the corner ashlar from the internal raw masonry.

fective link between the two parts that tend to separate: the outer voussoir bands and the inner raw masonry. Another critical situation of the same kind occurs at the top of these columns, where arch voussoirs stand only on raw masonry and not on the corner ashlar, thus fostering the separation of the two parts. The advance of the separation of the corners generates that some of them may become fully detached from their inner and fail by buckling, as happened in the past in one of the columns. Therefore the three mentioned problems requires priority interventions to restore the integral action of the two materials.

Confinement of arches. To tie together the corner voussoirs and the raw masonry at the bottom part of the arches, thereby avoiding reopening of longitudinal cracks that have occurred in the bottom of the channel, it has been proposed to place transverse tie rods crossing the width of the arches. (Figure 22b). These bars will be embedded in the stone voussoirs and the raw masonry, and will be prestressed.

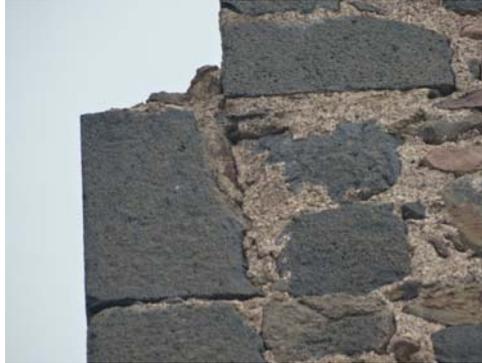
Defective support of arches on columns. This deficiency comes because the base of the arches is much smaller than the upper end of the columns, and therefore, arch voussoirs stand only on raw masonry and not on the corner ashlar. This situation fosters separation of the column ashlar corners from the inner raw masonry, through elongated longitudinal cracks at the interface between the two materials or, occasionally, in the adjacent raw masonry (Figure 13). The most critical case of this type of damage occurred in one of the tallest columns and had been corrected, probably since the time of construction. Repairs involved tearing off a

considerable part of the column shaft, and substituting both ashlar and raw masonries by a new masonry with smaller stones and with a more effective bonding array.

Figure 13: Damage due to eccentric load transfer from the arch to the top of the column.

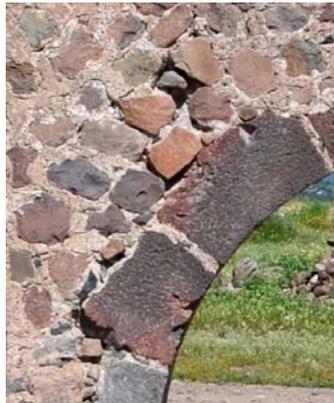
Cavities in raw masonry. In the intrados of several arches, raw masonry shows cavities of considerable depth (Figure 14). Most of these cavities can be attributed to runoff water from the upper canal, due to its cracking or to loss of its waterproofing coating. There are also cavities in the faces of columns and arches, essentially caused by the loss of mortar. A particularly delicate case is that of cavities and loss of masonry stones at some of the column bases, because storm water runoff eroded the masonry mortar (Figure 15).

Figure 14: Cavities in raw masonry.

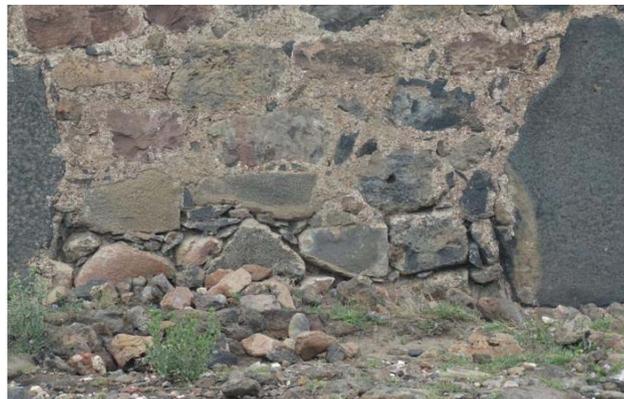
Figure 15: Scour damage at a column base.

An additional situation of risk requiring priority attention is found in the bases of the columns of the central arch, on the ravine, where degradation of the raw masonry due to scour at the columns base has generated an imperfect contact between the column base and the underground rock, thus giving rise to high stress concentration at the ashlar corners. This makes it necessary to protect the bottom of these two columns to prevent that scour of the mortar continue to advance due to storm water runoff, thus affecting the safety of the structure.

Other actions. The column bases and foundation of the span crossing the ravine should be restored to their original shape, and the topography of their surrounding land must be modified to avoid scour at the column bases. Furthermore, the surface of the subgrade portion of the column must be protected with a waterproof coating until at least 0.5 m above the ground level. The remains of the adobe walls deserve to be preserved, as evidence of the construction system used to build the arched bridge. They should be protected to avoid increasing degrading.

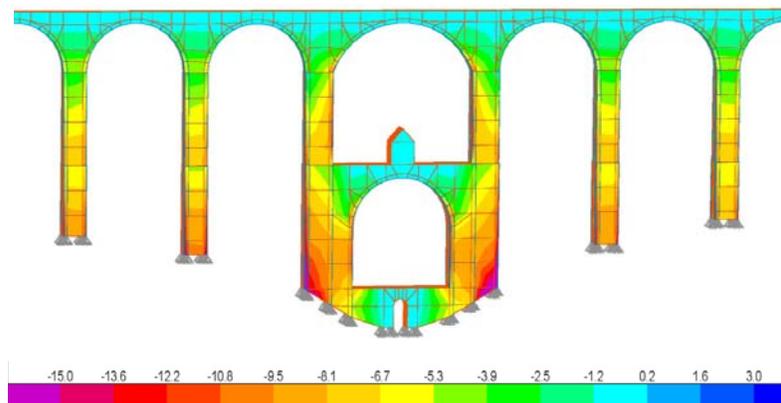
The analysis of the structure under gravity loads was performed to quantify its total weight, in addition to stresses and displacements. The weight of the whole structure is 14,285 t, of which 12,225 t correspond to raw masonry, and the remaining 2,060 t to the ashlar masonry of the columns corners and the voussoirs of the arches. Loads on columns varied with their height, reaching 625 t for the tallest columns. Figure 17 shows the distribution of vertical stresses generated by gravity loads along the central segment of the bridge. Great concentration of stresses occurs at the borders of the columns sections, and the maximum stresses occur the corners of the column base which, for the tallest column adjacent to the central arch reaches 13 MPa, while the average stress on the column section is only 0.6 MPa. As previously pointed out, this situation can be attributed to the ashlar stone possessing greater stiffness than the rest of the masonry. It should be bear in mind that the model did not consider the separations between the two materials, and, therefore, underestimates stress concentrations occurring in some of the actual columns.

Figure 17: Vertical stresses in the central part of the bridge under gravity loads.

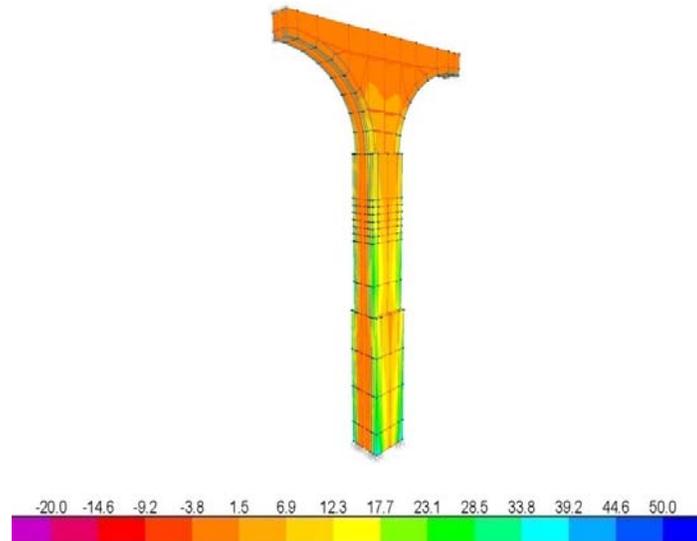
A spectral modal analysis was performed for the combined effect of the dead load plus the design seismic action in the direction normal to the plane of the bridge. The main results of this analysis are the following. The greatest lateral drifts occur in the central and tallest segment of the bridge. The maximum lateral displacement is 13.5 cm. Maximum vertical stresses occur at the corners of the columns bases, reaching 9.7 MPa in compression and 4.7 MPa in tension. As shown in Figure 20, in raw masonry stresses are much smaller than in the ashlar. Maximum computed tensile stresses widely exceed those that can be withstood by the masonry; therefore, even seismic events of much lower intensity than the design earthquake should have occurred in the lifetime of the bridge were likely the cause of the horizontal cracks now appearing in the mortar joints of ashlar and raw masonries.

Figure 20: Vertical stresses from the modal spectral analysis in the tallest column.

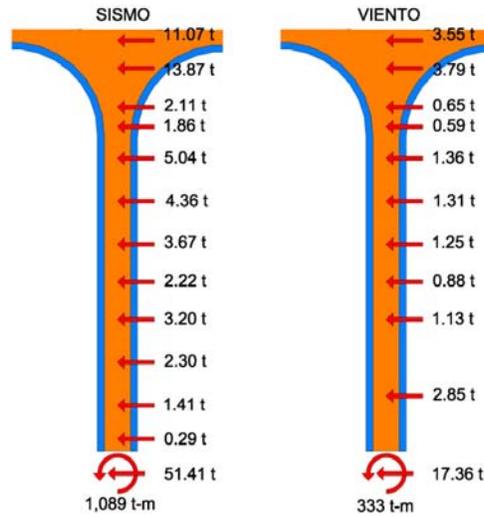
The site of the aqueduct is far from areas affected from extreme weather events; nevertheless, due to its relatively flat topography, is often subject to rather strong winds. Wind forces were computed for an event with a return period of 200 years, corresponding to a regional wind speed of 130 km/h. A simplified wind analysis, ignoring dynamic effects, was carried out for the tallest column of the bridge. Results are shown in Figure 21, in terms of the equivalent lateral thrusts exerted by wind along the column height, and are compared to those of a similar simplified static analysis performed for computing seismic effects. The total lateral force due to wind at the column base is equal to 17.3 t. In comparison, the lateral base force applied by design quake is almost 3 times greater. A more sophisticated analysis of the effects of wind forces was not considered to be necessary, given that the structural safety against collapse is clearly governed by seismic effects. Nevertheless, it must be taken into account that, the simplified analysis shows that the wind forces are large enough to induce significant tensile stresses in the tallest columns. Therefore, even winds of smaller intensities than those prescribed by the code, as those having return periods of a few decades, are strong enough to

induce stresses exceeding the tensile strength of the masonry, and, therefore, to contribute to the horizontal cracks found at the mortar joints.

Figure 21: Comparison of results from simplified static analyses for wind and seismic actions.
