PERFORMANCE OF MASONRY MONASTERY STRUCTURES IN THE M 6.9 SIKKIM EARTHQUAKE OF 18 SEPTEMBER, 2011: A GENERAL OVERVIEW

Keywords: Sikkim earthquake, Buddhist monastery, earthquake damage, masonry

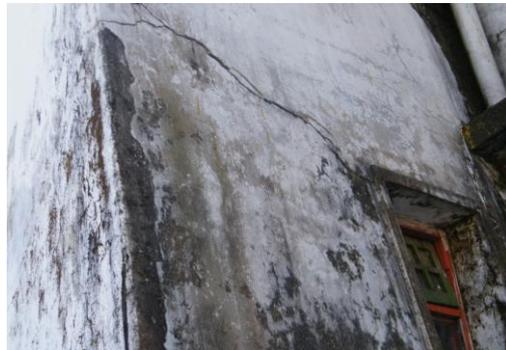
precinct, the Nalanda Institutes, constructed in 1972, sustained significant damages. These buildings sustained damages primarily at wall corners, and at sill, spandrel and pier masonry panels (Figure 4).

Figure 4: Corner crack

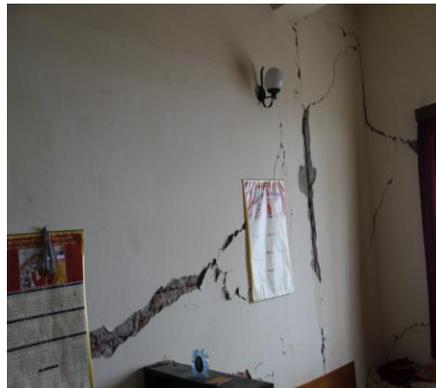
Major diagonal cracks developed in the wall panels. There were cracks in the spandrel masonry panels on all floors, with the cracks running in different directions (Figure 5).

Figure 5: Diagonal crack

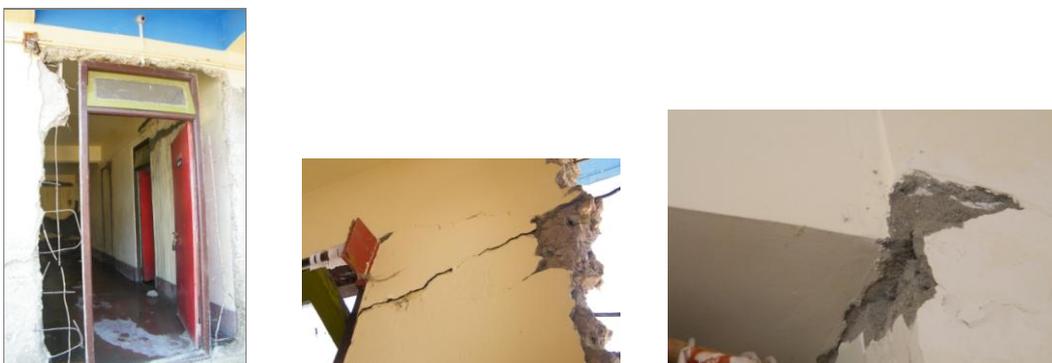
Non-structural elements such as window glass panels were broken as a result of the shaking. Building interiors also sustained damages at intersections between two walls, at roof-wall junctions, and also at lintel levels, evidently due to absence of lintel beams. There are instances of separation of door and window frames from the walls due to inadequate connections between these (Figure 6).

Figure 6: Detachment of door frame (left), Crack on pier masonry panels, (middle), Crack on spandrel masonry (right)

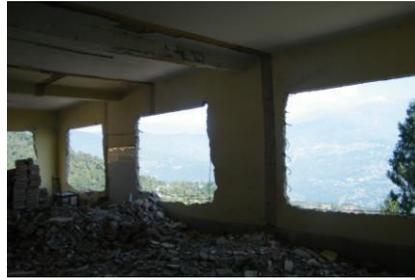
The Guest house suffered major damages wherein some parts of the RC wall due to poor quality of concrete and inadequate reinforcement (Figure 7).

Figure 7: Collapse in the wall

These damage patterns indicate a general absence of earthquake resistant features in the structure, such as lack of horizontal bands to contain the wall panels against out of plane failures, inadequate number of reinforcement bars in the columns, improper detailing and dimensions of the stirrups and poor workmanship. Other glaring inadequacies include poor tying of stirrups and insufficient lap lengths, 90 degree hooks instead of 135 hooks, which led to spalling of concrete from the beams and columns.

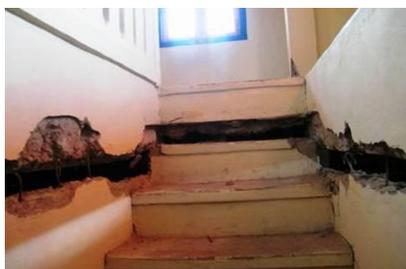
The Old Rumtek Monastery, Phodang Monastery, Labrang Monastery, Phensang Monastery, Pemayangtse Monastery are more or less similar in plan configuration. All of these are square or rectangular in plan and have single units. Except Pemayangtse, all the monasteries made masonry infilled RC frame extensions to their original structures. The upper floors had a number of floating columns at the upper levels. These proved disastrous for the structures, resulting in major damages to these upper floors. The top most floor of Old Rumtek monastery had spalling of cover concrete in the floating columns, along with cracks at the beam column junctions, indicating poor flexural performance. Similar damages were noticed in Phodang Monastery. An instance of separation of RC staircase from the floor slab was observed in the Old Rumtek Monastery. Long horizontal separation cracks were observed between the staircase beams and the infill walls of the staircase well. The beams also lacked adequate shear reinforcement and did not have proper ductile detailing (Figure 8). Staircase separation was also observed in Pemayangtse Monastery due to lack of connection between the wooden staircase and the masonry walls (Figure 9).

Figure 8: Disconnection of stair with floor Figure 9: Separation of unconnected wooden staircase

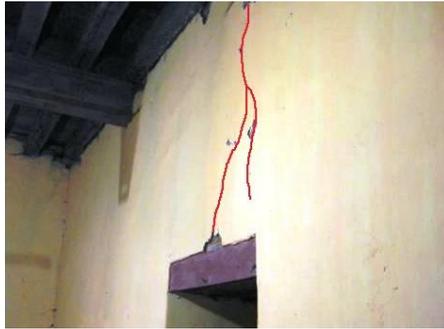
This monastery sustained damages primarily in the western and northern facades, at wall corners, sill, spandrel and pier masonry panels of openings. The corner of the north and west

face sustained shear cracks in the masonry walls originating at the corner and progressing diagonally along the wall surfaces. Cracks at the first floor window sill levels were seen to progress both diagonally and vertically along the wall face along with cracking in spandrel masonry panels above lintel level. (Figure 10).

Figure 10: Crack on spandrel masonry

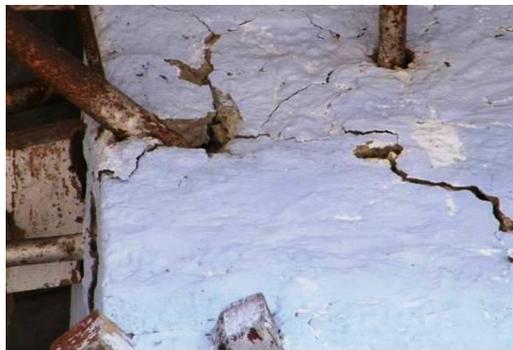
Lack of confinement of the window openings by horizontal and vertical bands resulted in the formation of diagonal cracks starting at the corners of the lintels and proceeding horizontally across the pier masonry panels (Figure 12).

Figure 12: Cracks on wall masonry

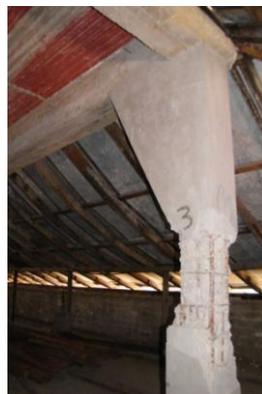
Phodong Monastery situated in the northern part of Sikkim is a three storied structure constructed with stone masonry. It has a simple rectangular plan and has a pitched roof with corrugated G.I sheet above the first floor. The ground and first floors are of same dimension. There is an extension above the first floor with RC floating columns and beams (Figure 14).

Figure 14: Poor column - beam joint

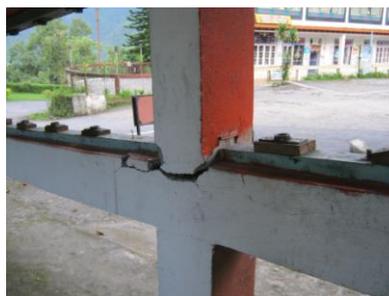
Long shear cracks were noticed both on outside and inside surfaces of the external walls. Short column effects caused serious damages at the top floor and also on the first floor verandah level (Figure 15).

Figure 15: Short column

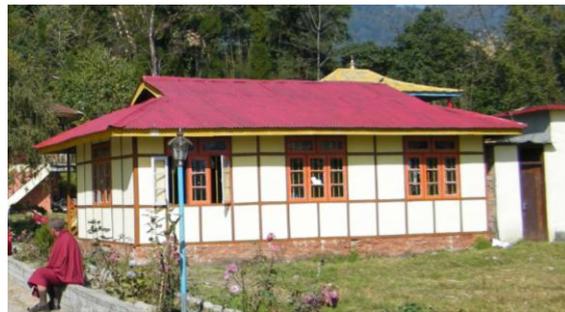
However, the outhouse of the monastery, made of traditional *Ikra* house having simple configuration with light weight walls, and pitched roof did not suffer any damage at all pointing at the inherent earthquake resilient attributes of vernacular construction in earthquake hazard prone areas in parts of North-eastern India.(Figure 17).

Figure 17: Outhouse of traditional *Ikra* style

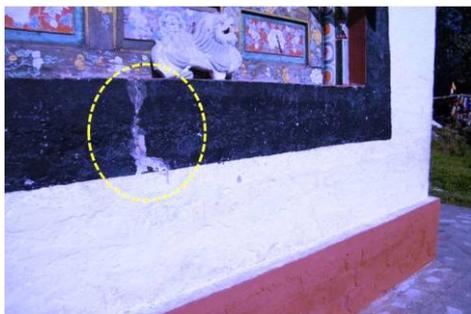
Phensang Monastery, situated in the northern part of Sikkim was built in 1721, and rebuilt in 1948. The main monastery building did not suffer any significant damage during the recent earthquake. Strong column and wooden beam support made the structure stable and safe. Some vertical cracks in the sill masonry were noticed due to the absence of sill bands (Figure 18).

Figure 18: Vertical crack on sill

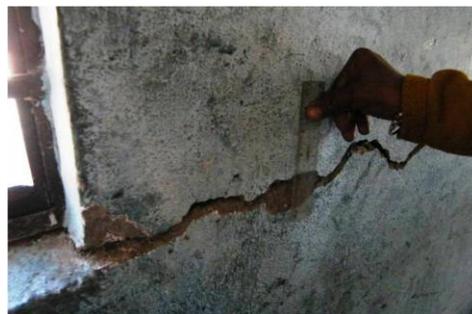
In the first floor of the two storied brick built outhouse, a continuous deep horizontal crack developed on the wall facing the monastery at the window sill level due to the absence of sill bands (Figure 19).

Figure 19: Horizontal Crack on sill level

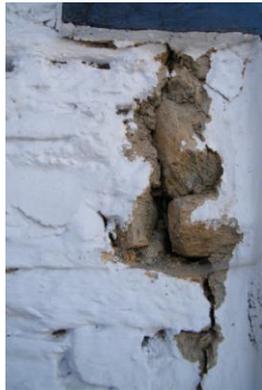
Labrang Monastery was built in 1814. Unlike many monasteries which were gutted by fires, this one still retains its original shape and structure. It is a cross in plan, symmetrical about both axes, and double storied with a pitched roof. The roof is made of a truss, covered by corrugated G.I sheets. It has projected wooden verandahs on each side at first floor level. Since the walls are of random rubble stone masonry, no proper bonding exists within the wall masonry; or even between adjacent walls. This appears to be the reason for the development of long vertical zigzag cracks during the earthquake. Shear cracks in the masonry wall facades and wall corners originated from the roof where the accelerations are the highest. Numerous such vertical cracks were noticed. The corner cracks are due to poor connections between the walls. The cracks in pier masonry move down along the wall. (Figure 20).

Figure 20: Crack on pier masonry

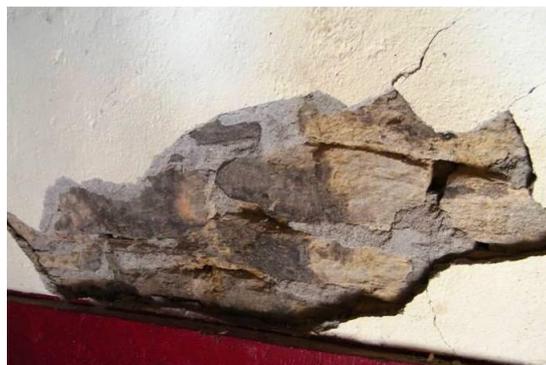
Similar cracks appear also in the spandrel masonry. Cracking of plaster in first floor wall surface, and shear cracks in the skirting level were noticed (Figure 21).

Figure 21: Cracking of plaster
