DAMAGE SURVEY AND STRUCTURAL ASSESSMENT OF THE ROSARIO CHURCH IN FINALE EMILIA AFTER THE MAY 2012 EARTHQUAKE IN EMILIA-ROMAGNA, ITALY

Abstract. *The paper is aimed at presenting some results regarding the causes of damage of a masonry church (Chiesa del Rosario) located in Finale Emilia, a town stricken by the May 2012 Emilia Romagna seismic event. The church exhibits a diffused state of damage on the façade (rocking along a horizontal hinge), lateral nave walls (shear), transept (shear and out-of-plane bending) and bell tower (detachment at the connection of the tower to the church and subsequent rotation along a vertical axis). The approach adopted is multidisciplinary and it is conducted within a research project that involves the Technical Universities of Milan, the Technical University of Bari and the Italian Cultural and Architectural Heritage Ministry (MiBAC). The survey analyses conducted comprise a detailed geometric recover of the volumes and materials used, basing on post-seismic photogrammetric studies, historical research on existing documentation and repeated in situ investigation. Preliminary structural analyses are conducted in agreement with the Italian Code. In p

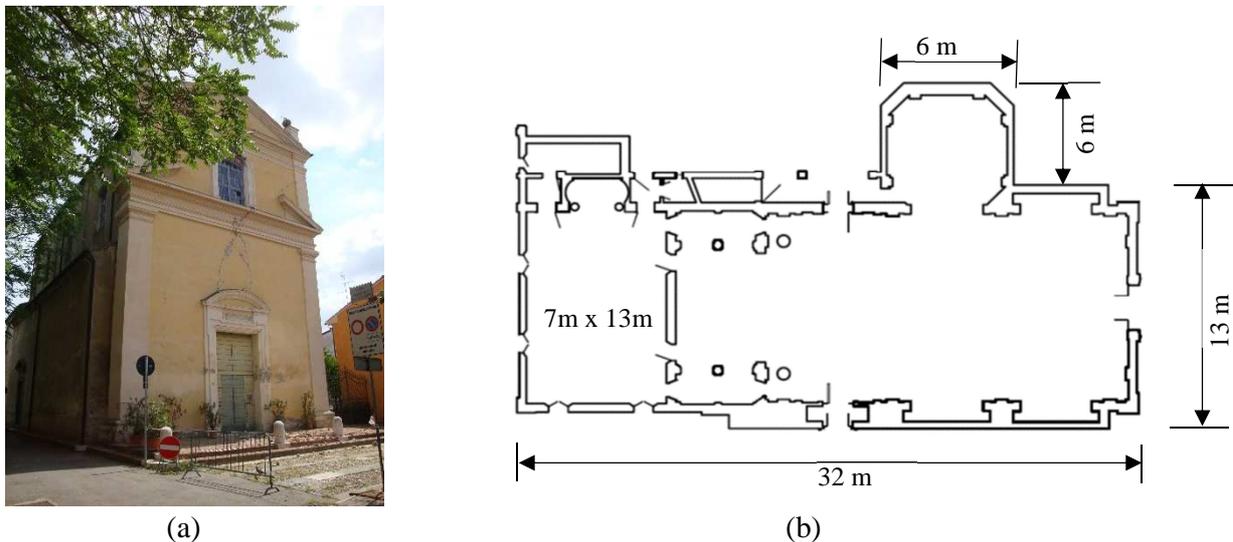
Figure 1: (a) Chiesa del Rosario (b) Plan view of the Church

The Rosario Church, see Figure 1, is a historical unreinforced brick masonry structure located in Finale Emilia, Italy. Geometrically, it is constituted by a large single nave 20 meters long and 13 meters wide and a presbytery with rectangular shape with approximate dimensions equal to 7 x 13 m. Roughly, the structure has rectangular dimensions equal to 32 × 13 m, with an average thickness of the walls equal to 50 cm. The height of the façade is around 17 m and a two story building 13 m high is directly attached to the back of the apse. The interior walls are supported by semicircular arches and columns. The bell tower has a height of around 20 meters and is partially connected to the church at one corner of the structure.

From the conducted survey, it was found that the church exhibits a diffused state of damage on the façade (rocking along a horizontal hinge, with detachment from perpendicular walls), lateral nave walls cracks due to shear (especially in correspondence of openings), transept partial collapse for shear and out-of-plane bending and a quite relevant detachment at the connection between the bell tower and the church, with subsequent rotation along a vertical axis of the tower.

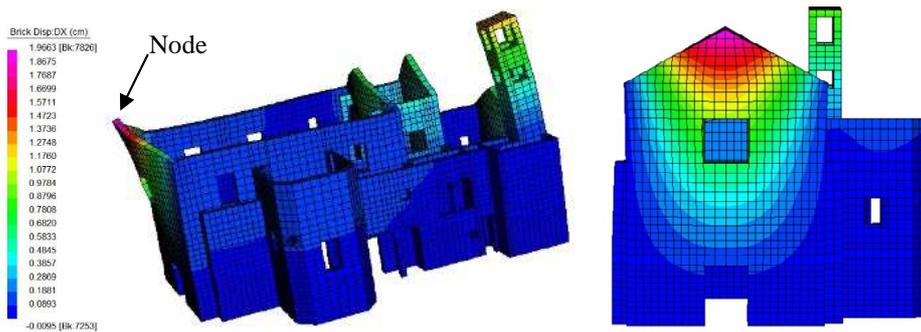
Figure 5: Deformed shape at collapse with the contour plot of maximum displacement due to Load case I in Positive X Direction.

As can be noticed from Figure 5, where the deformed shape at the last iteration for G1-X+ case is shown, the non-linear pushover analyses along the longitudinal direction (with loads from the apse to the façade) results into the formation of a failure mechanism that involves façade overturning (upper part), bell tower failure and damage of lateral walls of the central nave. The general state of inelastic deformation and the active failure mechanisms appear in satisfactory agreement with the actual state of damage occurred in reality.

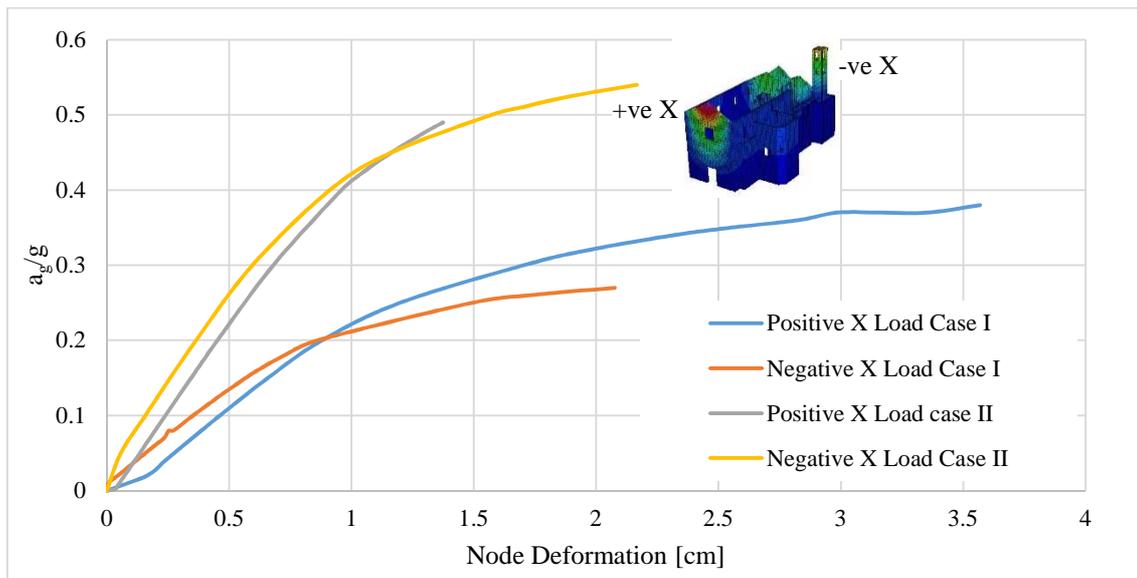
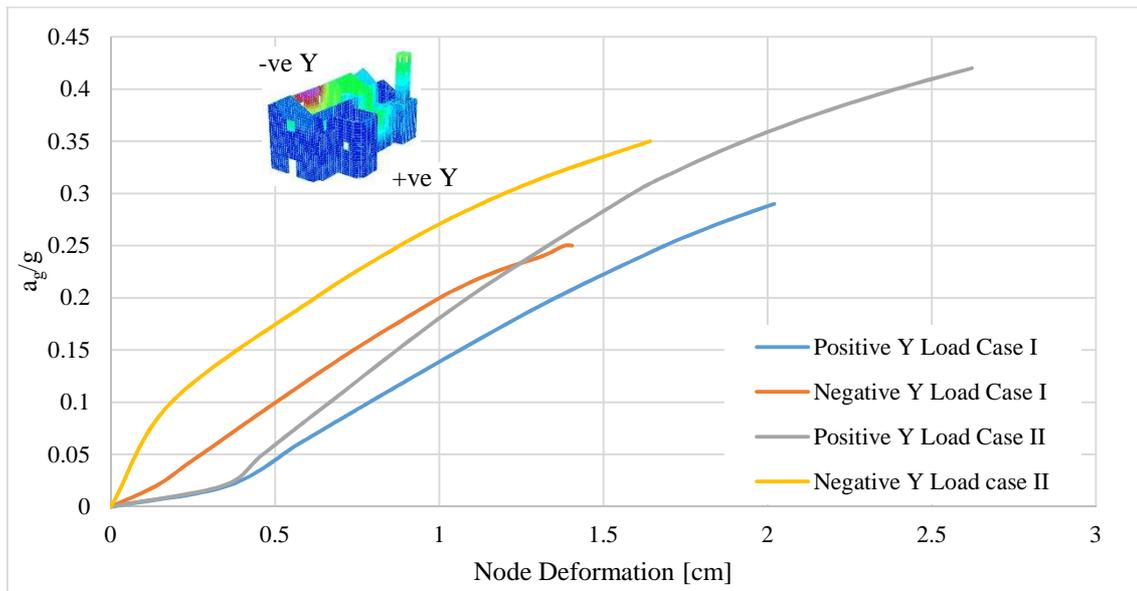
Figure 6: Pushover curves with cohesion 0.15 MPa (a) Load applied in X Direction (b) Load Applied in Y direction

In Figure 6, the pushover curves obtained with the numerical model discussed are represented for all the load cases investigated. Subfigure (a) refers to horizontal loads acting along the longitudinal direction, whereas subfigure (b) to the transversal direction. Along y-axis, the non-dimensional quantity a_g/g is represented, where a_g is the horizontal acceleration applied, i.e. the resultant static seismic load applied divided by the total mass of the structure.

As can be seen, collapse a_g/g is rather high, even for G1 distribution. Such result does not completely justify the state of damage induced by the earthquake occurred and is mainly linked to the high cohesion assumed for masonry.

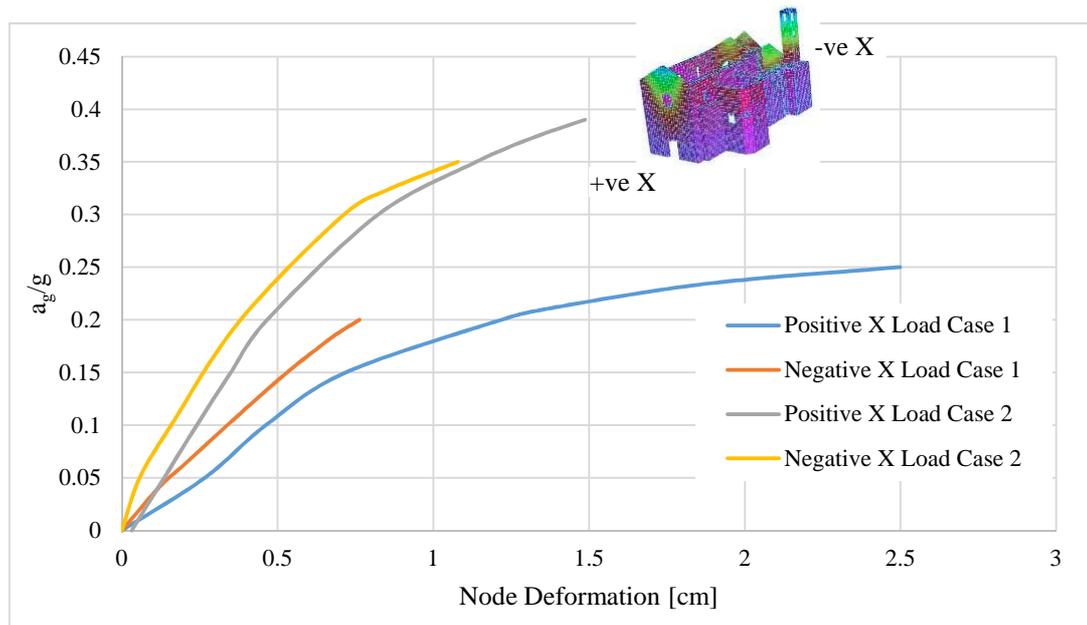
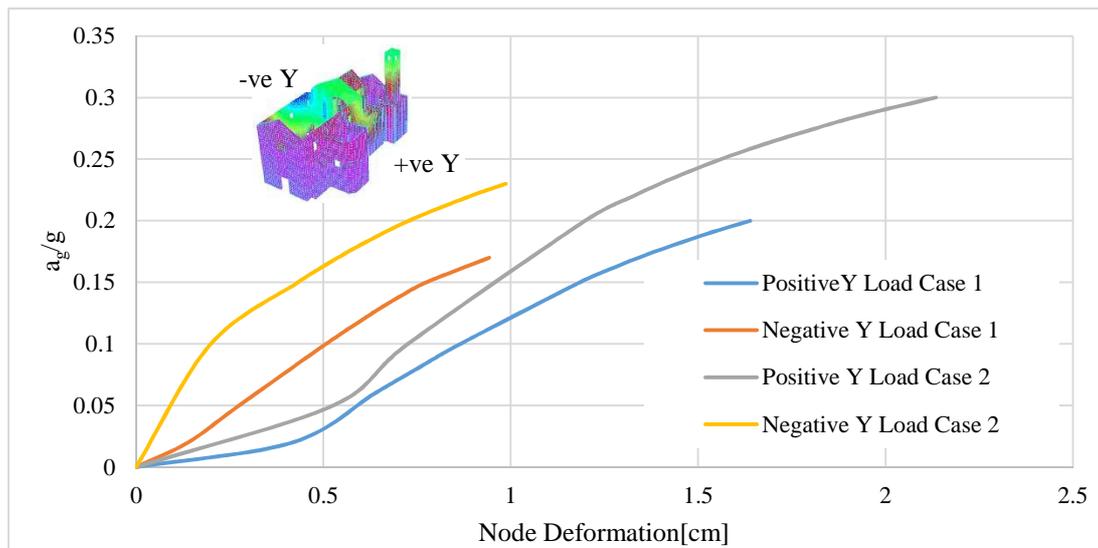
Figure 7: Pushover curves with cohesion 0.1 MPa (a) Load applied in X Direction (b) Load Applied in Y direction

Results obtained in terms of non-dimensional pushover curves are depicted in Figure 7 and Figure 8 for $c = 0.10$ MPa and $c = 0.05$ MPa respectively.

As can be seen, active failure mechanisms do not change considerably when compared with those found for a higher cohesion value. However, the maximum acceleration found, corresponding to the collapse of the structure, sensibly reduces. In particular, a gradual reduction in capacity of the pushover capacity curves generated with different cohesions is observed.

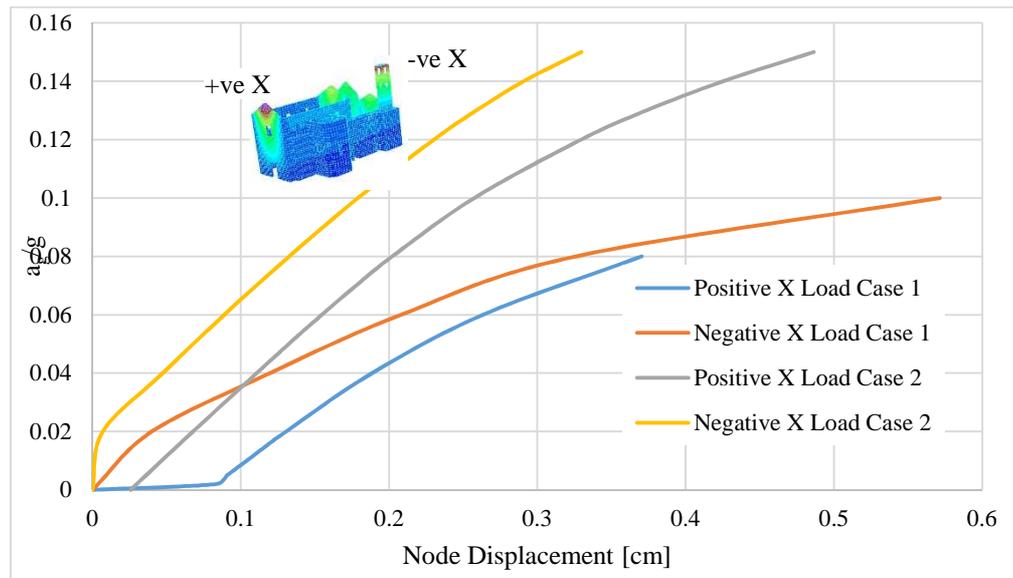
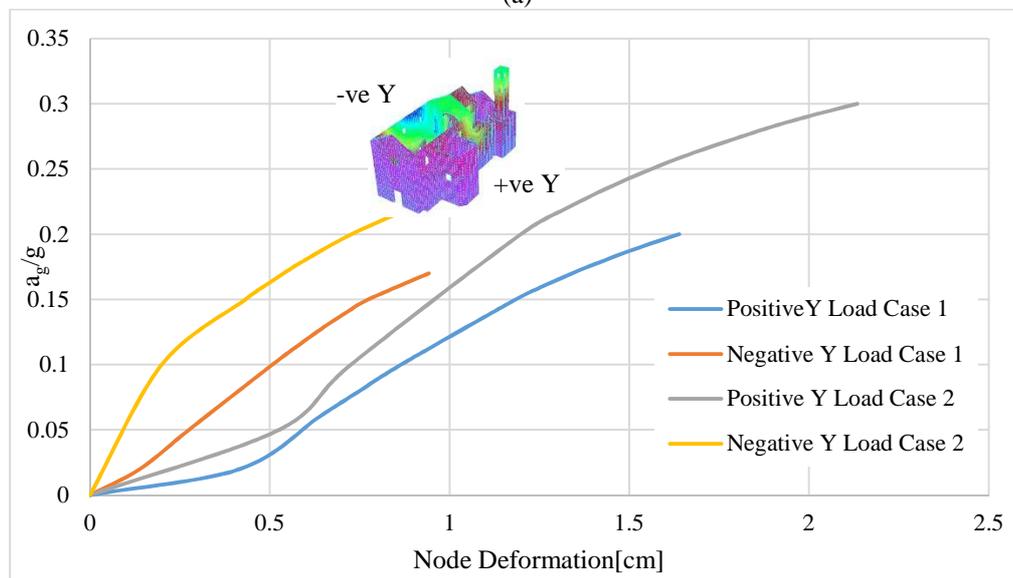
Figure 8: Pushover curves with cohesion 0.05 MPa (a) Load applied in X Direction (b) Load Applied in Y direction

Especially for the case with very low cohesion, it is found that an acceleration lower than $0.1g$ is responsible for the collapse of the structure, which appears reasonable in light of the experience collected with damages induced by the seismic sequence and the knowledge about the characteristics of the accelerograms.

It is interesting to notice that, along the transversal direction, the activation of a partial failure mechanism involving one of the long lateral walls of the central nave and the bell tower, occurs for an acceleration slightly lower than that found for the longitudinal direction. Visible inelastic shear deformation may be also noticed on the façade, a result which appears consistent with that observed in practice.
