## DOCUMENTATION, ASSESSMENT AND PROPOSED INTERVENTIONS FOR THE HISTORAL BUILDING OF VILLA KLONARIDI

**Abstract.** *The paper presents the methodology which was followed in order to assess the current state of a late 19th century building, and to propose compatible and adequate interventions for its conservation. Villa Klonaridi, Athens, Greece has been listed as a cultural heritage building because of its significant historical and architectural value. Three separate construction phases are identified. The load bearing system of the building is made of rubble stone masonry and brickwork masonry (depending on the construction phase), whereas the floors and roof structures consist of timber and steel members. The first step in assessing the building's bearing capacity and overall response is to document its present condition. The non-destructive technique of the radar was applied in representative areas so as to identify the construction type of the stone masonry. This was supplemented by an explicit survey of the building's pathology (damages due to seismic actions, material deterioration etc.). Masonry mechanical characterization was achieved through material sampling and subsequ

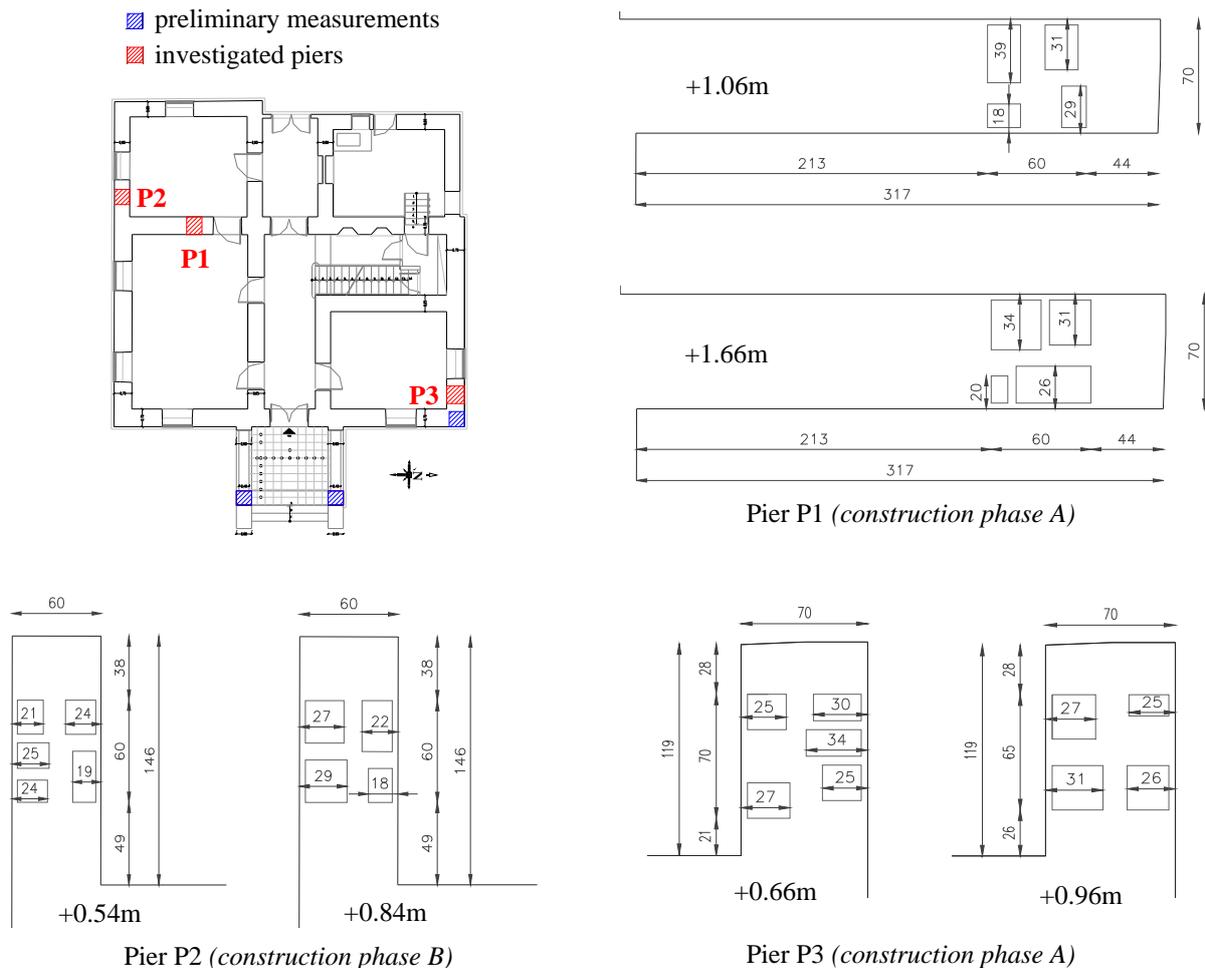
Radar settings were calibrated by performing preliminary measurements on areas where the masonry geometry was known (i.e., all three sides of the stones were visible). It should be mentioned that throughout the building the stones dielectric constant was assessed at an approximate value of 6.5. Three characteristic piers, the faces of which were completely covered by plaster with a mean thickness of 3-4cm, were thoroughly investigated. Horizontal and vertical scans were performed on each side of the piers. The obtained results indicate the use of the well-known three-leaf stone masonry construction type. As illustrated in the typical horizontal sections of Figure 2, the masonry comprises of two parallel external layers and a loose inner core. It was shown that the specific technique was used in both construction phase A and construction phase B.

Figure 2: Regions where radar measurements were performed, and typical horizontal sections of piers P1, P2 and P3 at various heights above the ground level.

More specifically, the application of compatible grout injections in conjunction with deep repointing is proposed for the homogenization of the three-leaf stone masonry walls met upon construction phases A and B. The designed natural hydraulic lime grout mixture has a compressive strength of 8MPa. After grouting the masonry will possess enhanced mechanical characteristics, and will be able to safely withstand the prescribed loads and seismic actions. The mechanical characteristics of the grouted masonry are summarized in Table 2 below.

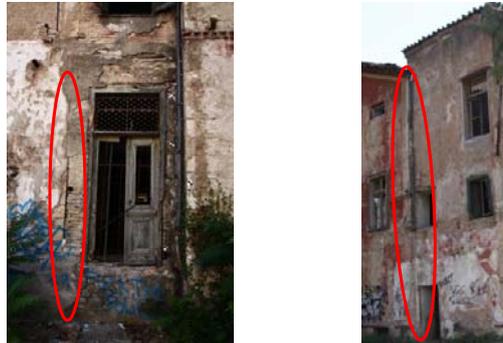
Over the years the building has suffered extensive damages and is considered to be in a rather poor condition due to the complete lack of conservation/maintenance. Seismic actions have caused a variety of cracks, as well as the detachment of the non-monolithically connected adjacent walls belonging to separate construction phases (see Figure 3). Extensive material decay is observed due to water penetration and fire outbreaks. Mortar has been washed out of the joints at significant depths, leading to masonry disintegration in several regions of the building. The brickwork masonry met upon construction phase C is of extremely poor quality. Several timber and steel members of the floor and roof structures are damaged or worn out. The timber roof of construction phase C is poorly constructed and badly preserved. Most of the door and window lintels are damaged beyond repair. The building's floors and roofs do not represent a rigid diaphragm, thus resulting in increased vulnerability against out-of-plane actions. Finally, the diversity of applied building materials and construction methods has resulted in strength and stiffness disparities along the structure's load bearing system.

Figure 3: Evident detachment cracks due to the lack of interconnection between adjacent masonry walls belonging to different construction phases.

As far as the poor quality brickwork masonry of construction phase C is concerned, (partial) reconstruction with the use of vertically perforated bricks is recommended. In order to eliminate the vulnerability against out-of-plane actions and minimize the relative displacements between separate construction phases, the restoration of the masonry continuity is proposed. Specifically, a monolithic connection by means of interlocking should be achieved not only between adjacent stone masonry walls, but also between the reconstructed brickwork masonry walls and the adjacent stone masonry ones (see Figure 6).

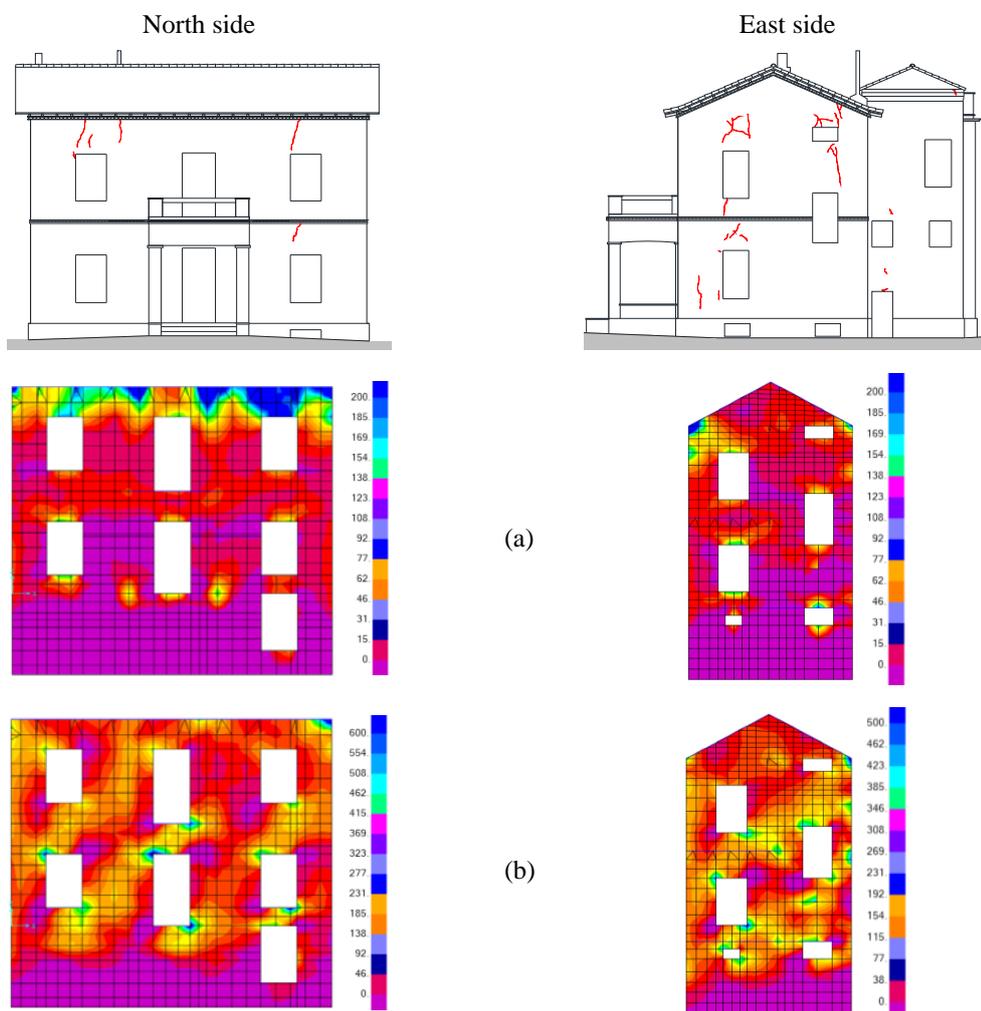
A numerical analysis was carried out with the help of the finite element modelling software SAP2000 [2]. Thick shell elements were employed to model the masonry walls, while frame elements were used to model the timber and steel members of the floor and roof structures, as well as the sections of the lintels. The structure was assumed to be fixed on the ground. The material properties adopted for the numerical analysis were derived by the data presented in section 2.3. The equivalent seismic load method of analysis was employed (i.e., equivalent seismic actions were distributed along the height of the building), so as to be able to extract the quantitative data (action-effects) required to perform capacity checks. Nine load combinations were investigated (1 for vertical loads and 8 for seismic actions) according to the Greek Seismic Codes of 1959 and 2000 ([3], [4]). It should be mentioned that the obtained principal tensile stress diagrams were well in accordance with the observed pathology (see Figure 4), thus verifying the validity of the computational model.

Figure 4: Verification of the building's pathology through typical principal tension stress diagrams obtained by the analysis for the cases of: (a) vertical loads combination, and (b) seismic actions combination.

Safety checks against in-plane and out-of-plane loading were performed in every critical section of the structure. This allowed for the bearing capacity margins to be estimated, and also for the areas of deficiency to be identified. More specifically, 12% of the masonry piers, in addition to the majority of the lintels, proved to be unable to safely withstand the applied

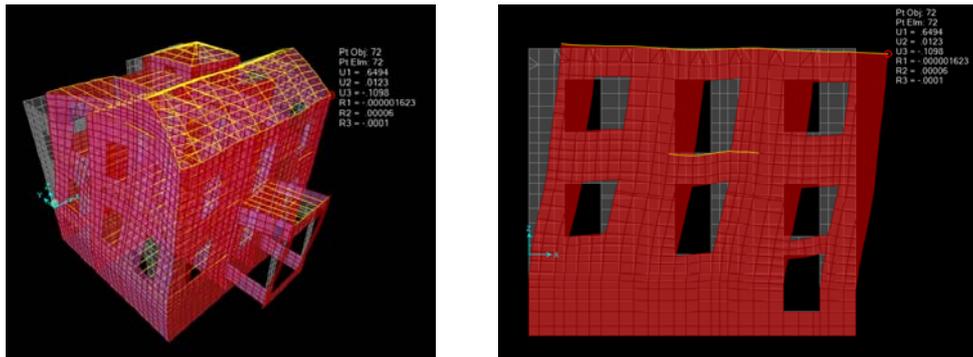
What's more, qualitative data regarding the overall seismic response of the structure was obtained through the finite element analysis. The deformed shape of the model (see Figure 5) demonstrated the enhanced vulnerability of the building against out-of-plane actions, due to the lack of diaphragm action at floor and roof levels. The analysis also recorded large relative displacements between the separate construction phases of the model (non-monolithic connection).

Figure 5: Deformed shape of the model and large relative displacements between separate construction phases.
