The Performance of Truss-Type Reinforcement in Masonry

H.R. Hodgkinson, H.W.H. West
(British Ceramic Research Association, Stoke-on-Trent, England)

Abstract

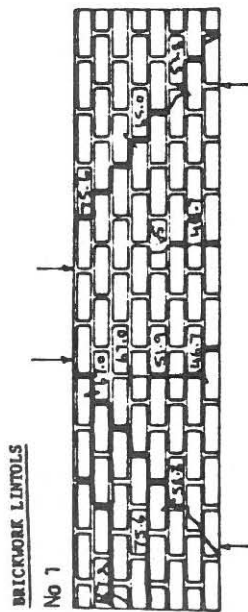
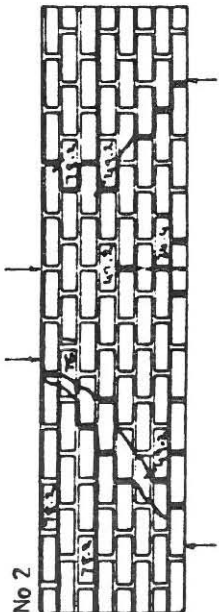
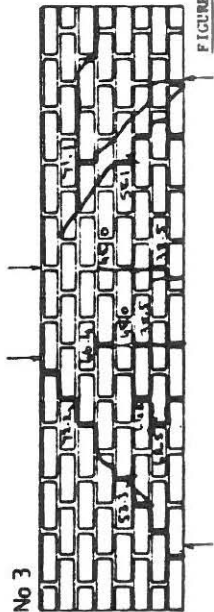
FIGURE 6. CRACK PATTERN OF LISTOL BEAMS

The lintols behaved as beams and the mode of failure was shear, due to failure of the bond between the mortar and the bricks or blocks. In no case did any of the reinforcement fail in tension. Plots of the crack patterns are given in Figures 6a-f.

The beams failed in shear and, at the failure load, the calculated maximum horizontal shear in the bed joints was 1.1 N/mm^2 for the brickwork beams and 0.4 N/mm^2 for the AAC beams compared with a BS 5628 characteristic value of 0.35 N/mm^2 .
