IN-SITU TEST OF THE SHEAR STRENGTH AND DEFORMABILITY OF AN 18TH CENTURY STONE-AND-BRICK MASONRY WALL

ABSTRACT In the paper a description is given of how the shear strength and deformability of a load-bearing, stone-and-brick masonry wall in an 18th Century building in Ljubljana were determined by means of an in-situ test. The tested wall element, of dimensions 1.60 x 0.80 x 0.45 m, was loaded horizontally at mid-height until symmetrical diagonal cracking occurred. It was then repaired by full cement-grouting, and retested to failure. The results obtained are compared with those obtained in tests of similar wall elements in the laboratory.

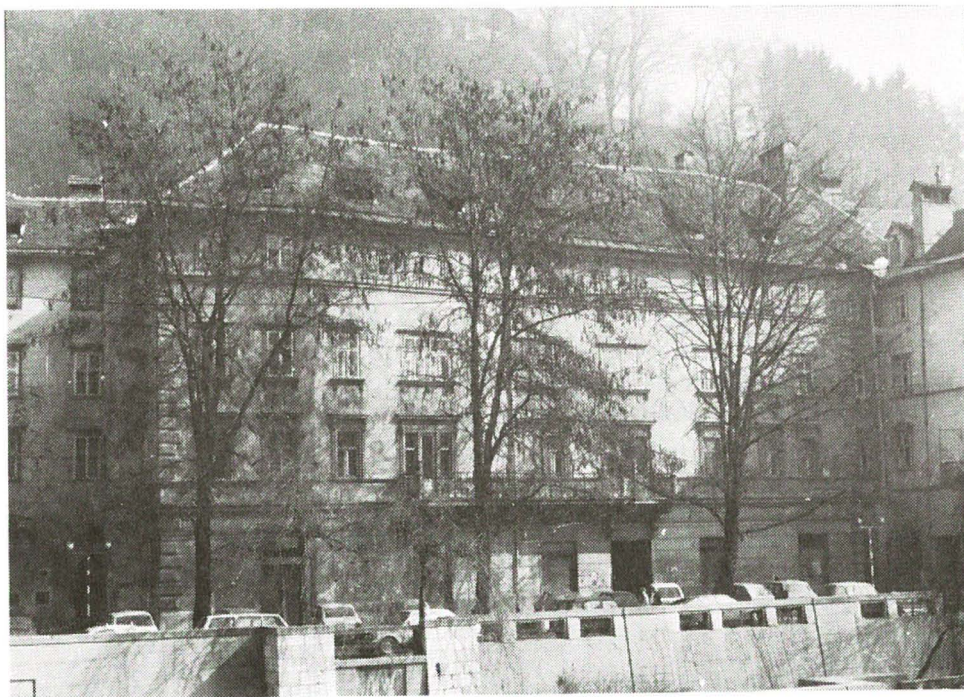
Fig.1 : View of building in the old part of Ljubljana, where the in-situ test was carried out.

It was decided that the in-situ test be carried out inside a typical, 4-storeyed masonry building in the older part of Ljubljana's city centre (see Fig.1). Historical records indicate that the greater part of this building was built during the 17th and 18th Century, although parts of the ground-floor walls probably date from an earlier period.

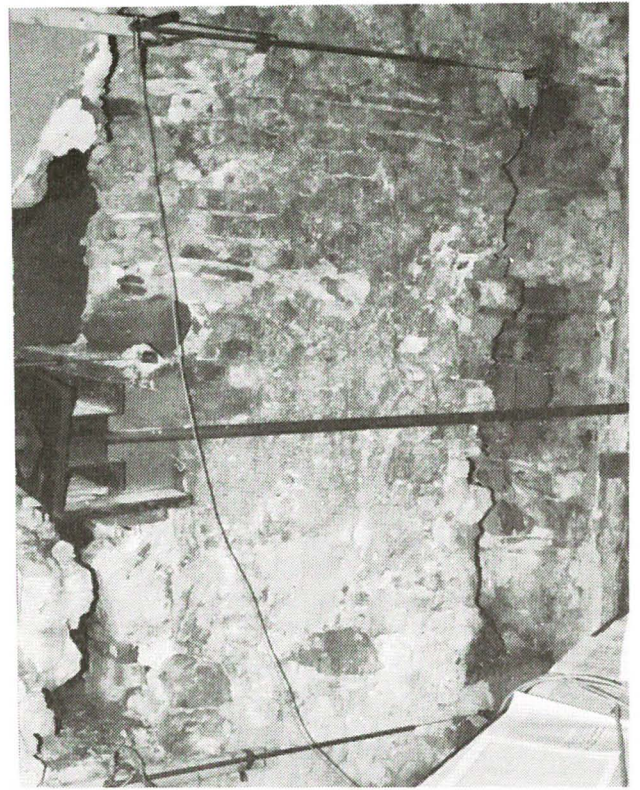
Fig.6 : Basic wall element
during test

The uni-directional horizontal load ($2H$) was gradually increased, in equal increments of approximately 15.0 kN, with intermediate unloading steps, until maximum horizontal load was achieved and diagonal cracks, indicating shear failure, occurred in both the top and the bottom half of the wall element (see Fig.6). Horizontal deformation of the wall element was measured by means of three LVDT's, located at the top, mid-height and bottom of the wall as shown in Fig.9 (c). The resulting horizontal load-deformation (" $H-\delta$ ") diagrams for the top and the bottom half of the wall element, which were practically identical, were plotted on two "x-y" recorders. The results for the top half of the wall are shown in Fig.9 (a). Vertical elongation or shortening of the wall was measured by means of two dial-gauges.

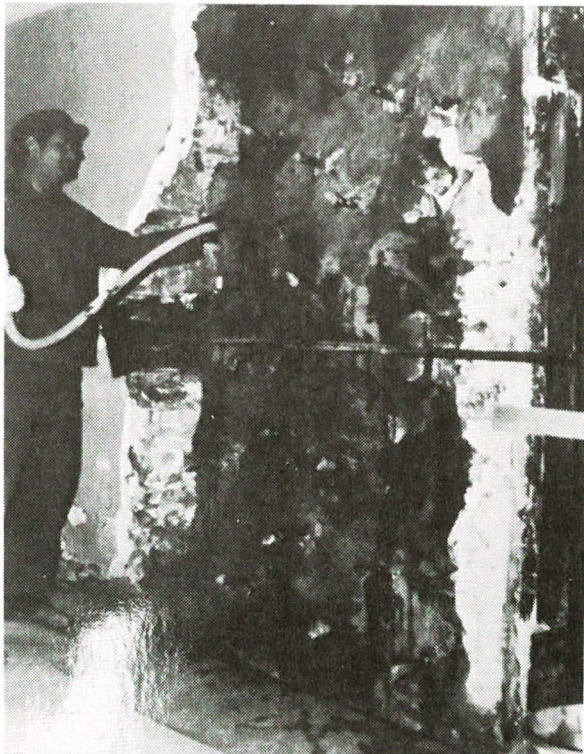
Fig.7 : Cement-grouting of
wall element

At the end of the first test, strengthening of the tested wall element by means of full cement-grouting was carried out (see Fig.7). The mixture used for grouting consisted of 90% ordinary portland cement according to B.S.12 (or quality PC-45 according to the Yugoslav standard JUS B.C1.011), and of 10% pozzolana, to achieve plasticity and to prolong suspension of the mixture. According to volume, the ratio of the dry mixture to water was 0.75 to 1.0. A total of 75 kg of the dry mixture per cubic metre of the wall's volume was used, the maximum working pressure used for grouting being about 2.5 bar. The average compressive strength of three hardened cylinders of a sample of the grout mixture after a period of 28 days amounted to 24.5 MPa.
