## **PROBLEMS ISLAMIC MONUMENTS IN CAIRO FACE**

**M. Orphy<sup>1</sup> and A. Hamid<sup>2</sup>**

### **Abstract**

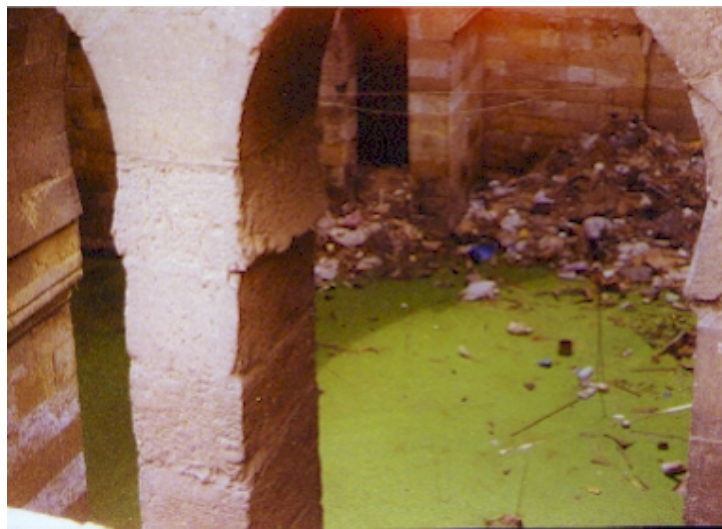
*Figure 1 Sewage and garbage found in Hammam Al Mu'ayyad*

The rise in ground water is a factor that has been the most commonly found in Old Cairo today. Most historic structures were built at a time when the ground water level was much lower, as was the street level. Water has flooded many basements and ground floors of historic buildings in Old Cairo. Two notable examples are the Hanging Church where the water had covered the lower level that is composed of part of the fort of Babylon. A second example is Beit El Sinnari (a historic house) where the water had covered the ground floor hiding an entire fountain in the courtyard; many other historic houses experienced the same fate. As the water rises, it brings up salts to the stone walls and the porous stones absorb these salts. When the soluble salts come into contact with air they crystallize (often to a larger size than the pores) and can cause spalling or flaking. Not only is this water rising, but also, in many cases, it is mixed with sewage water. Figure 1 displays how this undesired water has flooded the floor of the bath of Al Mu'ayyad, which is one of many examples where this situation can be found. Naturally, sewage water is much more dangerous because along with it comes bacteria, fungi and chemicals such as chlorides, sulfates and nitrates. The Egyptian government is currently undergoing efforts to try to solve the sewage problem by rearranging the network.

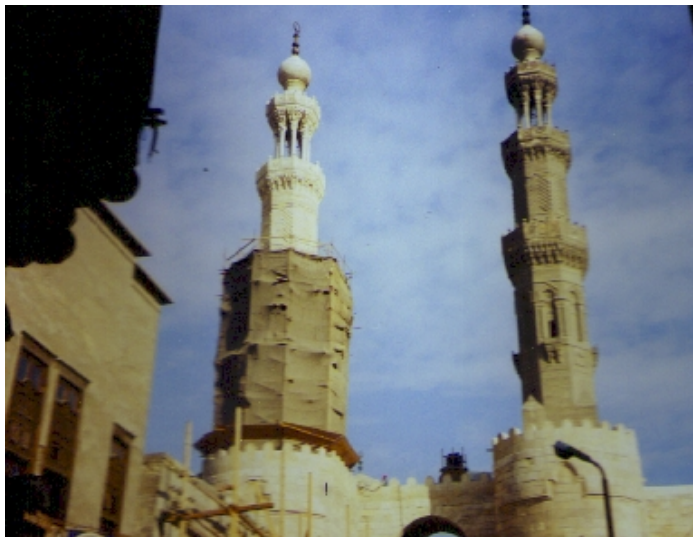
The level of dust has increased over 60 percent in Cairo from 1962 to 1988 (Abo El-Ela 1995). Included in the dust are a lot of heavy metals coming from nearby factories. This dust has caused many of the structures to change in color to a grayish shade. Originally the structures are commonly of a cream or white color and some are even striped with the “ablaq” style (in some instances it is hard to spot the stripes due to the amount of dust covering the surface). Many repair projects are involved in cleaning such buildings. For example, a lot of the work done on Bab Zuwayla (an 11<sup>th</sup> century gate into Old Cairo) minarets were added in the 16<sup>th</sup> century by the ruler al Muayyid Sheikh) and the exterior of the El Azhar mosque was cleaning the surface from all the dust and exhaust which had caused its original yellow color to turn gray. Figure 2 shows how dramatic the difference is between the clean and un-cleaned minarets of al Muayyid on top of Bab Zuwayla.

*Figure 2 View of Bab Zuwayla showing the difference between clean and unclean surfaces.*

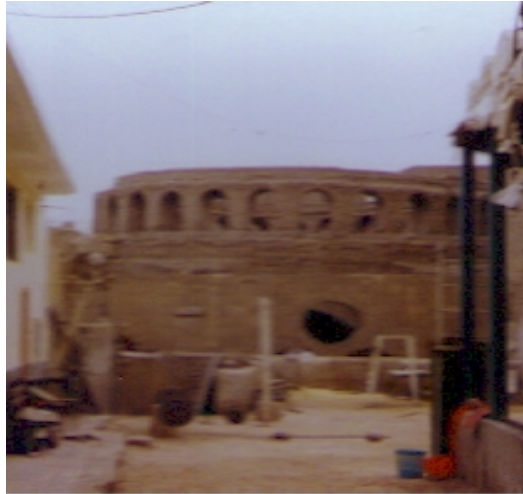
Elements such as domes, slabs, roofs, minarets and top bulb of minarets have been collapsed. The mausoleum of El Ghuri and the Hammam of Al Mu'ayyad (Figure 3) are both examples of structures where domes have collapsed. Other parts of buildings like minarets and slabs have also collapsed and, in some cases, repair attempts have replaced them with inappropriate newer ones. For example, in some cases, the missing dome was replaced with a new concrete one. The Qalawun Mausoleum is an example of this approach.

*Figure 3 Dome of Hammam Al Mu'ayyad no longer exists*

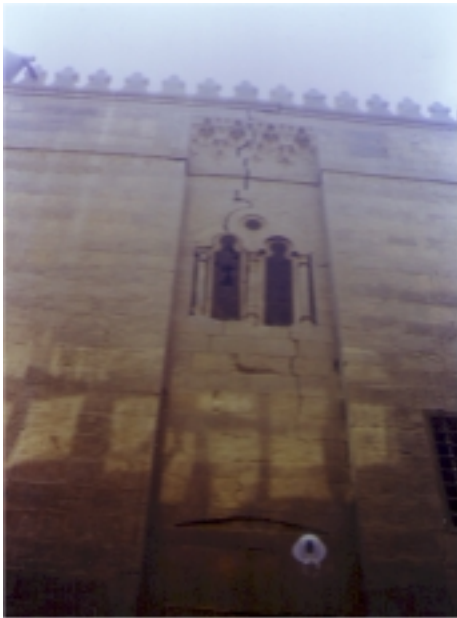
Cracks can be classified based on width, activity (active versus dormant) and orientation. Cracks found range from vertical to stepped cracks. These cracks can be found where there are openings, see Figure 4. Diagonal cracks can also be observed in piers around openings. The cracks in stone buildings are different than those in buildings primarily composed of brick. In stone structures the cracks tend to propagate through mortar joints causing separation of stones. Being a brittle material, stone masonry cracks when tensile stresses due to loads and/or differential movement exceeds the material's tensile strength (Drysdale et al 1999). Cracking may or may not have a significance on the structural integrity of the structure depending on wall boundary conditions at the supports and the degree of indeterminacy (Drysdale et al 1999).

*Figure 4 Madrasa of Amir Mithqal (vertical crack propagating through openings)*

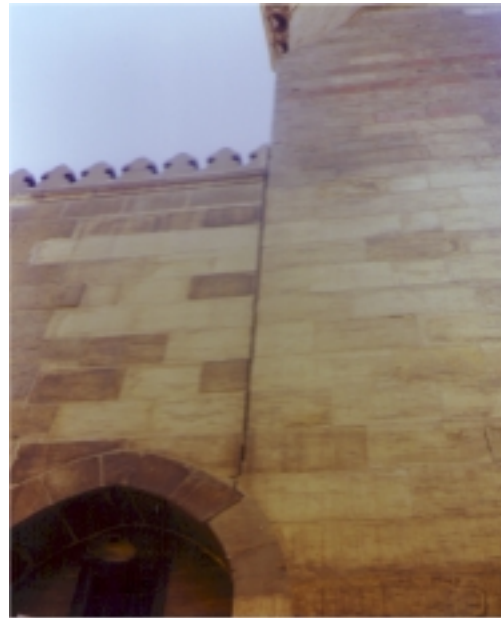
Separation of elements such as minarets from rest of the mosque structure has been observed (Figure 5). Minarets are the most common of elements to separate because they have a different shape and mass distribution than the rest of the structure. Figure 6 shows the minaret of the Amir Mithqal Mosque separating from the rest of the building. There is no bond between them since the stones are not teathed together. Therefore the minaret is creating for itself a separate movement joint which is not disastrous if controlled.

*Figure 5 Crack between minaret and mosque*

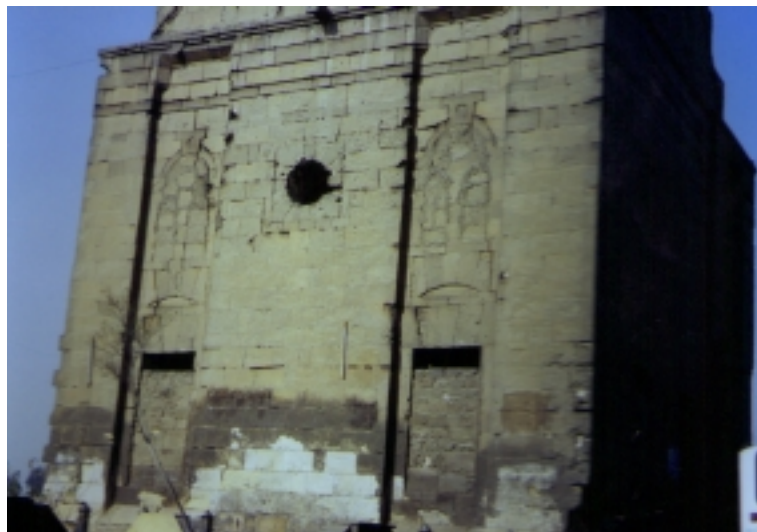
Most Islamic monuments are built of limestone. With rising underground water discoloration of the stones occur as well as further decomposition. Deterioration of the stone can range from flaking to spalling to delamination. The loss of mortar in the mortar joints is another factor that can be found. The Mausoleum of Sultan Abu Said (located in the cemetery area) is an example that displays all of these problems.

*Figure 6 Display of deterioration of stone in Mausoleum of Abu Said*

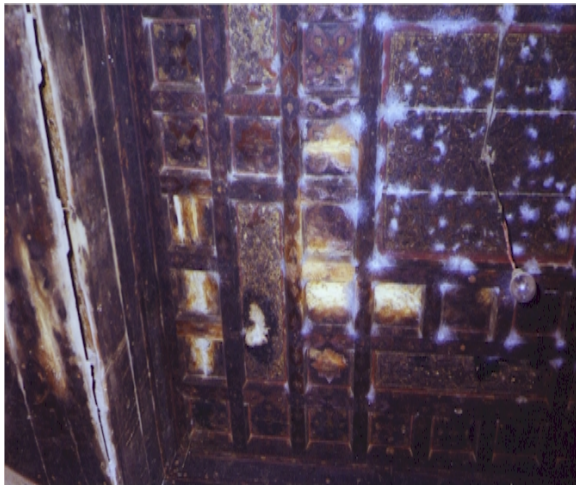
In many cases ceilings of Islamic monuments were constructed of wood. With increasing humidity and moisture wood is affected. Deterioration in the form of staining ( Figure 7), delamination and cracking are observed. A lot of times rotting occurs especially at the end of wooden beams which rest on masonry affected by moisture or are under wet areas such as roofs or bathrooms.

Figure 7 Wooden ceiling belonging to the Mausoleum of Sinan

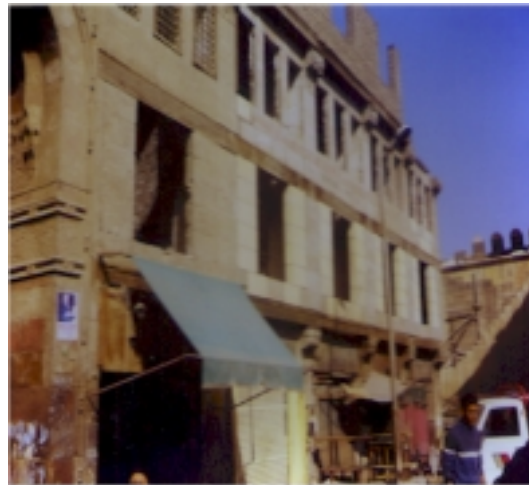
Missing elements vary from fountains and other various finishes, missing windows and grilles. Figure 8 is a photograph of Wekalat Qaitbay and it is missing many of its window grilles.

Figure 8 Wekala of Qaitbay
