SHAKE TABLE TESTING OF POST-TENSIONED CONCRETE MASONRY WALLS

Abstract

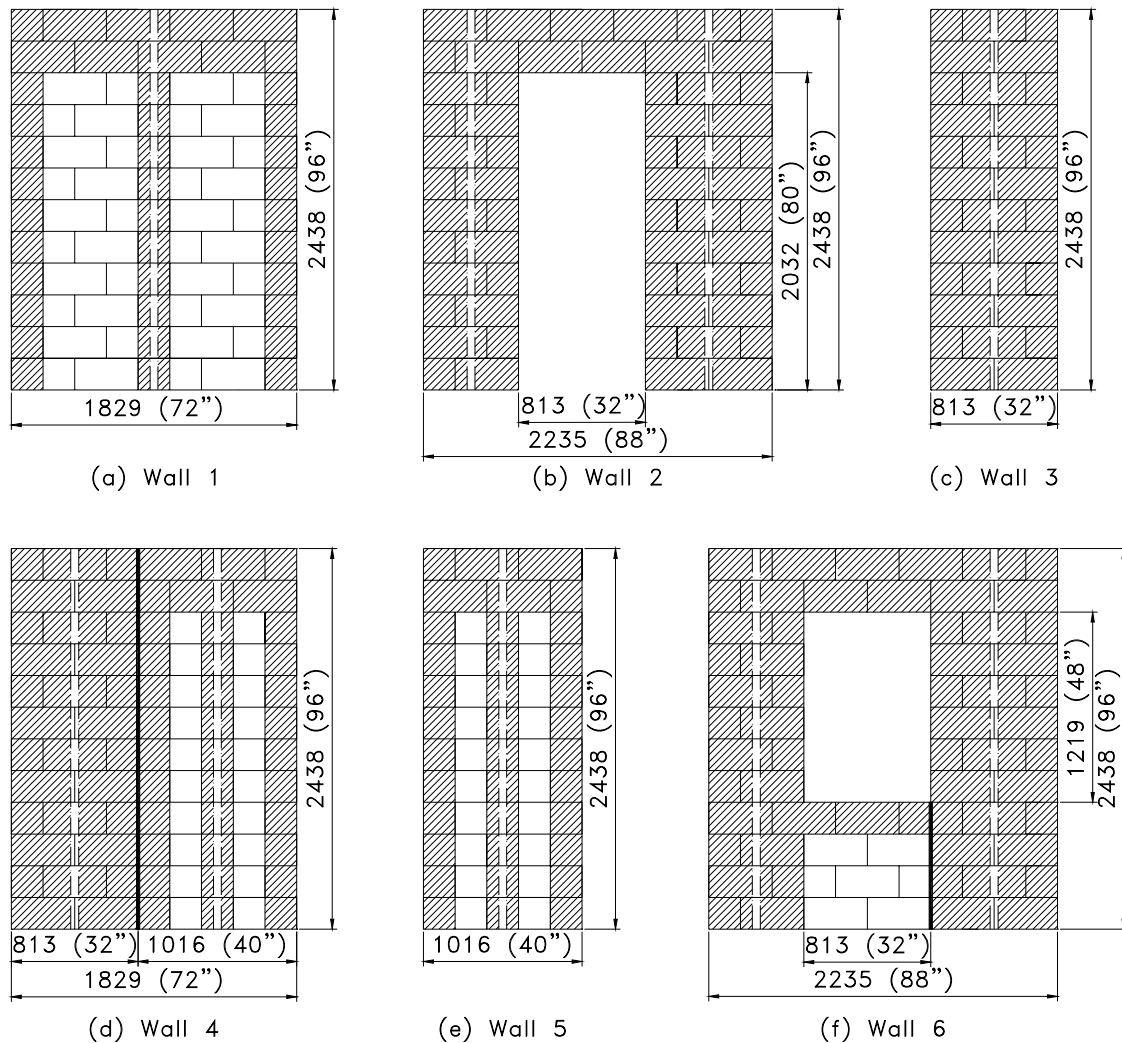
Figure 1 Wall dimensions

Wall dimensions are listed in Table 1 and shown in Fig. 1, where the hatched area indicates cells that were grouted and the prestressing ducts are depicted as a clear space inside a hatched cell. This system requires the cell containing the tendon and the two end cells to be grouted. Due to dimension limitations caused by the size of the shake table, this resulted in some walls being fully grouted. Wall 3 was derived from wall 2 after completion of earlier testing. Upon completion of testing wall 4, the 800 mm wide panel was removed and the remaining panel tested as wall 5.

The bond beam in all walls consisted of 2×16 mm (No. 5) bars, with one bar located in each of the top two block courses on opposite sides of the centrally located post-tension duct. Stirrups were spaced at 600 mm centres except when the bond beam formed a lintel as was the case for wall 2 and wall 6, where they were spaced at 165 mm on centre over the opening. Wall 4 contained two dowel bars crossing the control joint with a total length of 800 mm. One half of the bar was greased and coating with a plastic sleeve to ensure bond was not formed with the surrounding grout. ASTM-706 mild reinforcing longitudinal steel, which is the seismic grade mild reinforcing steel in the USA, having a specified yield stress of 414 MPa (60 ksi), was used in all walls tested. The stirrups used in the bond beam were ASTM-615, 6 mm round wire stirrups, with the same specified yield stress.

Wall 6 was subjected to twelve ground excitations at a prestress level of approximately $0.46f_{py}$ and then a further three records at a prestress level of approximately $0.28f_{py}$. At the initial prestress level, minor cracking of the bond beam occurred, allowing the two side panels to rock at the base. A maximum wall displacement of 8.7 mm (0.36% drift) was recorded with minimal loss in strength, as indicated by Fig. 4(f). The non-symmetric shape of the force-displacement backbone curve is a result of the control joint below the window opening, which allowed the left panel, as shown in Fig. 1(f), to

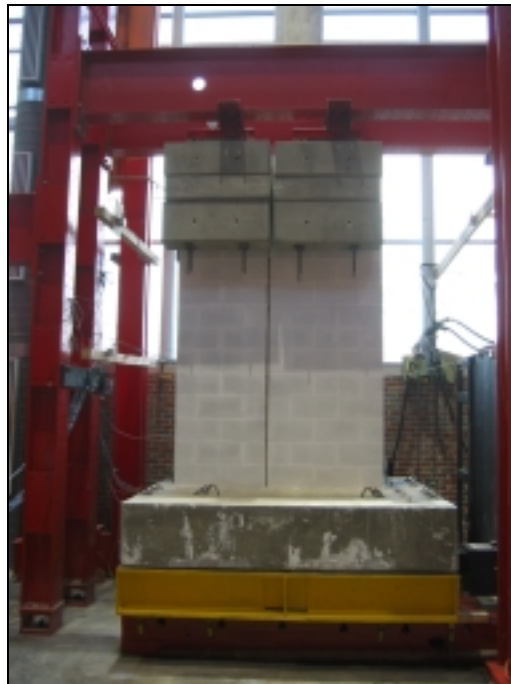
Figure 2 Wall 4 ready for testing

Fig. 2 shows wall 4 ready for testing. The shake table had a surface area of 2438 mm² (8 sq. ft) and a displacement capacity of ± 127 mm (± 5 in.). It could provide an acceleration of 1G to a mass of 18,143 kg (40,000 lbs). The walls were built on reusable concrete foundations then moved onto the shake table using an overhead crane. The foundations contained the lower prestress anchorages and were bolted down to the table using a series of 16 mm (5/8 in.) threaded rod. The additional seismic mass blocks were placed on the wall top with a layer of high strength mortar placed in between to provide an even bearing surface. The top prestress anchorage was installed on top of the mass blocks, to hold the structure together. The additional seismic mass applied to the wall top on walls 1, 2, 4 and 6 was 2880 kg, which represented a loading of 3 kPa over a length of 5 m. The remaining walls had an additional seismic mass of 1440 kg installed.

Support frames were erected to provide out-of-plane support to the walls, with a number of rollers used to allow for the table and wall displacements. Instrumentation was installed to record accelerations and displacements at key locations. The data acquisition system recorded 200 scans per channel per second to provide accurate time history data. The walls were post-tensioned using a hollow core jack and hand pump, and the prestress force was measured using load cells.

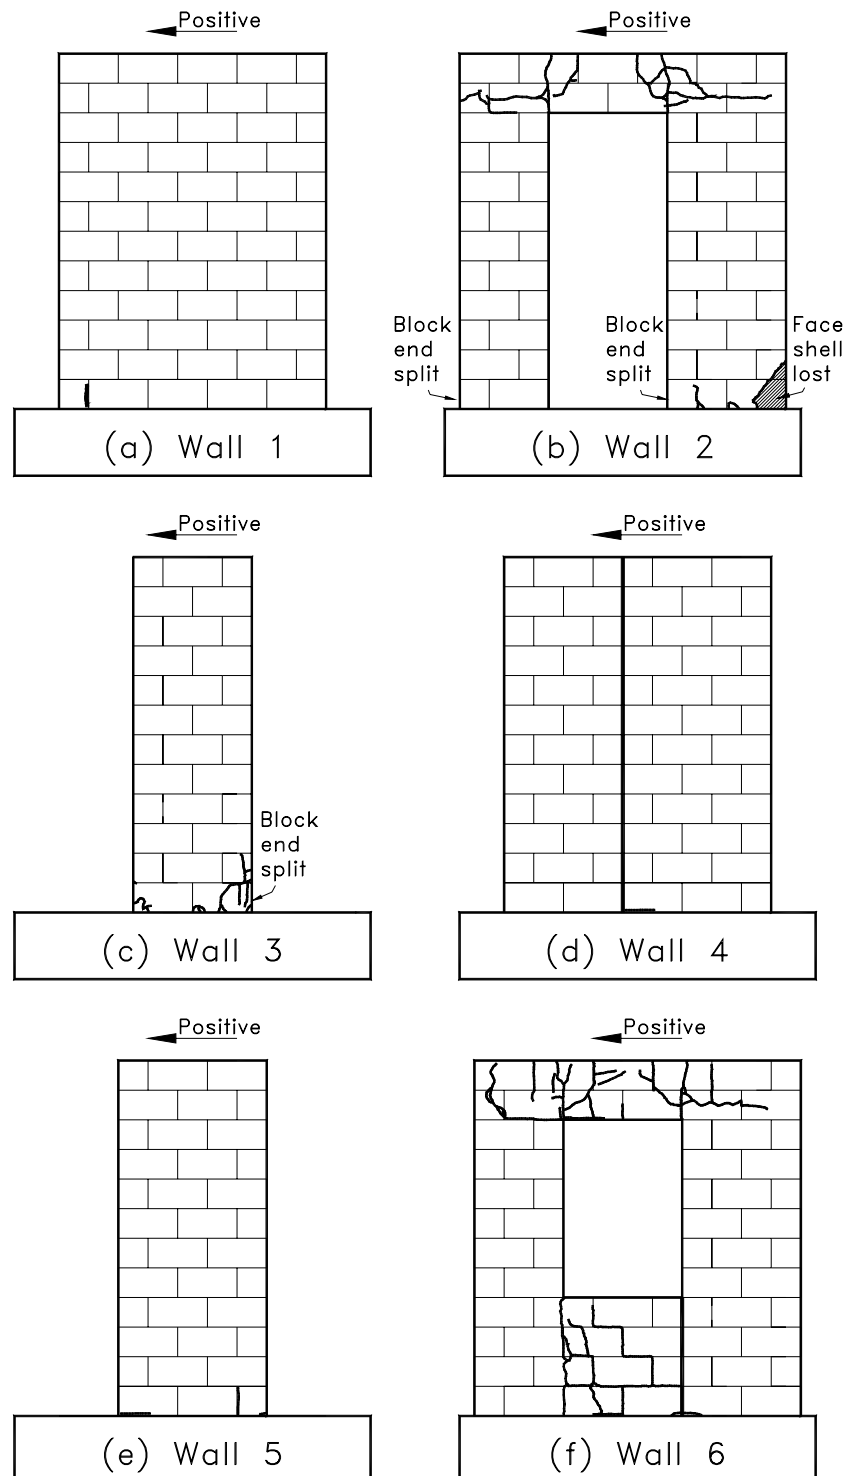
Figure 3 Wall crack patterns at end of testing

Fig. 3 depicts the crack patterns and wall damage for each specimen at the conclusion of testing. Fig. 4 shows the force-displacement backbone curves for the six walls, which were derived using the equation of motion for a SDF system subjected to an external force. Recognising that the velocity at the peak displacement must be zero, the force at peak displacement is simply the seismic mass multiplied by the total acceleration. By plotting the force at the peak displacement of each wall oscillation throughout the duration of an earthquake record, a backbone curve can be fitted which encompasses all these points. Fig. 4 contains backbone curves for a number of ground accelerations run for each wall. It should be noted that any base sliding was subtracted from the top of wall displacements prior to plotting, and this was seen to be small compared with the top of wall displacements for all dynamic tests. The backbone curves captured for the three rectangular walls are compared with the analytical predictions of Laursen and Ingham (2000) showing an acceptable match for all three walls.

For wall 2, the seismic mass was installed in two equal amounts of 1440 kg, one on top of each of the two wall panels, ensuring that the mass block did not stiffen the door lintel. The wall was subject to eleven records before testing was ceased due to considerable crushing of the wall panel lower corners, as shown in Fig. 3(b). Fig. 4(b) shows that the wall stiffness reduced throughout all the runs as a result of the accumulation of lintel cracking, but that there was no significant loss of strength until the final run in the negative direction when the lower corner was crushed.

During the third run at the lower prestress level, significant cracking of the wall occurred, resulting in the masonry below the opening breaking away from the left hand rectangular panel, as shown in Fig. 3(f). A maximum displacement of 31.6 mm (1.32% drift) was achieved and testing ceased due to substantial wall damage.

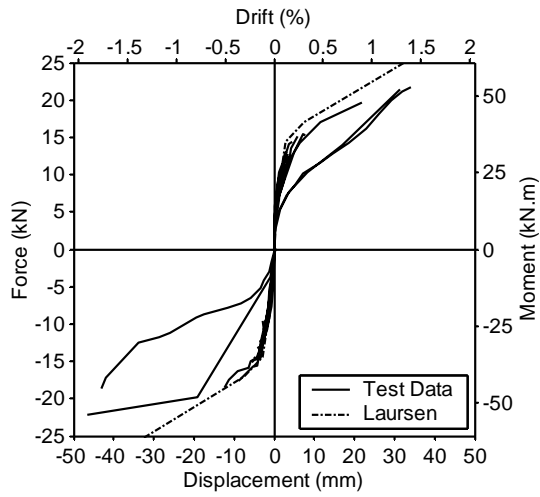
(c) Wall 3

Wall 3 was subjected to thirteen ground excitations before testing ceased due to splitting of the repair mortar in the lower wall corners. Fig. 4(c) shows that the wall maintained initial strength and stiffness out to a drift limit of approximately 1% before corner crushing resulted in reduced stiffness for the final two ground excitations. Wall strength was not seen to decrease until the wall reached a drift of 2.0% in the negative direction and corner splitting occurred.
