DOWEL ACTION OF TITANIUM BARS CONNECTING MARBLE FRAGMENTS AT DIFFERENT ANGLES

E.Vintzileou¹, E.-E.Toumbakari²

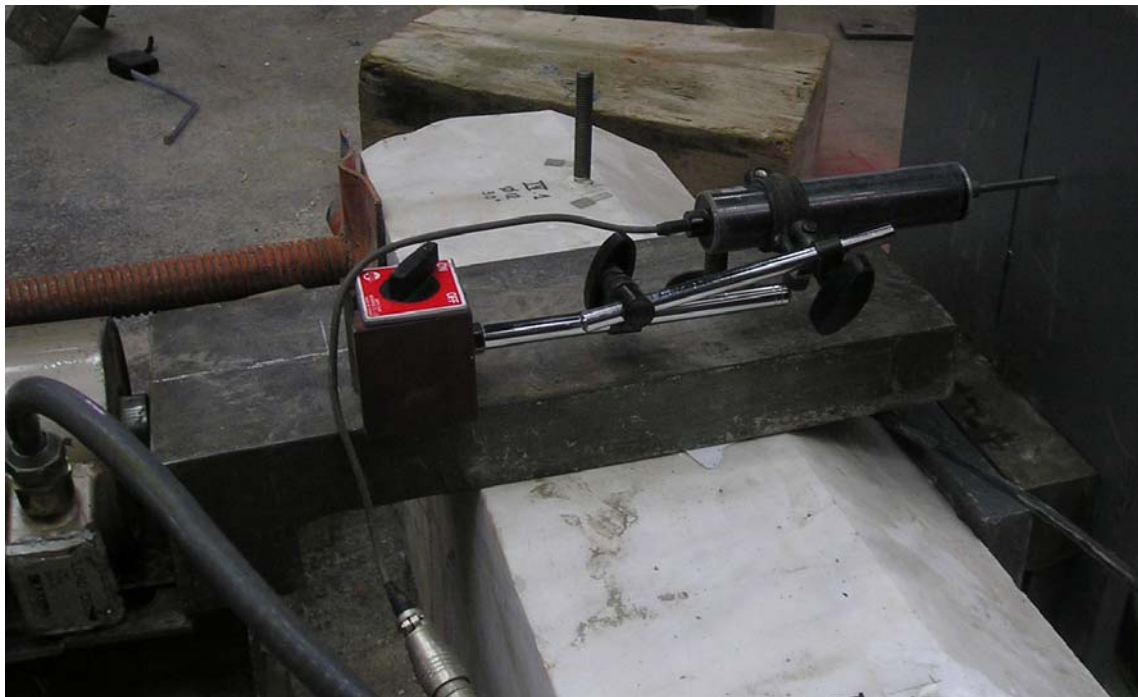
Figure 3 Marble specimen during testing. On the right, the angle between the marble surface and the dowel (which is inside the rigid slab) is visible.

Eight pieces of Dionysos marble were used for testing in the strong direction of the marble. All pieces were free of macroscopic discontinuities and imperfections. The cross section of the marble pieces was initially rectangular, with dimensions ranging from 23 x 25 cm² to 28 x 30 cm². On the one side of the rectangle, a triangular piece of marble was cut, to materialize a surface inclined in relation to the dowel (Figure 2). Three inclination values were selected: 30°, 45° and 60°. This value expresses the angle between a plane perpendicular to the dowel longitudinal axis and the marble surface. At the edge between the horizontal upper surface and the inclined one, holes were drilled to the marble, to accommodate titanium dowels (Figure 3).

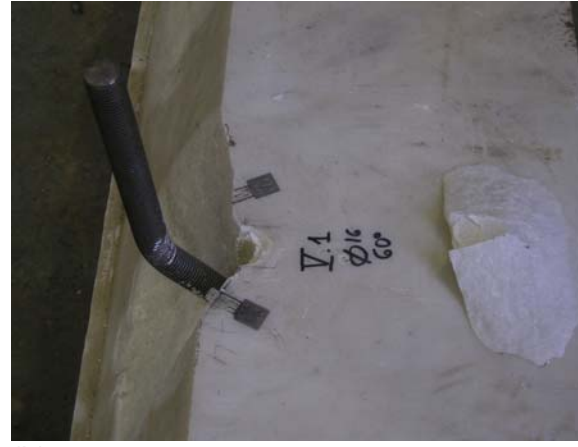
Figure 5 (a) Example of failure mode II with simultaneous failure of the dowel ($D=12\text{mm}$, inclination 45°) and (b) example of failure mode II without failure of the dowel ($D=16\text{mm}$, inclination 60°)

In the present experimental program, care was taken to provide a cover equal or bigger than 6 times the bar diameter (in this case, the “cover” represents the length of the inclined surface). Nevertheless, it was observed that all failures belonged to mode II. There was however a differentiation related to the angle of inclination and to the diameter of the titanium bar. When the diameters are small (8mm and 12mm for all angles) or for small angles (30° for all diameters) failure mode II was accompanied with simultaneous failure of the dowel (Figure 5a). At bigger diameters (16mm) and steeper angles (45° but mostly 60°) failure mode II occurred sometimes without failure of the dowel, which, of course, was substantially deformed (Figure 5b).
