NON-DESTRUCTIVE TESTING OF THE SANCTUARY OF VICOFORTE

Abstract

A series of non-destructive tests such as Radiation Thermometer, Electromagnetic Radar, Impact Echo Scanner, Concrete Test Hammer, Scratch Tester, Windsor Pin System, and Electromagnetic Induction Scanner are carried out for diagnostic inspection of deterioration on the Sanctuary of Vicoforte. In this paper, 1) Delamination of stone finishing and fresco painting, 2) Thickness of main dome and vaults above chapels, 3) Detection of reinforcement, 4) Continuity of iron ties, 5) Subsidence of ground level, 6) Fundamental frequency of the dome, and 7) Estimation of compressive strength and Young's modulus of the brick are discussed.

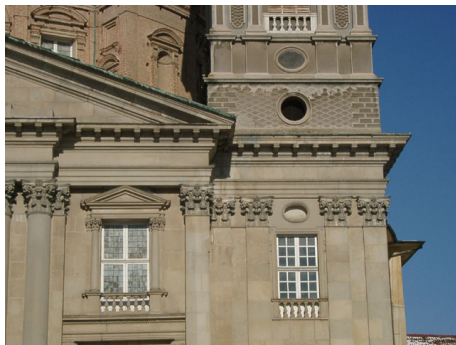
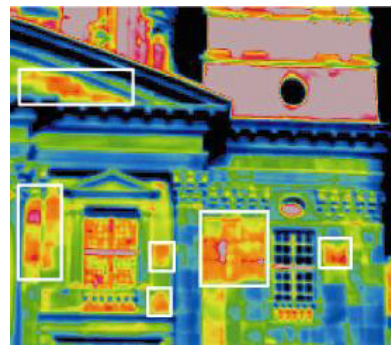
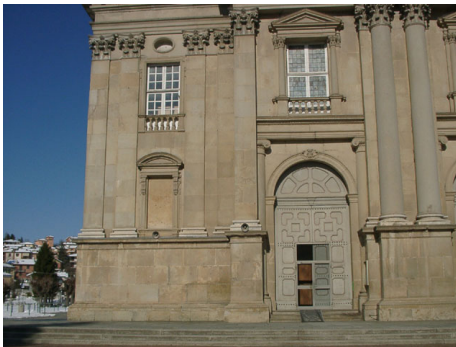
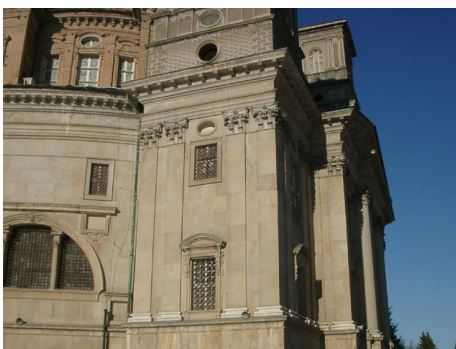
Figure 2 Delamination of stone finishing

In order to detect defects such as delamination and water leakage, Radiation Thermometer is applied (Komiya et al 2002). Delamination of stone finishing at both south and west sides are seen in the rectangular areas in Figure 2. The state of delamination of stone finishing is very dangerous, and this means that some measures should be taken against it.

(a) Visual image at south side

(b) Thermal image at south side

(a) Visual image at west side

(b) Thermal image at west side

- Delamination of stone finishing and fresco painting by means of Radiation Thermometer: The state of delamination of stone finishing is very dangerous,

hence some measures should be taken against delamination. A lot of delaminations of fresco painting are detected at the dome cornice level and at chapels.

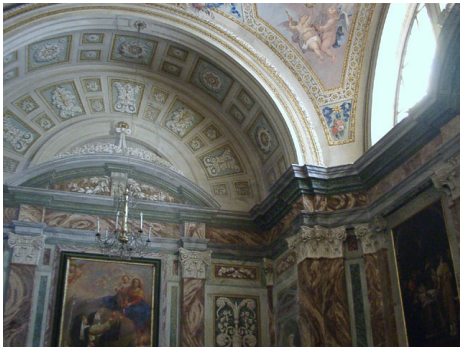
Figure 3 Delamination of fresco painting in the northwest chapel

As for the detection of delamination and/or water leakage of fresco painting, active heart source are used. Figure 3 shows delamination of fresco painting in the northwest chapel. Delaminations of fresco painting of the main dome at both north and west sides are shown in Figure 4.

(a) Visual image

(b) Thermal image

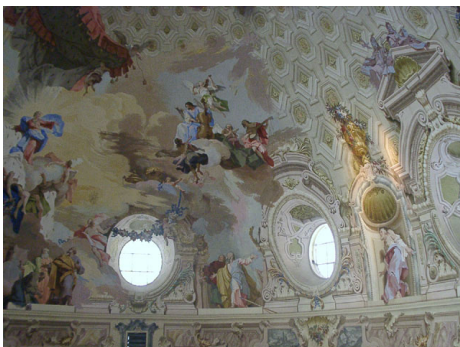
Figure 4 Delamination of fresco painting of the main dome

(a) Visual image at north side

(b) Thermal image at north side

(a) Visual image at west side

(b) Thermal image at west side

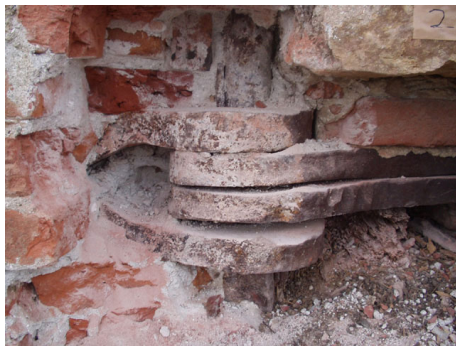
Figure 9 Iron ties embedded at the base of the main dome by Eng. Gallo

There are three sets of iron ties embedded at the base of the main dome by Eng. Gallo in 1734 (Figure 9). During and after construction, plastic deformation of the dome occurs, the materials separate into blocks, slippage begins, fractures develop, and the discontinuous deformation begins due to many reasons including dead load, differential settlement, temperature stress, and also chemical degradation (Figure 8). In order to estimate the continuity of these iron ties, Impact Echo Scanner is applied (Komiyama et al 2002). A sensor of longitudinal wave type is used here. The total length of the iron ties is around 104 m. As the sound velocity of iron is about 5,000 m/sec, one circuit time should be around 0.0208 second. As shown in Figure 10, these iron ties are probably continuous. As to the iron reinforcements, it is interesting to note that those embedded at the base of the dome of San Pietro have been broken.

(a) Original iron tie

(b) Detail of iron tie
