DESIGN OF LARGE SIZE NON-LOADBEARING MASONRY WALLS: CASE STUDIES IN PORTUGAL. TECHNICAL AND ECONOMICAL BENEFITS

Paulo B. Lourenço¹

Abstract

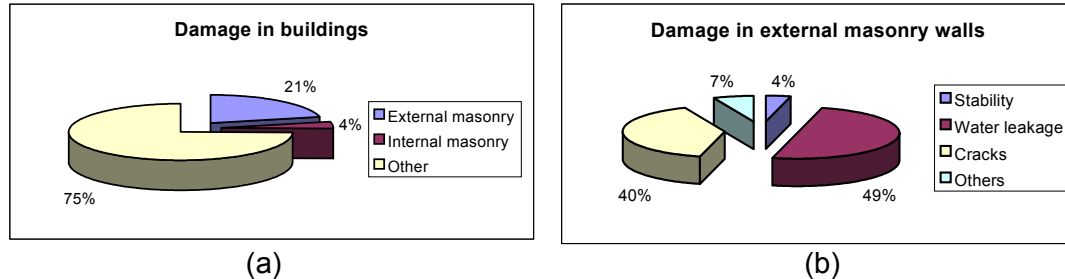
Figure 1 Survey of the damage indexes in masonry walls, Bureau Securitas (1984).

Masonry works, including rendering, amount to 13-17 % of the total building cost, Bezelga (1984). Nevertheless, it is common that walls exhibit inadequate performance and defects. Figure 1 illustrates the fact that masonry walls are responsible for 25% of the damage in buildings. From the damage in enclosure walls, around 50% are due to cracking and water leakage, both for France and Spain, Bureau Securitas (1984) and ASEMAS (1997). The performance of (non-structural) masonry walls is usually linked to the structural system and the foundations selected for the building. In particular, it is normal that damage results from inadequate behaviour of the beams, slabs and foundations, due to shrinkage, creep, thermal movements, excessive deformation and soil settlements.

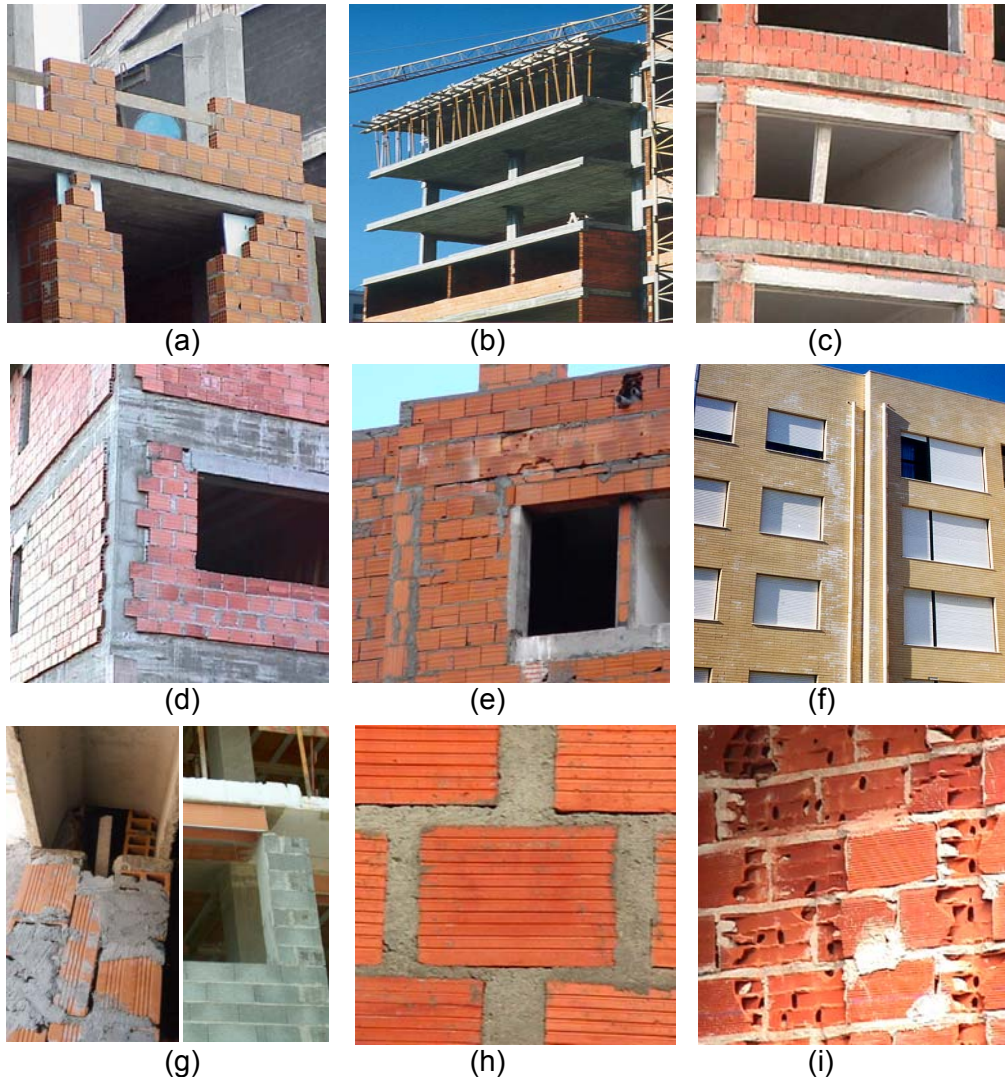
Figure 2 Examples of damage-prone situations: (a) simultaneous construction of the structure and the walls; (b) large cantilever spans and flexible structures; (c) curved walls and insufficient bond between the units; (d) inadequate correction of thermal bridges; (e) inadequate brick and bond; (f) lack of movement joints; (g) non-acceptable solutions around openings; (h) masonry joints with unacceptable thickness; (i) unacceptable opening of chases.

Figure 2 illustrates some damage-prone situations observed in different buildings, collected from Silva (2002) and Sousa (2002).

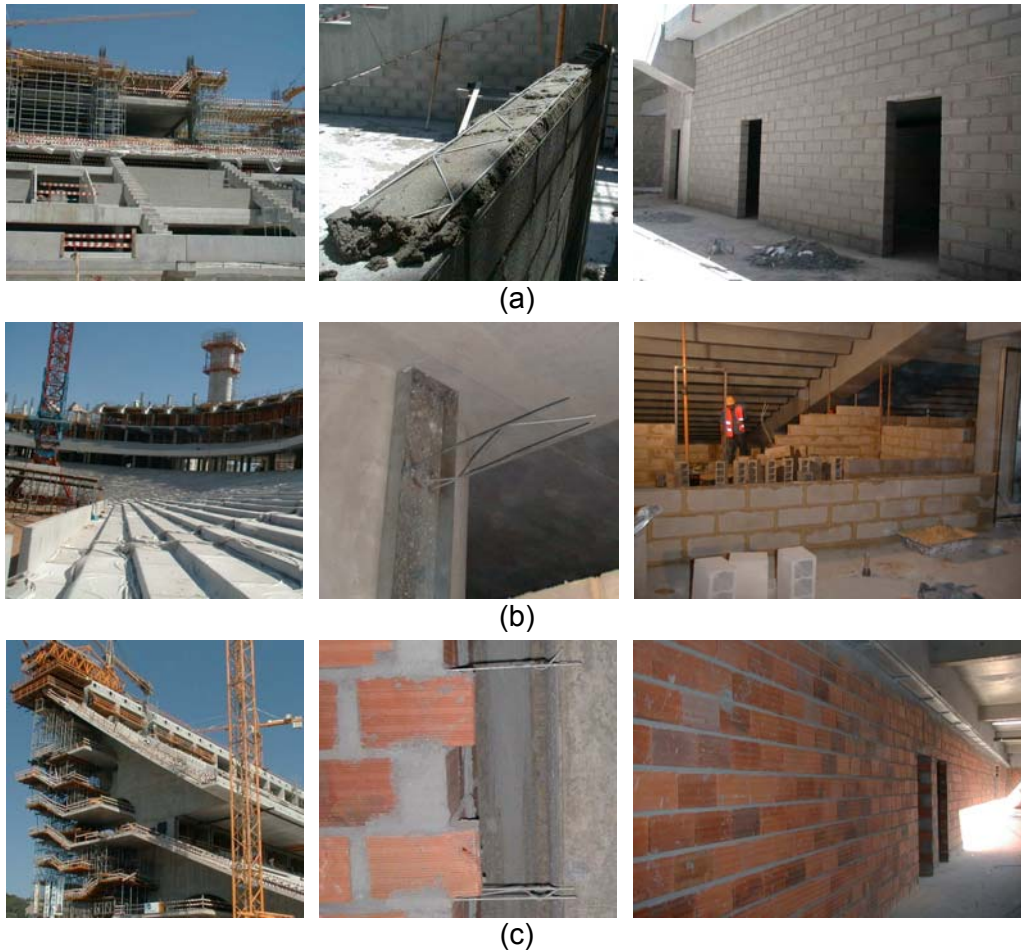
Figure 4 Global views and details of the Euro 2004 stadiums with bed joint reinforcement Murfor®: (a) Sporting; (b) Benfica; (c) Braga.

Figure 4 presents the examples of masonry with bed joint reinforcement in three new stadiums in Portugal, built for the European Championship 2004. These high performance walls are cost competitive in comparison with the traditional solution using vertical and horizontal embedded reinforced concrete elements. Bed joint reinforcement is introduced in the masonry simultaneously with the wall construction, meaning that almost no changes are made in the traditional technology for building masonry walls.

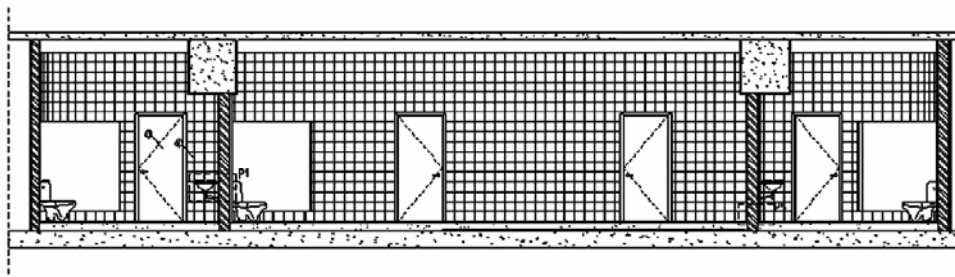
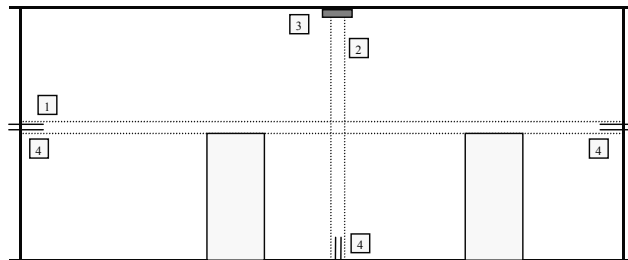
Legend: 1 - Horizontal r.c. element with $4\phi 10$ and stirrups $\phi 6@0.15$; 2 - Vertical r.c. element with $4\phi 10$ and stirrups $\phi 6@0.15$; 3 - Steel angle $L75\times 75\times 8$; 4 - Dowels $4\phi 10$ inserted in the surrounding concrete

Figure 5 Access walls for the toilet rooms: (a) architecture and (b) original solution.

One situation with repetitive pattern that is worth to discuss are the walls of the toilet rooms, which have a span of 10.40 m and a height of 4.40 m, with door openings for access. The original solution included apparent vertical and horizontal reinforced concrete elements embedded in the wall. The reinforced concrete elements would be connected to the structural neighboring elements by steel dowels and angles, see Figure 5. Figure 6a illustrates the adopted alternative solution using bed joint reinforcement, which features the following advantages: homogeneous material with tensile strength; no requirement for special U block in the horizontal element and for special two-large cells block for vertical element (if the r.c. elements are not to be apparent in the faces of the wall), and no requirement for any reinforced concrete embedded elements. Therefore, the alternative solution is faster to build and is more rational. Figure 6b provides the model adopted for analysis with respect to out-of-plane loading.

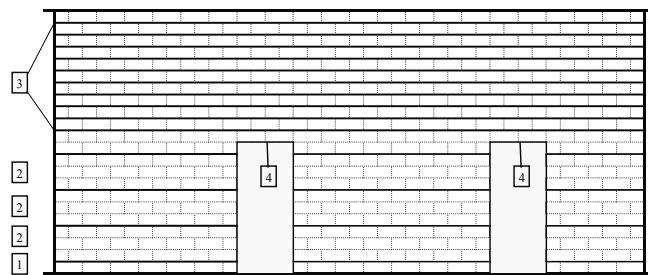
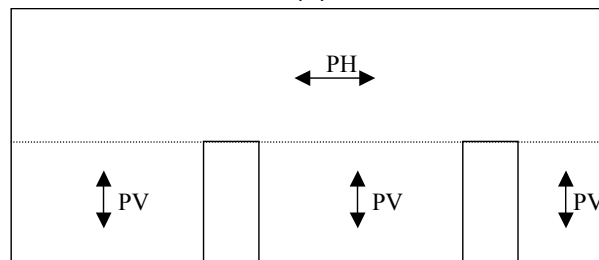
Legend: 1 - One truss RND/Z.5-150 at the wall base; 2 - One truss RND/Z.5-150 each three courses (each 0.60 m); 3 - Ten trusses RND/Z.5-150, 4 - Two hooks LHK/S 170

Figure 6 Access walls for the toilet rooms: (a) adopted alternative solution and (b) model for structural analysis and design (arrows indicate the spanning direction).

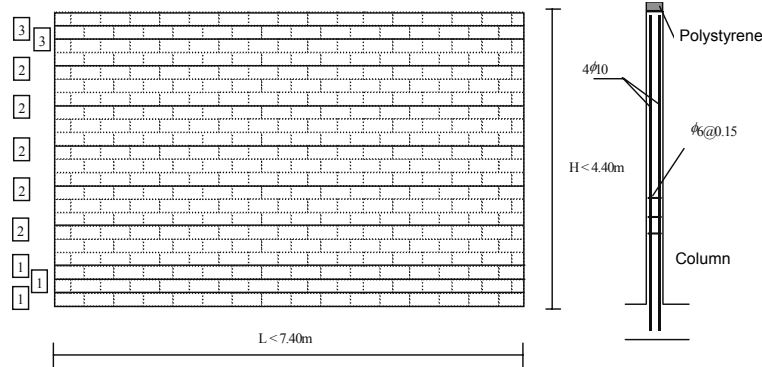
Legend: 1 - Three trusses RND/Z.5-150 at the wall base; 2 - One truss RND/Z.5-150 each three courses (each 0.60 m); 3 – Two trusses RND/Z.5-150 at the wall top

Figure 7 Typical example of the walls built in the new stadium of Sporting.

The following typical solutions have been adopted (maximum height of the walls $h < 4.40$ m), see also Figure 7:

- Spacing of r.c. vertical elements up to 7.4 m, without support at the top. Bed joint reinforcement (in general): RND/Z.5-150, each 3 courses (0.60 m). Base reinforcement: 3 consecutive courses. Steel in r.c. element ($4\phi 16+\phi 6@0.15$);

- Spacing of r.c. vertical elements up to 7.4 m, with support at the top. Bed joint reinforcement (in general): RND/Z.5-150, each 3 courses (0.60 m). Base reinforcement: 2 consecutive courses. Steel in r.c. element ($4\phi 10 + \phi 6 @ 0.12$);
- Spacing of r.c. vertical elements up to 9.0 m, without support at the top. Bed joint reinforcement (in general): RND/Z.5-150, each 2 courses (0.40 m). Base reinforcement: 4 consecutive courses. Top reinforcement: 2 consecutive courses. Steel in r.c. element ($4\phi 10 + \phi 6 @ 0.12$);

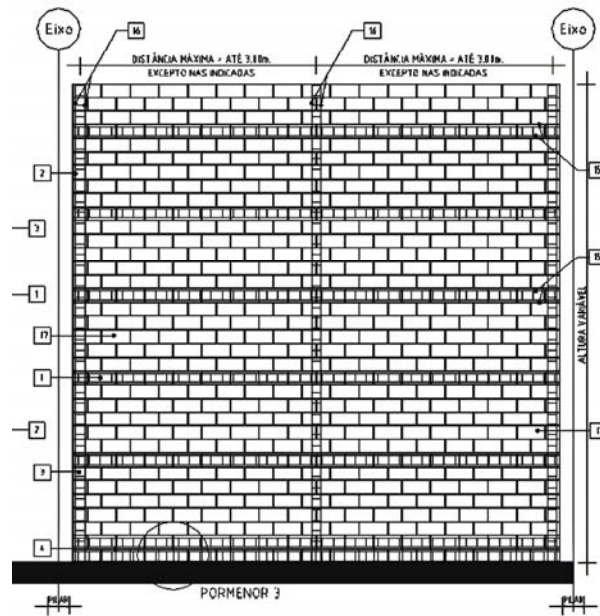
Figure 8 Aspect of the original solution for non-load bearing masonry walls in a shopping mall.

The alternative solution proposed for a large shopping mall in Portugal, Odivelas Parque, is similar to the solutions detailed in Section 3.3. The walls are made of concrete blocks with $0.50 \times 0.20 \times 0.20 \text{ m}^3$, with typical spans of 12.0 m and a typical height of 5.80 m. The experience of damage in these constructions resulted in the original prescription of heavily reinforced walls, see Figure 8. The original solution included r.c. columns at a maximum distance of 3.0 m and r.c. beams every 5 courses (or 1.20 m). In addition, dowel bars were supposed to be placed at the base, every 0.40 m.

The original solution includes a beam of $0.20 \times 0.20 \text{ m}^2$, with $A_{sl} = 4\phi 10$ and $A_{st} = \phi 6 @ 0.20$ every 1.20 m. For each square meter of wall, the weight of steel $M_{sl} = 4 \times 0.785 \text{ cm}^2 \times 1 \text{ m} \times 7700 \text{ kg} / 1.20 \text{ m} = 2.01 \text{ kg}$ and $M_{st} = 5 \times 0.283 \text{ cm}^2 \times 0.65 \text{ m} \times 7700 \text{ kg} / 1.20 \text{ m} = 0.59 \text{ kg}$, in a total of 2.61 kg of steel / m^2 of wall. Also, per square meter of wall, the concrete volume is $V_c = 0.14 \text{ m} \times 0.17 \text{ m} \times 1 \text{ m} / 1.20 \text{ m} = 0.0198 \text{ m}^3$ of concrete / m^2 of wall. In such a way, the additional cost of the original beam per m^2 of wall, with respect to a standard masonry wall, can be estimated as $2.61 \text{ kg} \times 0.78\text{€} + 0.0198 \text{ m}^3 \times 99.0\text{€} = 4.0 \text{€} / \text{m}^2$ of wall.
