EXPERIMENTAL DETERMINATION AND NUMERICAL MODELLING OF THE FAILURE BEHAVIOUR OF HISTORICAL MASONRY

Abstract

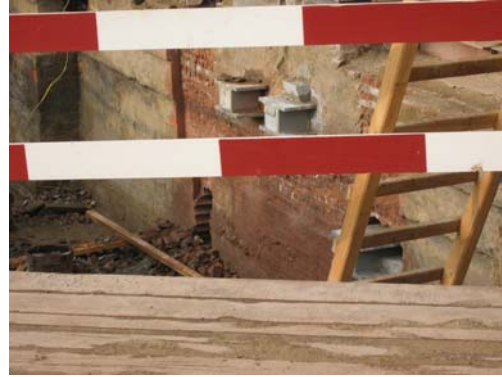
Figure 2: Location of drilled out cores

Subsidence is unavoidable and the only question is how much subsidence the building can tolerate before cracks form in the historical masonry. The façade of the building cannot be used to take samples. However during the building cores have been drilled out of the foundation walls, to place steel beams. These cores have been used to manufacture specimens. Figure 2 shows the drilled holes in the foundation wall with the steel beams protruding from the surface.

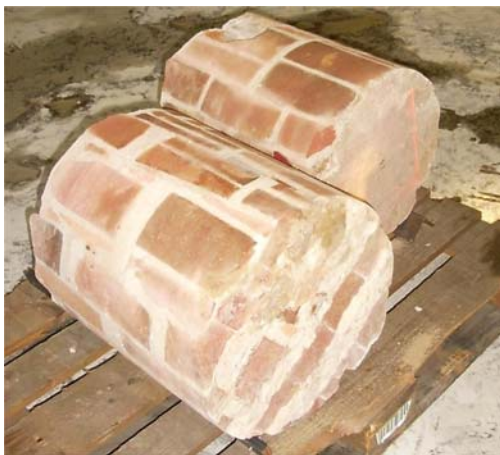
Figure 3 : Drilled cores before cutting

The cylindrical cores are illustrated in figure 3. These cores were cut into rectangular beam specimens using a water cooled laser controlled diamond wheel saw usually used to cut marble into tombstones. The cutting revealed a rather heterogeneous structure composed of several qualities of brick and also quite irregular lime joints. The specimens were washed with demineralised water after cutting and left to dry for a week.

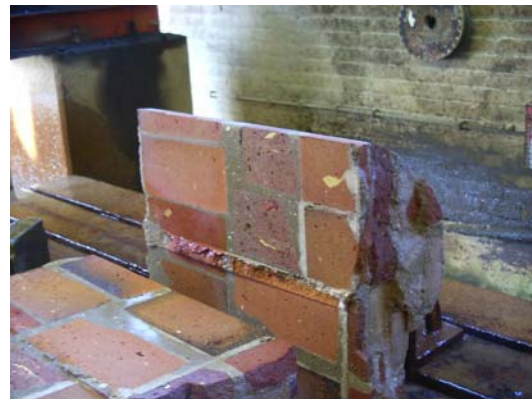
Figure 4 : heterogeneous structure revealed after cutting

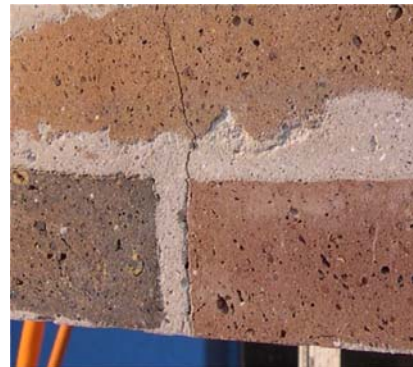
Figure 5: beginning of failure process of specimen 1.

Specimen 1 started to fail at the boundary of the lime and the brick. A crack grew along the bottom brick layer, arrested momentarily and the crack grew through the second bricklayer. The stress-displacement curve is given in figure 4 and the initial failure is shown in figure 5.

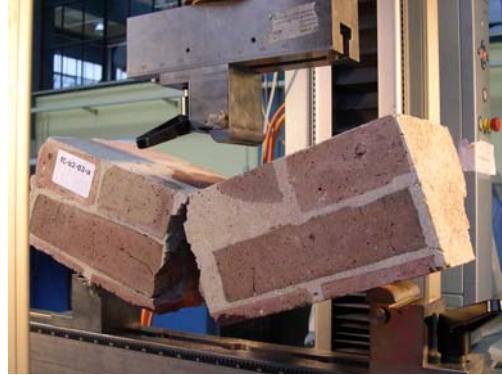
Figure 7: beginning of failure process of specimen 2

Specimen 2 had a thin lime mortar layer on the bottom. This was well supported by a brick spanning the centre section. The specimen failed suddenly as the brick that carried all of the load failed. The stress-displacement curve is given in figure 6 and the initial failure is shown in figure 7.

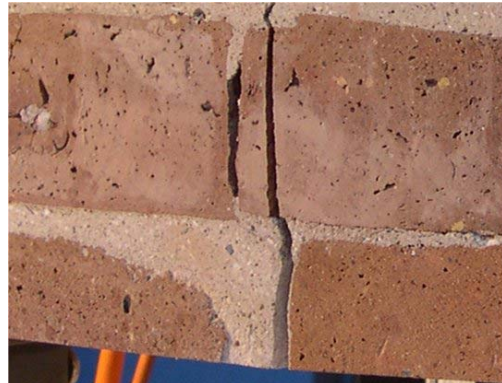
Figure 9: beginning of failure process of specimen 3

Specimen 3 was the weakest. A crack grew along the brick mortar interface at the bottom. The second layer contained a damaged brick already containing cracks which could not carry any load. The stress-displacement curve is given in figure 8 and the initial failure is shown in figure 9.

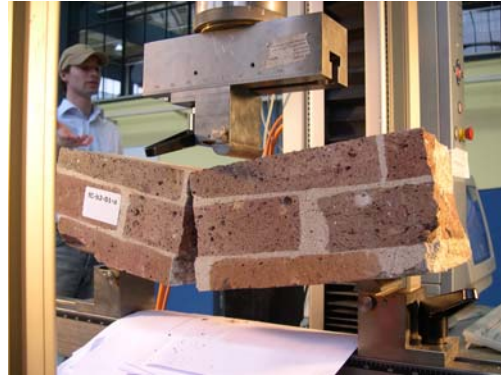
Figure 11: beginning of failure process of specimen 4

Specimen 4 was well supported by bricks in the centre section. Failure started along the brick-mortar interface with the crack immediately running through the supporting bricks leading to total failure. The stress-displacement curve is given in figure 10 and the initial failure is shown in figure 11.

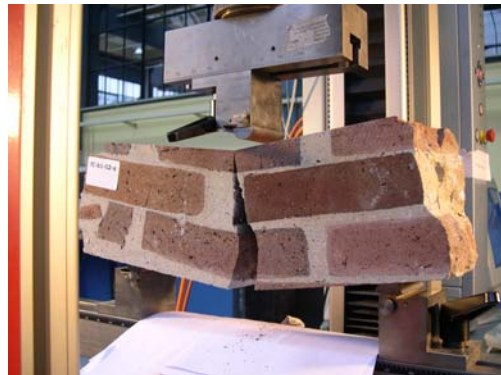
Figure 13: beginning of failure process of specimen 5

Specimen 5 had a thin mortar layer on the bottom supported by a brick. Failure started in the mortar interface with the crack immediately running through the supporting bricks leading to total failure. The stress-displacement curve is given in figure 12 and the initial failure is shown in figure 13.

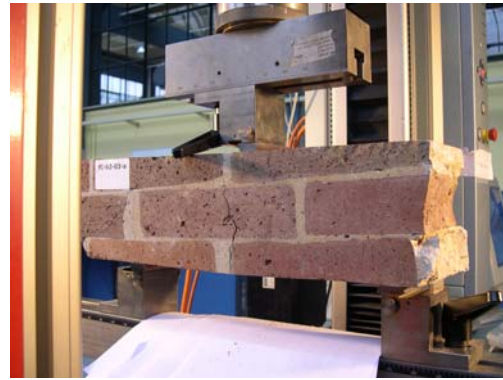
Figure 15: beginning of failure process of specimen 6

Specimen 6 was well supported by bricks in the centre section. Failure started along the brick-mortar interface with the crack immediately running through the supporting bricks leading to total failure. The stress-displacement curve is given in figure 14 and the initial failure is shown in figure 15.

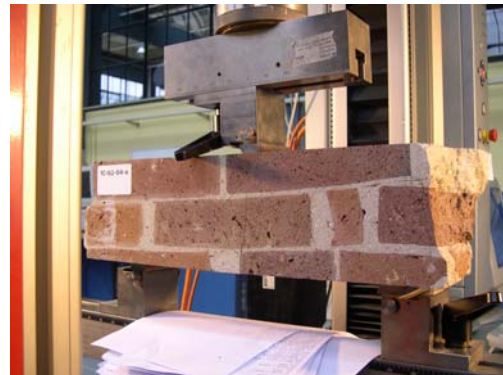
Figure 17: beginning of failure process of specimen 7

Specimen 7 was well supported by bricks in the centre section. Failure started along the brick-mortar interface with the crack immediately running through the supporting bricks leading to total failure. The stress-displacement curve is given in figure 16 and the initial failure is shown in figure 17.

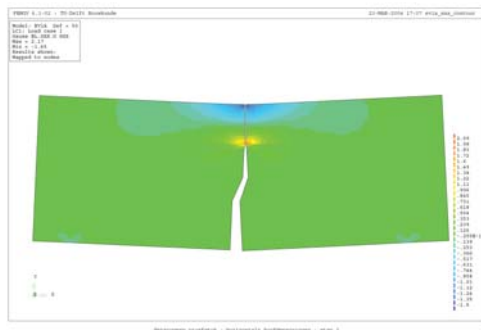
Figure 18 : FEM calculated stress distribution at moment of onset of final failure

The propagation of the crack in specimen 1 was studied numerically using the DIANA version 7.2 FEM software package. The guidelines given by CUR 1994 were followed. Specimen 1 was selected for modelling because it did not fail completely at the start of cracking, but showed crack arrest, followed by crack propagation, crack arrest and crack propagation to final failure. 2 and 3 dimensional models were made using cq16m and cte30 elements respectively. Young's moduli for the brick of 2.38 GPa and for the lime mortar of 1.19 GPa were used. The crack as actually grew in specimen 1 was modelled into the specimen, with the crack faces being uncoupled in stages to model the progressive cracking of the specimen. More advanced methods such as used by Giambanco and Mroz (2001) were considered but not used at this stage because they were not deemed to provide sufficient benefits for this particular case. Results were calculated at the point of initial crack growth, the point of subsequent crack propagation and the point where the crack propagated to final failure. The numerical results of the 2D calculations are summarised in table 2. The 3-D calculations are more complicated and results are not available at the time of writing. The results suggest that there is no single stress or strain criterion that can describe the crack initiation/propagation process. Further work on modelling the other specimens in 2-D and 3-D is continuing. It is hoped to extend this to modelling the whole façade analogous to the work done by Pegon et al. (2001). This work will be published later.
