A COMPARATIVE STUDY OF THE THERMAL PERFORMANCE OF CAVITY AND BRICK VENEER CONSTRUCTION

H.O. Sugo¹, A.W. Page², B. Moghtaderi³

Abstract

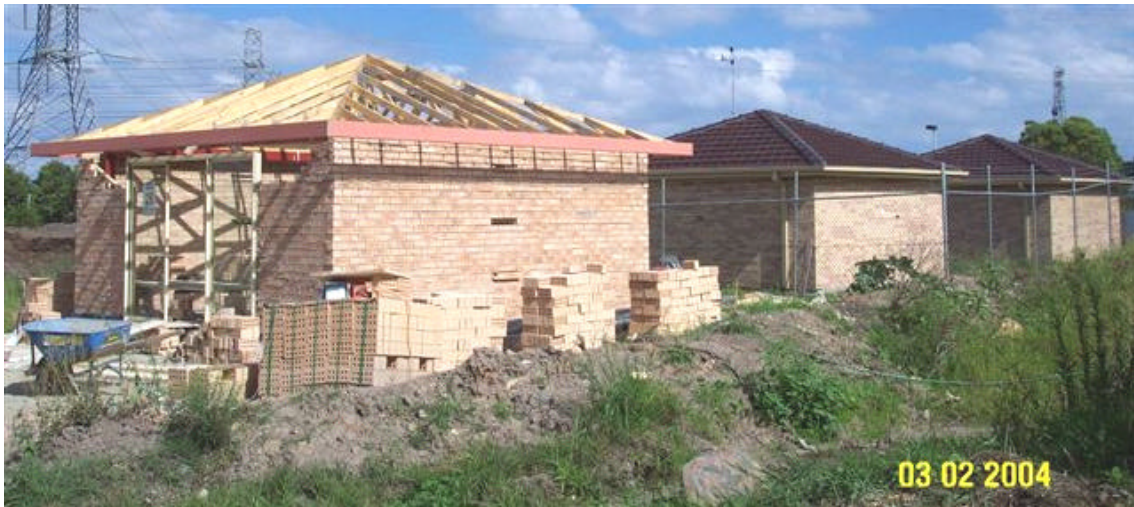
The building modules are built on the Callaghan campus at Newcastle in an open location with uninterrupted solar access. The two modules are shown in the background of Figure 1. The module containing the window (under construction) is shown in the foreground and will not be discussed further in this report. The modules are comparable in size to other buildings used in similar studies (Burch, 1982). The modules have a square floor plan of 6m x 6m and are spaced 7m apart from each other to avoid shading and minimise wind obstruction. With the exception of the walls, the buildings are of identical construction, being built on a concrete slab and aligned in a manner so that the north wall of the buildings is perpendicular to astronomical north. Timber trusses are used to support the roof, consisting of clay tiles placed over a layer of foil sarking. The timber trusses are in turn supported by a steel frame to provide the flexibility of removing/replacing walls at a future stage. The buildings have a ceiling height of 2450mm. The ceiling consists of 10mm thick plasterboard with glasswool insulation bats (thermal resistance or R-value=3.5 m².K.W⁻¹) placed between the rafters. The R=3.5 insulation has been used in the ceiling to minimise the "through-ceiling" heat flow. Entry to the building is via a standard solid timber door located on the southern face of the building. Again, to minimise the flow of heat through the door, a

Figure 1. The Three Building Modules for Thermal Testing.

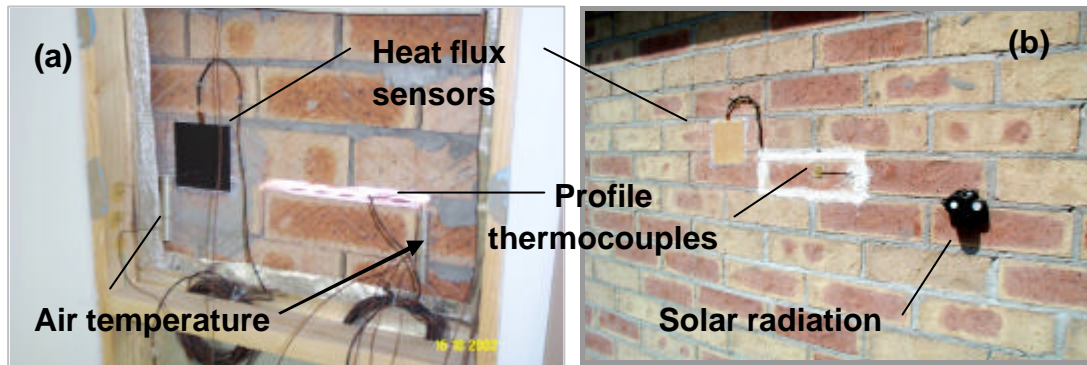
Heat fluxes are measured using 100mmx100mm sensors with typical sensitivities in the order of $25\mu\text{V/W/m}^2$. The heat flux sensors were placed on the wall in such a manner that the proportion of masonry unit/mortar ratio being measured was representative of that in the masonry wall. An attempt was made to match the absorbance and emissivity of the heat flux sensors to that of the masonry units by painting the exterior sensors a similar colour to that of the bricks. The interior sensors were painted white, to match the walls, whilst the sensors located in the cavity were painted black to allow radiation heat transfer. Figure 2 shows the typical sensor layout used in the brick veneer wall.

Figure 2. Wall sensors used in the Brick Veneer Wall, (a) internal and (b) external.

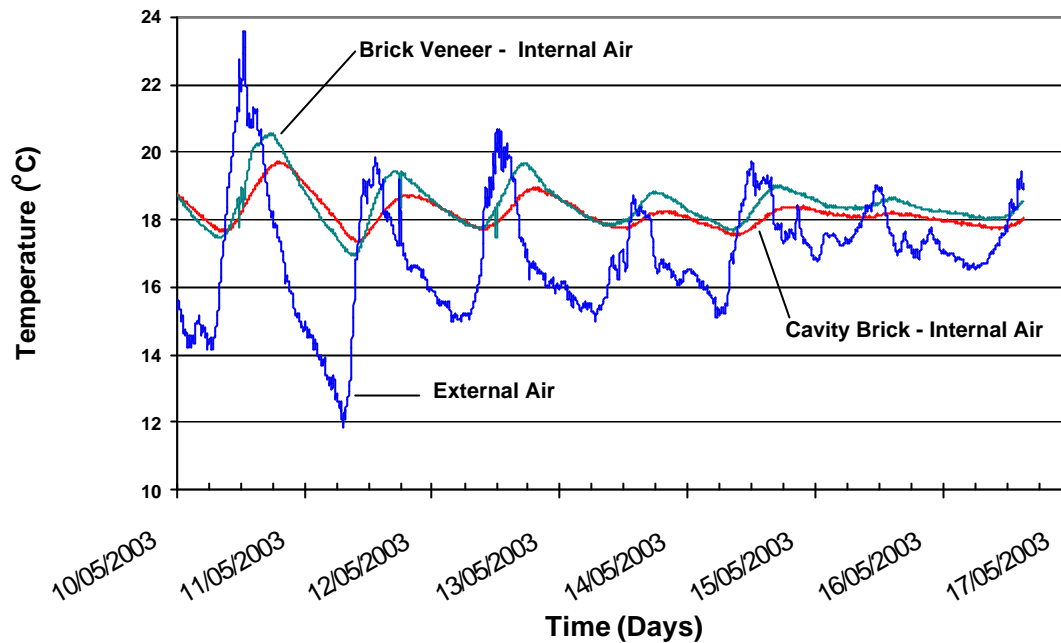
Figure 3 shows the external and internal air temperature for both buildings during the third week of May 2003. The mean external air temperature for this week was 17.5°C and the air temperatures within the cavity brick and brick veneer buildings were 18.5°C and 19.0°C respectively. As expected, the day-night temperature swing in the buildings was much less than that shown by the external air. At the beginning of the week, the swing in the brick veneer building was in the order of 3.5°C and for the cavity brick about 2.5°C whilst the external air swing was in the order of $10\text{--}12^{\circ}\text{C}$. Also, note the marked reduction in day-night variation and minor decrease in the internal temperatures during the latter part of the week due to the presence of cloud cover. In the absence of strong solar radiation, the temperature of the external wall surfaces followed closely the external air temperature. The temperature of the roofing material cooled down to below ambient during the night, regularly reaching $5\text{--}7^{\circ}\text{C}$ for the time period shown in Figure 3. Under sunny conditions, the maximum roof temperatures were in the range of $50\text{--}52^{\circ}\text{C}$.

Figure 3. External and Internal Air Temperatures for the Cavity brick and Brick Veneer Modules, May 2003.

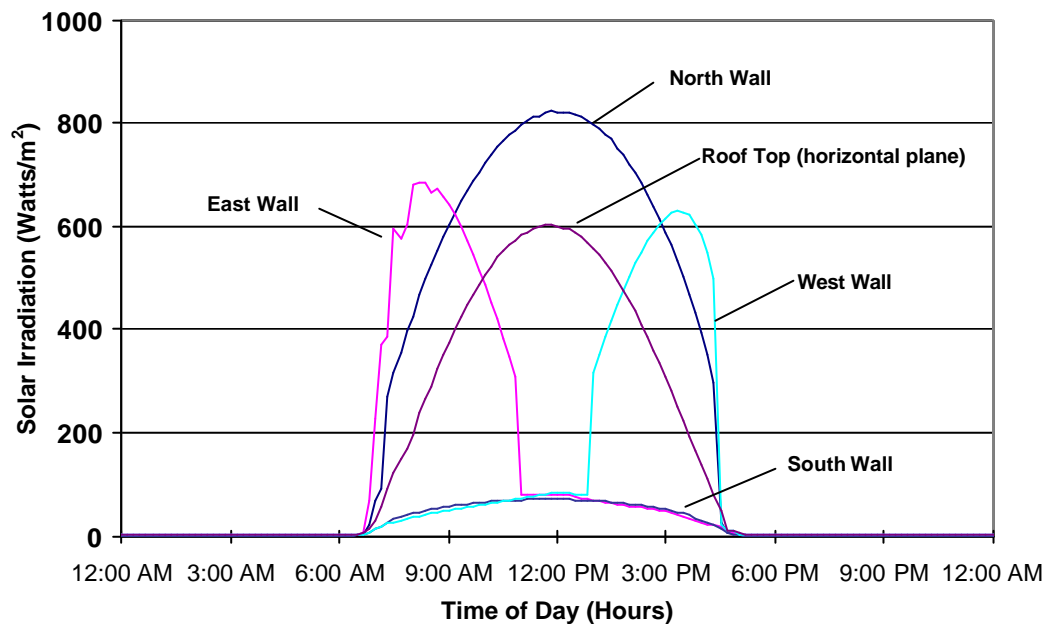
At this time of the year the solar altitude is approaching a minimum and this resulted in the north facing wall receiving a greater quantity of solar radiation than that observed on the horizontal plane, as shown by Figure 4. Note the reduced irradiation levels experienced by the east and west facing walls and, the diffuse radiation received by the south (shaded) wall which is in the order of 80 W/m^2 .

Figure 4. Incident solar irradiation on the exterior building surfaces for 22nd May 2003

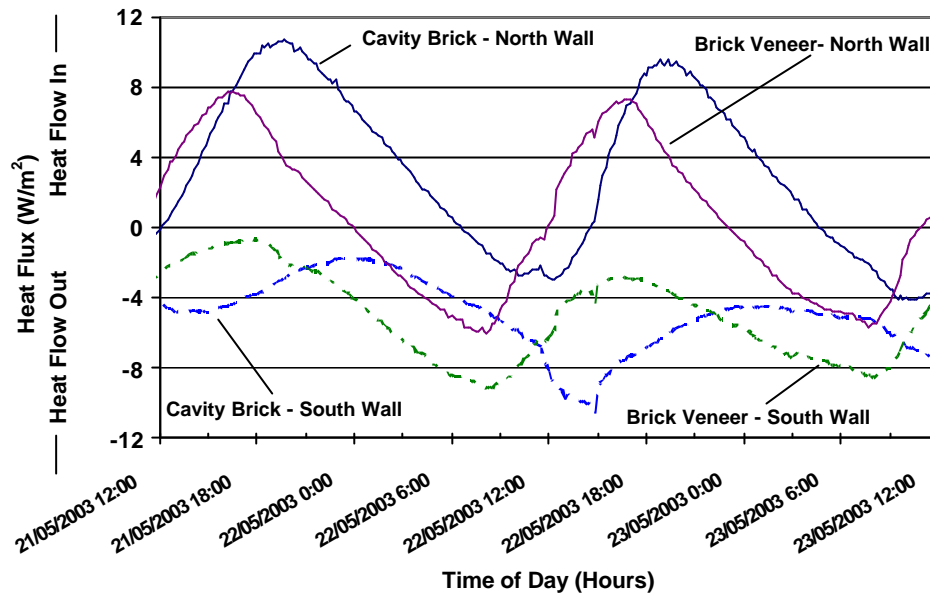
The effects of solar radiation can be observed by the rise in wall temperatures and the changes in the heat flux entering via the walls. During May, the exterior of the North facing walls regularly reached 35°C during sunny days. For clarity, only the data recorded by the North and South heat flux sensors, mounted on the internal walls, is shown in Figure 5. Note that the polarity of the sensors has been arranged with heat entering the interior space being recorded as positive whilst heat 'flowing out' being seen as negative. The flux entering through the North wall of the Cavity Brick building is greater than that observed for the Brick Veneer. Also, the heat flow balance, either in or out, favours a greater proportion of heat 'flowing in' for the Cavity Brick building. The

time when the maximum in-flowing flux occurs is also different, with the Brick Veneer Building showing a shorter lag time, (4.5 hours) compared to the Cavity Brick module of about 8 hours. The heat flux entering via the North wall also influences the South wall behaviour, with maximum and minimums being observed. In these cases, heat is continuously flowing out via the South walls since the values are always negative. Flux variations can also be observed in the East and West walls but are not as pronounced.

Figure 5. Heat Flux Measurements on the Interior North and South walls of the Cavity and Brick Veneer Buildings for 22nd May 2003.

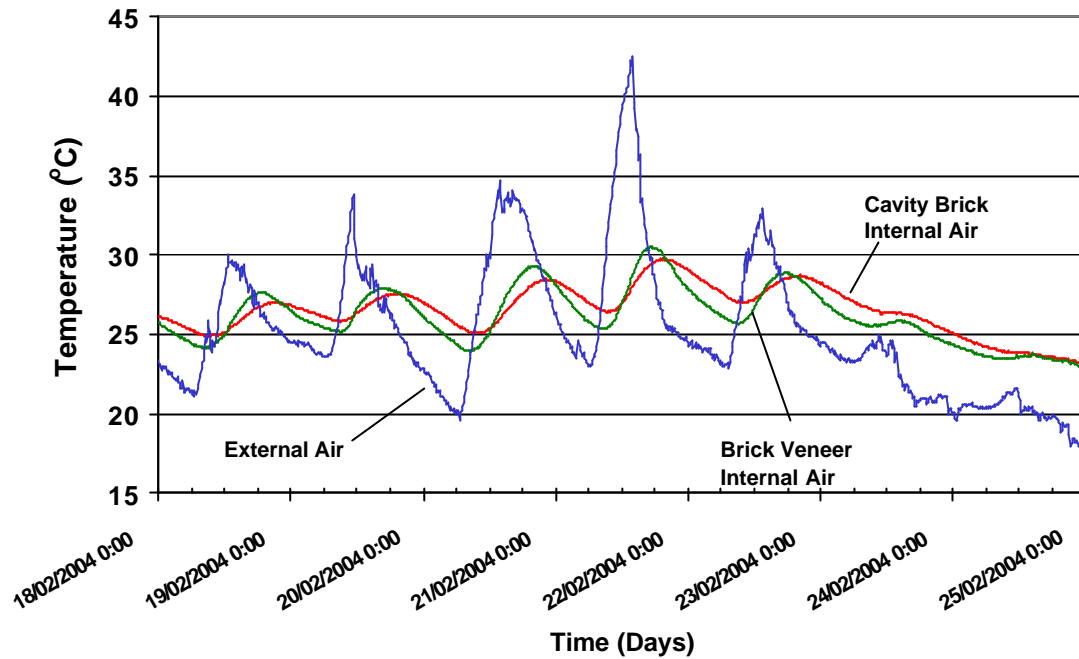
During February 2004 Newcastle experienced heat wave conditions with a maximum air temperature of 43°C being recorded. Figure 6 is similar to Figure 3 and shows the external and internal air temperature for both buildings during the third week of February 2004. The mean external air temperature for this week was 24.7°C and the mean air temperatures within the cavity brick and brick veneer buildings were 26.2°C and 25.9°C respectively. The maximum external air temperature recorded adjacent to the test buildings was 42.5°C at 2pm. At this time, the internal air temperature in the Cavity Brick module was 28.5°C and 28.7°C in the Brick Veneer building. The maximum internal air temperature for the Cavity Brick occurred at 8:30pm and was 29.7°C. For the Brick Veneer building a maximum of 30.5°C occurred at 6:00pm. The maximum external surface temperature recorded on this day was 72°C on the tiled roofs at 2pm. The hottest external wall temperature was 46°C recorded on the west facing walls at 4:30pm.

The external air day-night temperature swing was much greater at this time of the year than that in May, being in the order of 15-20°C. However, the temperature swing within the buildings shows only a minor increase, being 3-3.5°C for the Cavity Brick and about 5°C for the Brick Veneer building as indicated in Figure 6. Note the cooler weather conditions at the end of the week and the steady decline in internal temperatures of the buildings. Both buildings remained warmer than the external air conditions for several days.

Figure 6. External in Internal Air Temperatures for the Cavity brick and Brick Veneer Modules, February 2004.

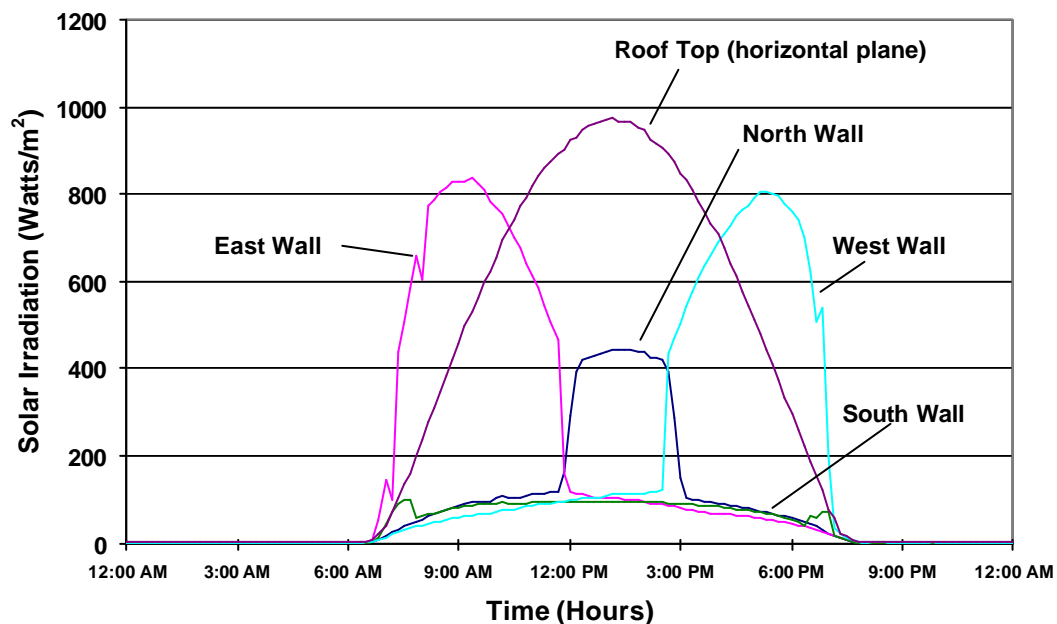
The incident solar radiation on the exterior surfaces of the buildings has also changed, with the East and West orientated walls receiving higher radiation levels for longer periods of time. The radiation falling on the North wall has decreased significantly ($\approx 450 \text{ W/m}^2$) due to the higher solar altitude and is further attenuated by the eave providing shade on the wall. The level of radiation observed on the horizontal plane has increased, reaching a maximum of just under 1000 W/m^2 . The diffuse radiation being received by the South wall has increased marginally up to a maximum of 100 W/m^2 . These trends are shown below in Figure 7.

Figure 7. Incident solar irradiation on the exterior building surfaces, 20th February 2004.

Comparison of Figures 7 and 8 shows that there is a substantial attenuation of the solar radiation flux, the peak value is in the order of 800W/m², yet only a small proportion of that enters the building. This behaviour is explained more clearly by observing the through-wall flux profile presented in Figure 9. Again, for clarity only the profile through the West wall of the Cavity Brick building is shown. The flux attenuation through the West wall of the Brick Veneer building has very similar characteristics.

The data in Figure 9 shows that the maximum heat flux entering the external brickwork on West wall is about 200W/m² compared to the incident flux of 800 W/m² falling on the wall over the same time period shown in Figure 7. This would indicate that a large portion of the heat is reflected or radiated back to the external environment by the exterior surface of the brick. Figure 9 also shows that significant amounts of the heat stored in the wall is released back to the exterior environment, indicated by the large negative flux regions occurring during the night. Also, note the significant difference

The data also demonstrates the ability of masonry walling systems to attenuate incident solar radiation. For summer conditions, Figures 7-9 show that the peak solar radiation levels falling on the West wall are in the order of 800W/m² with only about 200W/m² being absorbed by the exterior masonry surface. However, the peak flux values entering the buildings are very low, 12-13W/m². The reduction of flux values is a result of the thermal properties of the masonry walls and the cooler night time temperatures allowing much of the stored heat in the masonry wall to be re-radiated to the outside environment. The results also emphasise the need for appropriate roof insulation due to the extreme temperature range experienced by roofing materials (-4 to 70°C). The roof cools down below ambient temperature during the night and receives high levels of solar radiation for prolonged periods of time during summer.

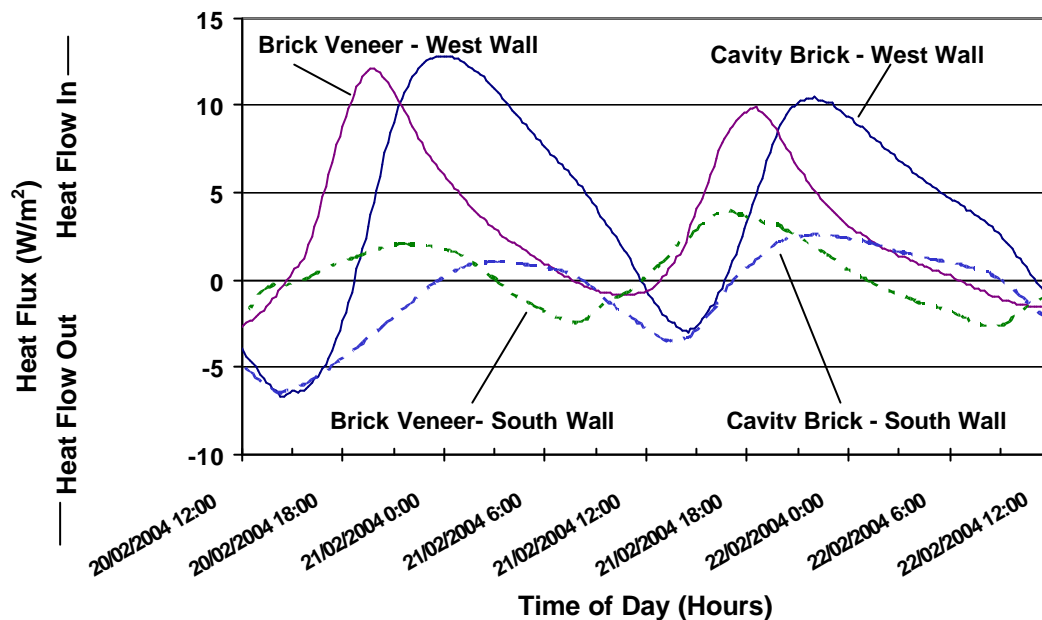
These changes in solar radiation influenced the thermal behaviour of the walls. The exterior surface temperature of the South and North walls followed closely the external air temperature. The East and West walls reached higher temperatures, with the West wall recording the hottest temperatures in the range of 40-52°C in the afternoon. When the walls were out of direct sunlight, in shade or at night, the exterior surface of the walls cooled down to the external air temperature. Examination of the heat flux readings on the interior surfaces shows that heat enters via the East and West walls and leaves via the South wall. Figure 8 shows this behaviour although for clarity only the West and South wall interior flux are shown. The peak flux entering through the West walls is in the order of 12-13W/m² for both buildings (also note that some heat flows out as well). Figure 8 also shows that heat generally flows out via the South wall with maximum and minimums being observed. Again, note the different lag time for the buildings, the peak solar radiation on the West wall was at 5:30pm however, the peak heat flux occurred around 8pm for the Brick Veneer and 10pm for the Cavity Brick building.

Figure 8. Heat Flux Measurements on the Interior West and South walls of the Cavity and Brick Veneer Buildings for 21st February 2004.

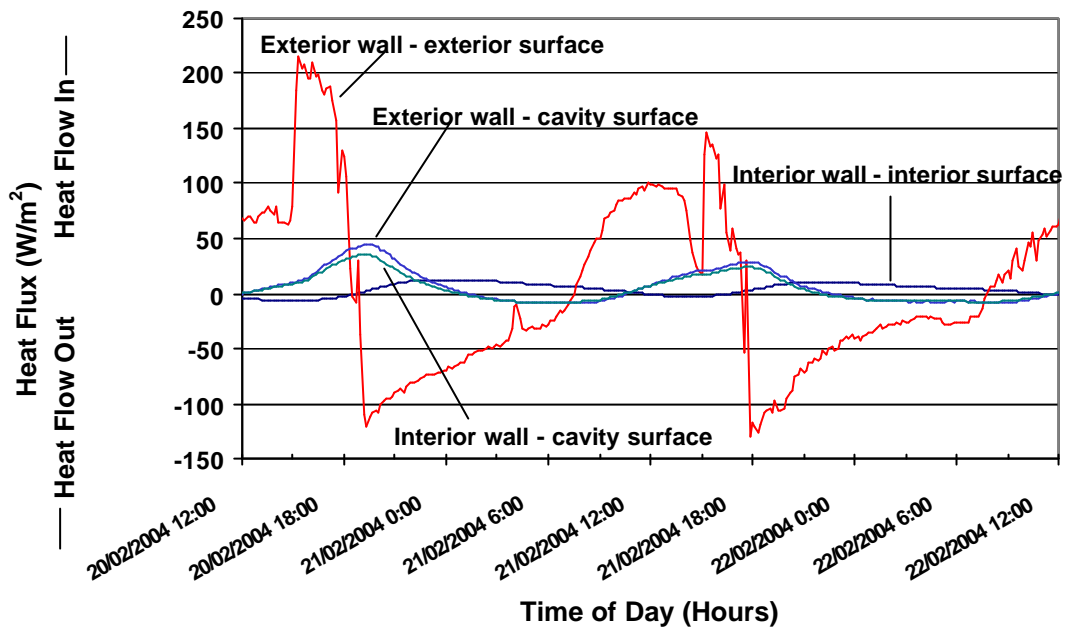
between the observed heat flux on the external and cavity surfaces of the exterior masonry skin. This attenuation reduces the peak heat flux from about 200W/m^2 to 50W/m^2 . This behaviour is again repeated by the interior masonry skin and further attenuates the flux down to peak values of $12\text{--}13\text{W/m}^2$ as shown in Figure 8. The flux reversal occurs through both masonry skins and reduces the net flux entering the building. This reversal is driven by day-night temperature swing with cooler night time temperatures increasing the radiation and convective heat transfer rate from the masonry wall to the outside environment.

Figure 9. Through-Wall Heat Flux Profile of the West walls of the Cavity Brick Building on the 21st February 2004.
