APPLICATION OF RESISTANT OVERLAYS IN PREVENTION OF PROGRESSIVE COLLAPSE IN MASONRY BUILDINGS

F. L. Oliveira¹ J. B. Hanai²

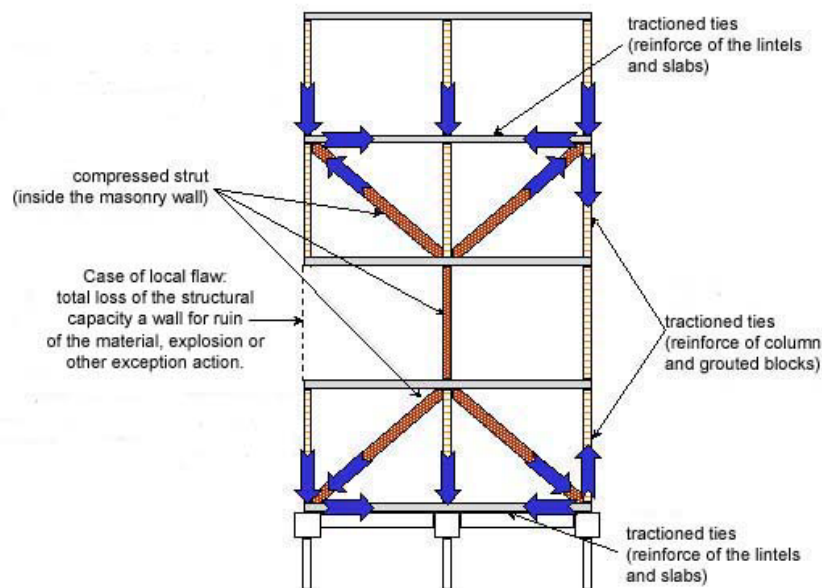
Figure 1 Illustration of possible resistant mechanism against the progressive collapse.

In practice, for example in some cases of cellular masonry buildings, this means that after a wall or a part of a wall is removed, the addition of stress on the slabs and the other walls are checked to make sure that the remaining structure can resist this. It is important to emphasize two points in this matter: elements should be removed one by one and the security coefficients can be reduced or eliminated. Figure 01 illustrates stress redistribution due to the located damage.

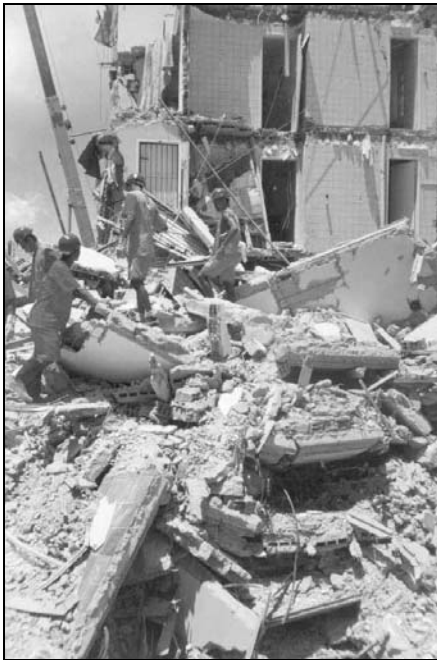
Figure 2 Damage of the building 1.

In Brazil some cases of damage were registered in the northeast of the country, in masonry buildings with 4 floors. The most serious cases happened in the city of Olinda, in November of 1999, where four people died in the collapse of the first building (Figure 2) and other seven in the collapse of the second building (Figures 3). The inspections pointed out damages in the foundation and that non structural ceramic units were used. That constructive system developed in an empiric way contains procedures which are incompatible with the good practice of Engineering, since the materials and consolidated techniques along with minimum procedures of quality control were rejected.

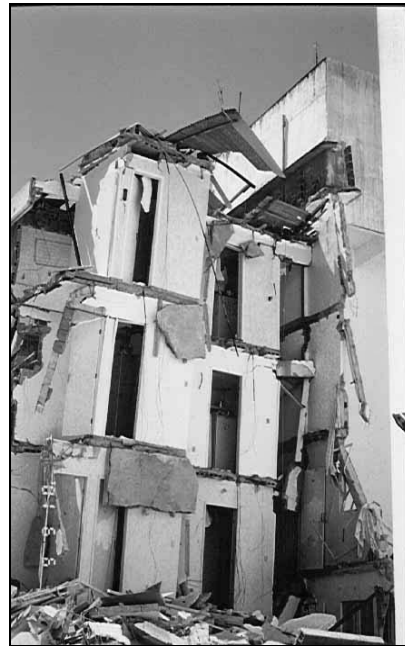
Figures 3 Collapse of the building 2.

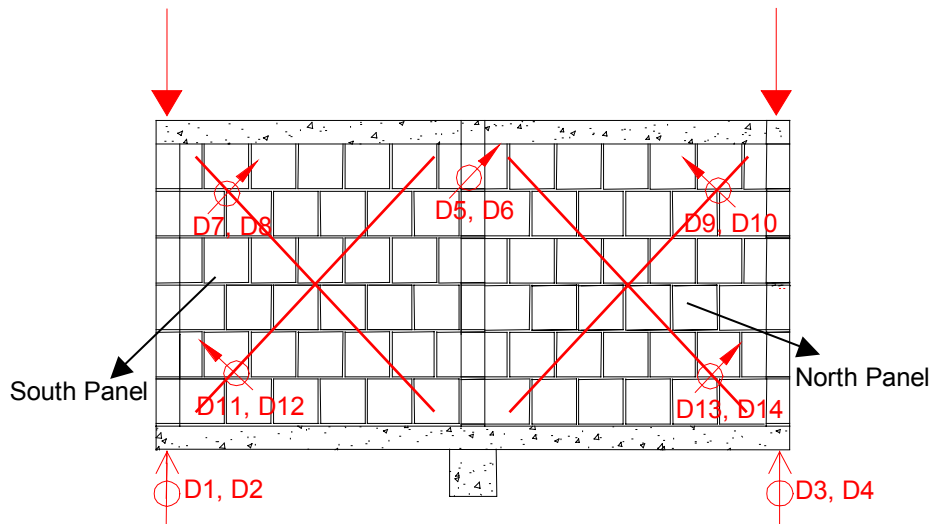
Figures 4 Instrumentation used in the models.

The series idealized for the tests were two models with two conjugated panels (denominated North and South) of non structural ceramic blocks. The dimensions of the panels were 120 x 120 centimeters and webs of 10 x 50 x 120 centimeters in their extremities. Each model was built on a slab of reinforced concrete with dimensions of 270 x 50 x 10 cm. That slab was simply supported on a concrete block (20 x 50 x 20 cm) in the middle. The lintel with a height of 10 cm outlined the top of the whole model (FIGURE 4).

The models were tested according to the model of Figure 4. The model supported on the concrete block in the middle and concentrated loads were applied on the extremities. For the application of these loads servo-hydraulic testing machines were used with a capacity of 500 kN to enable the realization of the tests with controlled deformation. The load speed was 0,005 mm/sec and the displacements were measured as seen in Figure 4. Figure 5 illustrates the sequences of the tests for each one of the built models.

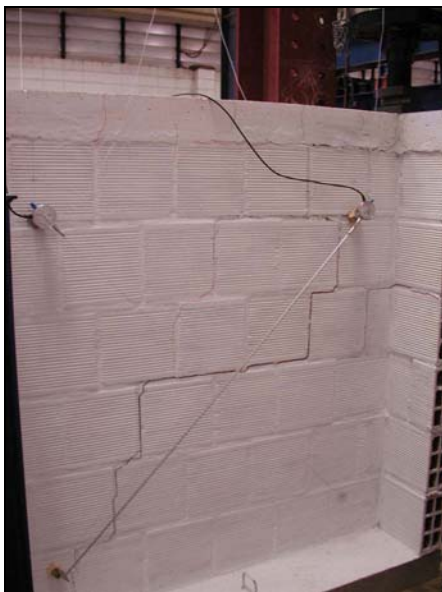
Figures 7 Damage of the model without coating.

During the transport of the specimen the north panel was damaged, affecting the test partially. This caused a premature crack in the north panel under a load of 19 kN. The pre-existent crack had been prolonged with the increase of the load and a new crack in "stairway" format appeared in the diagonal of the wall. The south panel didn't suffer any damage during the test.

The panels without coating demonstrated structural behavior as expected, presenting close to the damage diagonal cracks in stairway form. This fissure configuration was the same as observed in the shear tests in masonry walls carried out in the Laboratory of Structures.

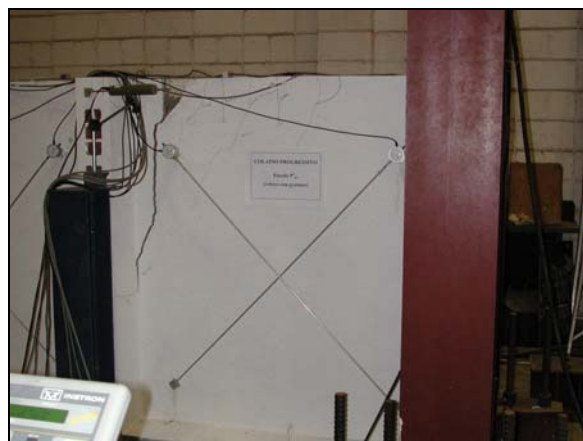
Figures 6 Damage of the model with steel bars.

The south panel was reinforced with steel bars of $\phi = 5\text{mm}$ (perpendicular to the diagonal cracks) and coating of simple mortar with the proportion of 1:0,5:6 (cement: lime: sand) and thickness of 2 cm. It presented a resistance to compression of 9 MPa. The coating was applied on the whole model (also in the lintel). The rupture of the model was given by damage of the south panel. The cracks that appeared in the model deviated from the region where the steel bars were and spread towards the central web. The model reached a maximum load of 70 kN. Many cracks were not observed in the north panel.

In the walls reinforced with steel bars the final load was also twice as high as the walls without coating. The damaged wall acquired its initial resistance and reached the same resistance as that of an entire coated wall.

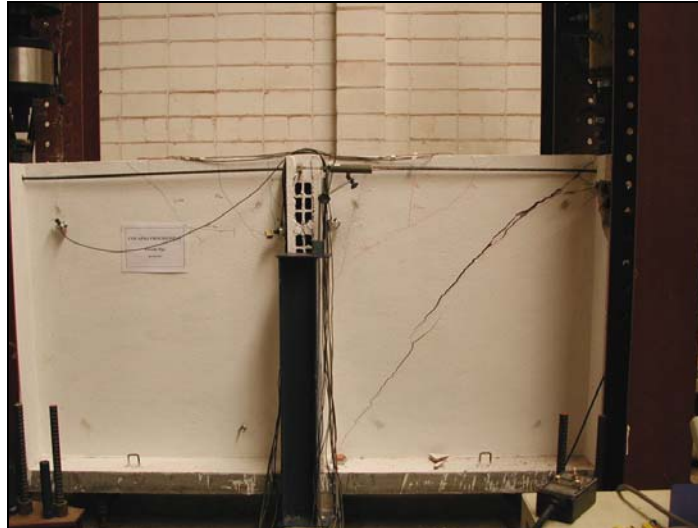
Figures 8 Damage of the model with prestressed tendons.

In the test of the model it was observed that the lintel reached the resistant capacity when the reinforce reached its limits of crip. So, The decision was made to reinforce it with two prestressed tendons with force of approximately 20 kN. The model reached the maximum load of 150 kN. The final configuration of damage was a diagonal crack in one of the masonry panels. Although the other masonry panel did not fail equally, the configurations of the cracks were similar.

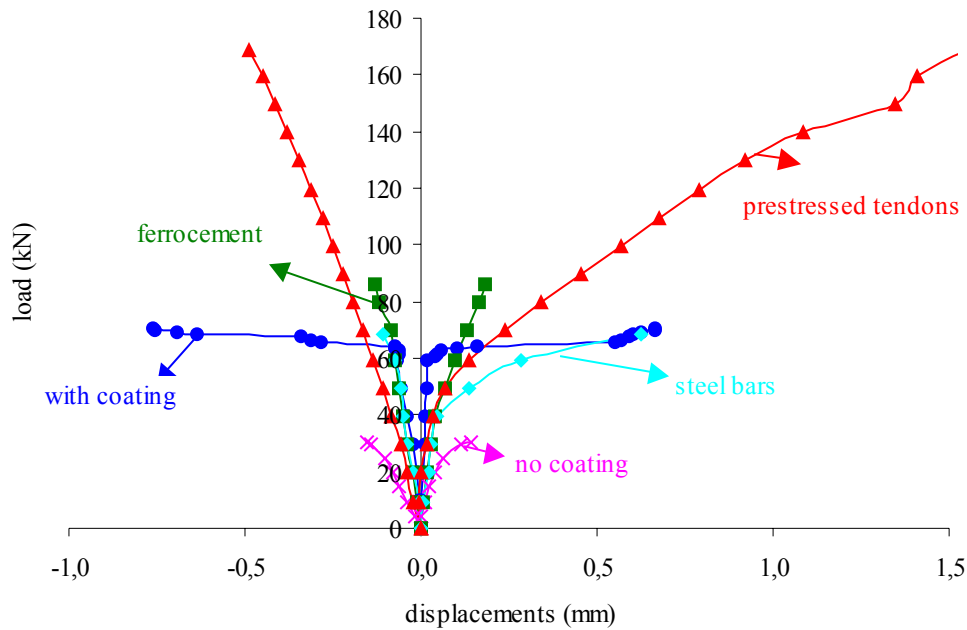
Figures 6 Load vs. displacement diagram.

Table 1 and diagram of the Figure 6 (*load x displacement*) show the values obtained in the tests of the models carried out for analysis of the prevention mechanisms for the collapse.

It was not possible to obtain the last load of the panel reinforced with ferrocement. But by observing Figure 6 the load x displacements curve, even in the linear phase, an improvement in the rigidity and ductility of the panel can be seen. It can be concluded that the meshes collaborated in controlling the appearance of cracks in the wall and retarded the fracture mechanisms. The wall reinforced with prestressed tendon presented better ductility and final load than the other test models. But it cannot be concluded that it is the best because a more complete analysis of these cases must be developed.
