WHITE EFFLORESCENCE ON BRICK MASONRY: TOWARDS PREDICTION OF EFFLORESCENCE RISK

Harold Brocken¹, Timo G. Nijland²

Abstract

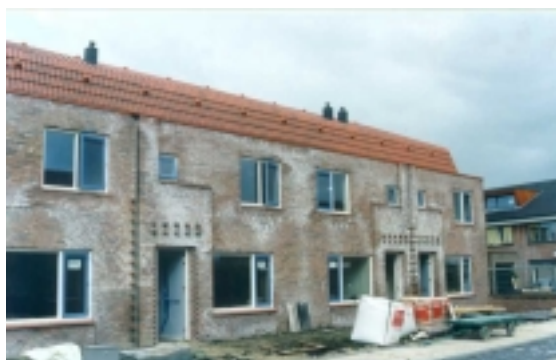
Figure 1. Early efflorescence of soluble alkali sulphates directly after construction of housing blocks.

Efflorescence often occurs on masonry façades made of brick or concrete masonry blocks. In some cases, it appears directly after construction (Fig. 1), generating controversy between parties involved about appreciation and acceptance of the work, appropriate cleaning methods and associated costs. In other cases, efflorescence starts to appear after a couple of years (Fig. 2), leaving the current building owner with questions about damage potential of the phenomenon and appropriate maintenance of the façade. Generally, efflorescence is considered as an aesthetic phenomenon only. It has been observed for decades on masonry works everywhere in Europe, and has proved to be very persistent and hard to remove in many cases.

Efflorescence of sulphates occurs often as an intense, white and fluffy deposit on the surface of clay bricks and sometimes also on mortar joints. In all investigated cases, it appeared already during construction of the buildings, before masonry units were pointed (Fig. 1,5). This demonstrates that pointing mortar does not provide any essential contribution to this type of efflorescence. Identification of minerals present in the efflorescence by X-ray diffraction showed that these were easily soluble alkali sulphates, notably thenardite, Na_2SO_4 , syngenite, $\text{K}_2\text{Ca}(\text{SO}_4)_2$, and glaserite, $\text{K}_3\text{Na}(\text{SO}_4)_2$, occasionally accompanied by the lesser soluble gypsum, $\text{CaSO}_4 \cdot 2\text{H}_2\text{O}$. Consequently, this type of efflorescence appeared to wash off fairly well by natural rain.

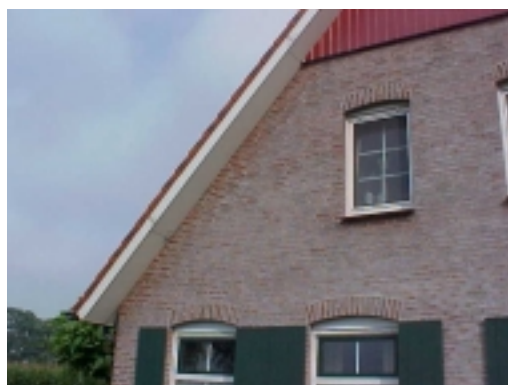
Figure 2. Efflorescence of gypsum that starts to appear after a couple of years

Efflorescence of gypsum occurs as a very thin, often semi-transparent, white foggy deposit on the surface of clay bricks (Fig. 2,4). It may also occur on the surface of the

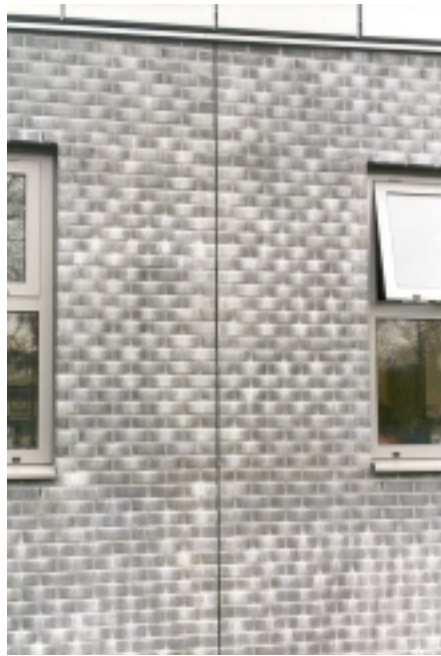
Figure 3. Efflorescence and wash out of lime occurring on masonry consisting of bricks or blocks with a low water absorption.

Efflorescence and wash out of lime typically occurs on masonry consisting of bricks or blocks with a low water absorption (Fig. 3). During wetting, rain drops will run off from the brick surfaces and cause excessive wetting of the mortar joints. This facilitates dissolution of lime in the pore water of the mortar joints and prevents carbonation of this lime as CO_2 from the air can not penetrate into the saturated mortar structure. As a consequence, lime will be longer available in its soluble form. Investigation of the case studies has shown that the potential of efflorescence and wash out of lime is always existing, even if all possible precautions (protection from wetting) are taken during construction. In one particular case, the protection was taken away two weeks after the masonry façade was pointed. Unexpectedly, the next day it started to rain, resulting in a thin white wash out of lime from mortar joints over the bricks, even at such an age of the hardened mortar. In an early stage (before carbonation has occurred), this type of efflorescence and wash out of lime can be removed fairly simple with warm, steamy water. Moreover practical experience learns that a slight degree of lime deposits (and corresponding colour differences of pointing) disappear within a couple of years by natural weathering.

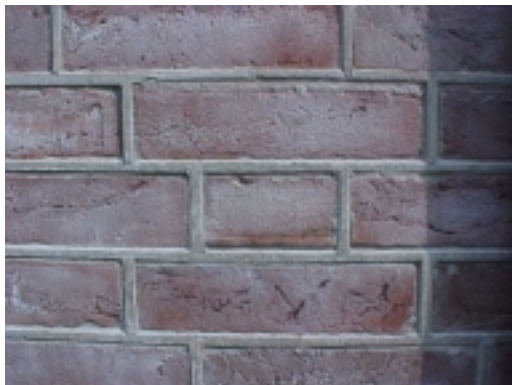
Figure 4. Detail of figure 2.

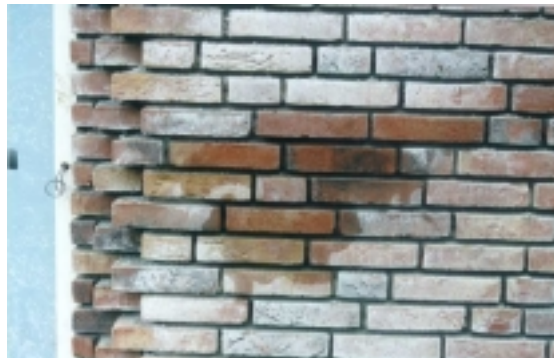
Figure 5. Detail of figure 1.
