## IMPROVEMENT OF SEISMIC BEHAVIOR OF UNREINFORCED MASONRY STRUCTURES IN LOW SEISMICITY REGIONS BY CAPACITY DESIGN

Ekkehard Fehling<sup>1</sup>, Mahmoud Nejati<sup>2</sup>, Panayotis G. Carydis<sup>3</sup> and Harris  
Mouzakis<sup>4</sup>

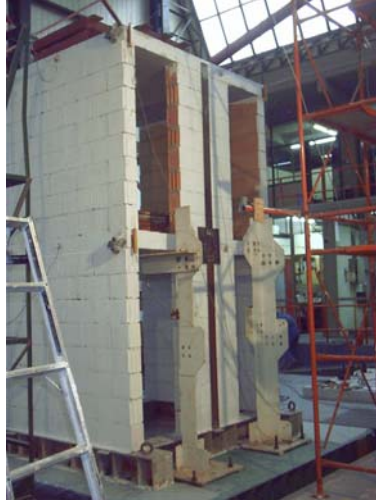
Fig. 4: Steel strip in lateral walls for prevention of out of plane failure

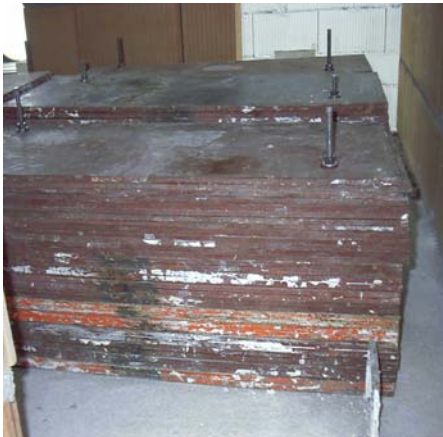
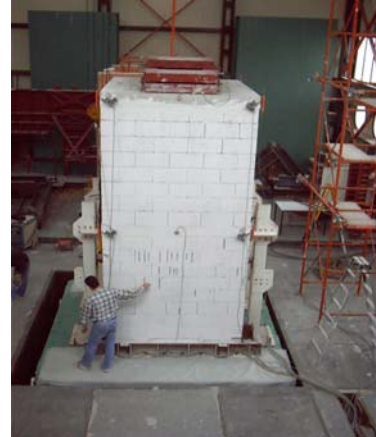
Fig. 5: Live loads on the first and second floor

After finishing of each story, a prefabricated roof has been pasted with a special type of glue on the walls. The steel masses for live loads were put on each story in a symmetric position to avoid slippery and were fastened to the floor with long bolts. The first story's live load consisted of 200 pieces of steel in six rows with  $980 \times 330 \times 10 \text{ mm}^3$ . On the second floor the mass consisted of only five big steel plates with symmetric distribution with dimension  $1000 \times 1000 \times 130 \text{ mm}^3$  (see fig. 5 showing live loads and their positions on the first and second floor).

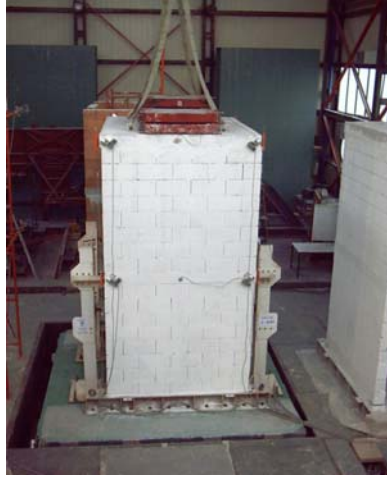
Fig. 6: Instrumentations on specimen #1 ready for testing (LVDTs & Accelerometers)

LVDT's were installed for recording displacements in vertical, horizontal and diagonal directions of the main and lateral walls. Accelerometers only recorded horizontal acceleration of roofs in two horizontal directions. Fig. 6 shows details of specimen #1.

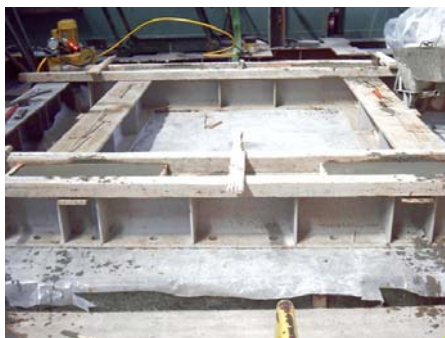
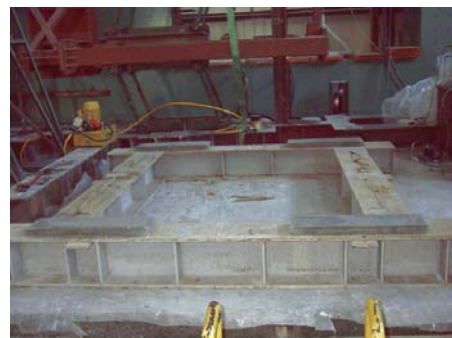
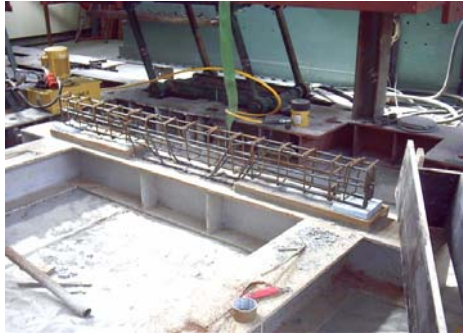
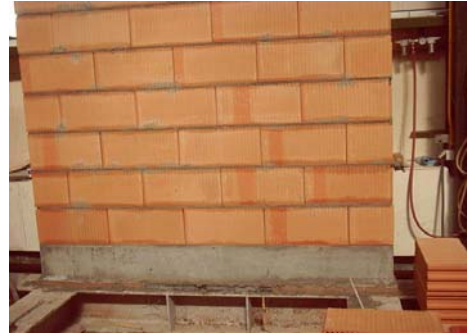
Fig. 7: Gap-Element building procedure

Specimen #2 as specified in table 1 is a prototype specimen with Gap-Elements but the other specifications are corresponding related to the first one. Specimen #3 was the main specimen that tested with Corner-Gap-Element by attention to obtained experiences from specimen #2. Both specimen #2 and #3 had the same built-up procedures that are shown in fig. 7:

In order to allow a rocking movement of the base-beam with the Corner-Gap-Elements, the middle reinforcement should not have any intentional tensile connection to the steel foundation frame that was mounted on top of the shaking-table (see fig. 7-d, where one finished corner gap beam under construction of the main wall in specimen #2 is shown). In the following the differences are described:

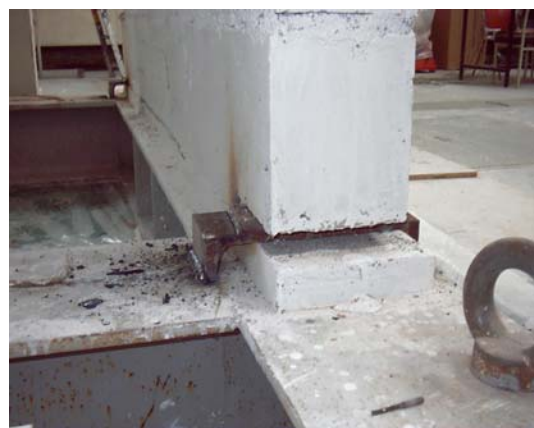
Fig. 8: Removal of all lateral walls and new type of sliding stopper for corner-gap beam, wall edges in first story reinforced with vertical steel strip

Due to experiences with specimen #2, some modifications have been implemented in specimen #3 as it is illustrated in fig. 8. For example the lateral walls are removed and vertical steel strip are put in between the Gap-Elements and the first roof, fig. 8.

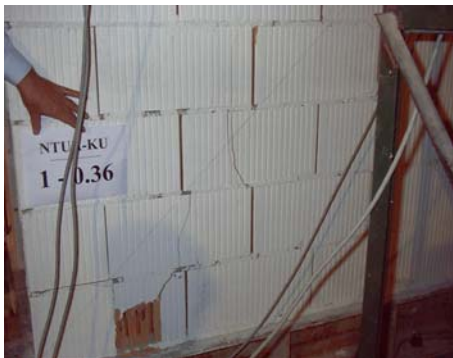
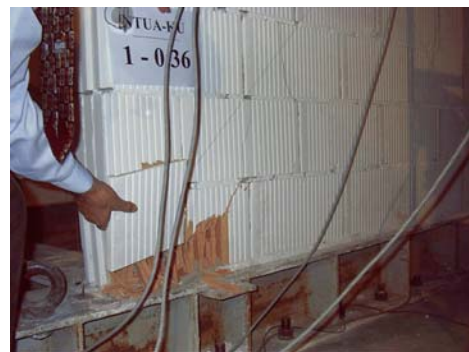
Fig. 9: Last test in specimen #1, shear failure caused collapse in first layer of the main wall

- until 8 % (nominal input data) of g, no cracking or separation in the joints could be observed,
- when the excitation was increased until 20 % of g, the first cracks in the first layer of the main wall's bricks appeared,
- at 36 % g, 'jumping' between the last layer of bricks below the first floor slab and one layer below could be noted. In this load step, severe damage of a corner brick in the first layer above foundation appeared (see fig. 9).

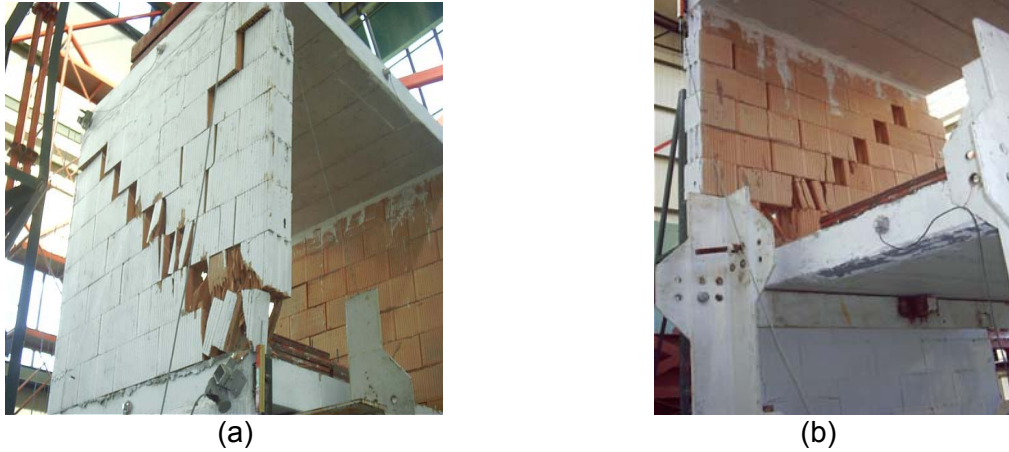
Fig. 10: Failure of the second floor at 80 % g excitation (12.03 m/sec<sup>2</sup>) in Specimen #3

- from 4 % g until 10 % g everything was like specimens #1 and #2.
- at 12 % g, some vertical movement has been observed in the Gap-Elements (dust in the air near the notches of Gap-Elements). No cracks could be observed.
- at 16% g, remarkable joint opening below Corner-Gap-Element.
- 28 % g: remarkable uplift
- 44 % g: in this stage a little horizontal slip occurred below in Gap-Elements because of the torsion effect.
- Increased input until 64 % g without further significant observations. Anchor bolt of steel strip came out in one of the Corner-Gap-Elements. All bolts were fastened again afterwards.
- At 72 % g, the rear main wall on the second floor showed step-like crack with horizontal movement.
- Failure of back wall on the second story occurred at nominal input of 80 % g (measured max. table acceleration  $12.03 \text{ m/s}^2$ , see figs. 10).
