TRANSPORT AND CRYSTALLISATION OF SALTS IN MASONRY AND PLASTERS

Abstract

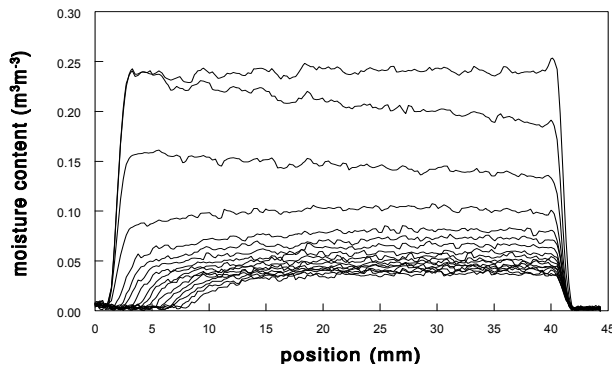
Fig.2 Drying behaviour of Dutch brick with water. Moisture distribution during drying. Time between different profiles 1 h. (NMR measurement, Pel 2002)

In a laboratory experiment the drying behaviour of brick was determined with the use of NMR (Pel 2002). The experiment was done first with water and is shown in fig. 2. A clear receding drying front is observed: the critical moisture content is reached.

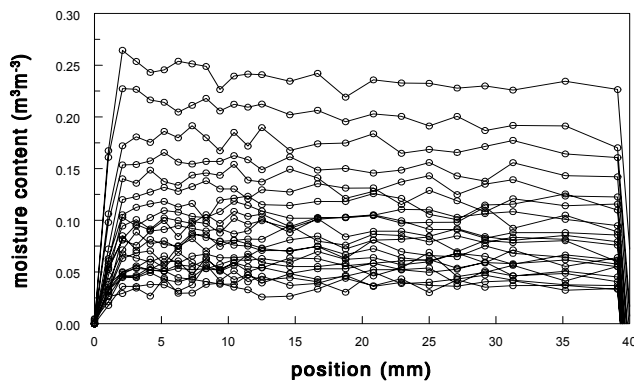
Fig.3 Drying behaviour of Dutch brick with NaCl solution. Moisture distribution during drying. Time between different profiles 3 h. (Pel 2002)

When the same experiment was performed with a NaCl solution (1M solution) the result was completely different: no receding drying front was observed under equal environmental conditions, as can be seen in fig. 3. The occurrence of salt crystallisation on the surface was observed at the moment that the salt concentration near the surface reached 6M, the saturation concentration of NaCl (fig.4). It is interesting to observe that in the NMR measurements no supersaturation was reached. Pel et al (2002) and Pel (2002) suppose that NaCl does not supersaturate and therefore postulate that any damage occurring with NaCl can not be attributed to stress developed by crystallization at supersaturation of the NaCl solution. Since, according to Correns' theory (Correns1948), the crystallization pressure is related to the degree of supersaturation, NaCl would not be able to develop high pressures. Further, Rodrigues-Navarro and Doehne (1999) state that cubic halite crystals result from crystallization at low supersaturation and these are supposed to be less harmful than the prismatic crystals growing at high supersaturation ratio. This may explain why in many laboratory experiments (see also the next example) it is much more difficult to have damage to building materials due to NaCl than due to Na_2SO_4 .

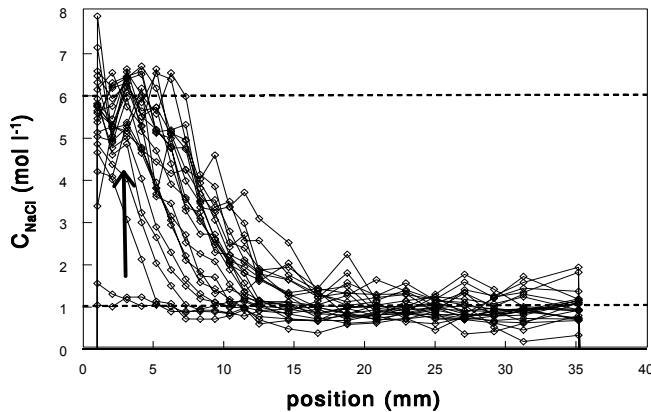
Fig. 4 NaCl-concentration distribution for Dutch brick during drying. Time between different profiles 3 h. Sample initially saturated with 1M solution (Pel 2002)

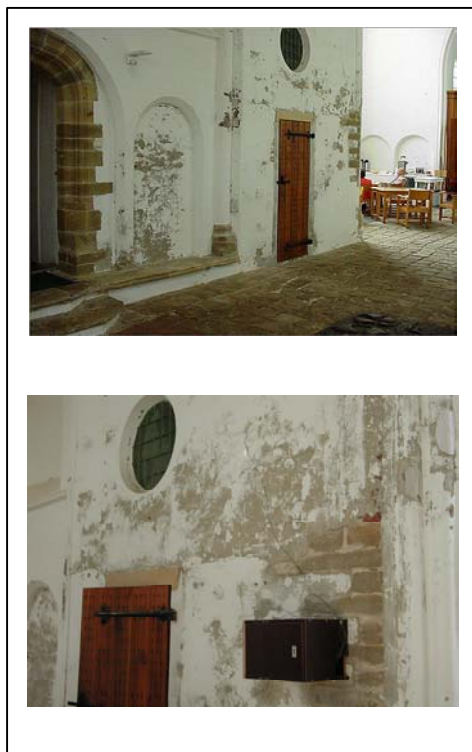
Fig. 5a Evolution of the damage at location B

Fig. 5a gives an overview of an internal wall in the church in respectively 2000 and 2002 (18 months later). Comparison of both overview photographs makes clear that the damage is increasing.

The most severe damage can be described as crumbling and falling apart of the plaster. In general the damage development starts with peeling of the paint, probably together with powdering of the plaster directly underneath. The damage further develops first following the pattern of hair cracks (craquelé) present in the plaster. In the next stage powdering and sanding of the plaster surface occurs, starting near hair cracks, until finally crumbling takes place, leading to complete segments, surrounded by hair cracks, falling apart.

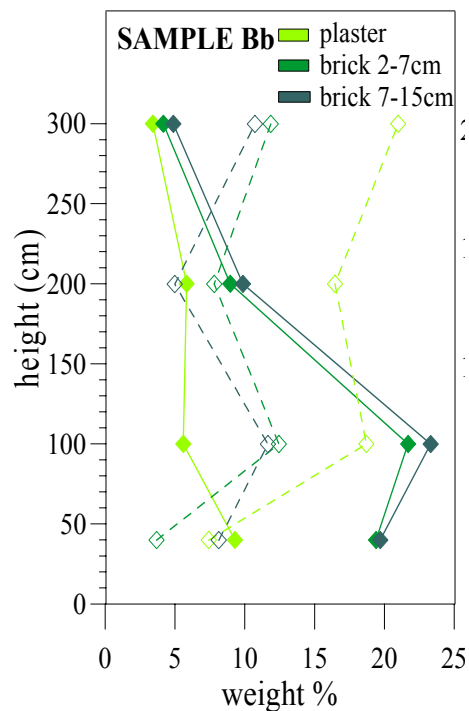
Fig. 5b Moisture and hygroscopic moisture distribution at location B

Fig. 5b gives the moisture distribution of the wall concerned, at location B. It can be seen that there is rising damp in the wall, currently up to a level of ca. 2 m. From the hygroscopic moisture distribution, the presence of a concentration of the salts around a height of ca. 3 m (and as can be seen from the actual damage, even reaching a higher level) can be assessed. The salt efflorescence collected at this height was analysed and was found to be mainly NaCl.

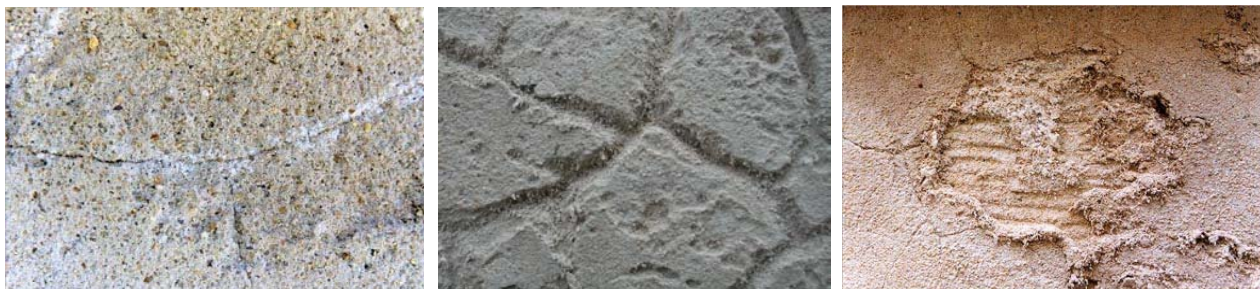
Fig. 6 Curaçao (NA) - nb colour differences due to the use of different camera types

After 1 to 2 years from the restoration, damage occurred. The damage development was quite similar to the one described for Brouwershaven: detachment of the paint and sanding of the plaster surface. Once the paint had disappeared, a clear craquelé pattern was visible in the surface; starting from the hair cracks damage proceeds to the complete falling apart of sections surrounded by the hair cracks. Fig. 6 gives some details of the damage development.
