## STATIC CYCLIC TESTS ON URM WALL BEFORE AND AFTER RETROFITTING WITH COMPOSITES

### Abstract

Four years ago, an extensive experimental program for retrofitting of unreinforced masonry (URM) walls has been switched on in Switzerland. The program includes in-plane dynamic and static cyclic tests on URM walls retrofitted using composites as well as shotcrete. This paper presents preliminary test results of the static cyclic tests. The test specimens are half-scale specimens built using half-scale hollow clay masonry units and weak mortar. The specimens, before and after retrofitting, are subjected to a series of force and displacement control test runs. The test shows that the composites improve the cracking and ultimate load of the retrofitted specimen by a factor of 3 and 1.5, respectively.

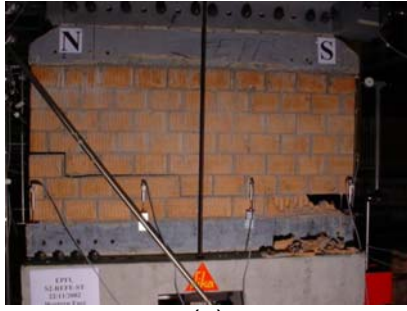
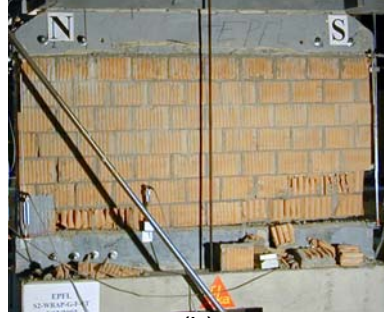
Figure 5 Specimens (a) S2-REFE-ST and (b) S2-WRAP-G-F-ST (unreinforced face) at the test end

Table 2 presents a summary of the test procedure, the measured lateral forces, and drifts for selected test runs. Figure 5 to Figure 7 show the observed damage to the test specimens during and at the test end. In order to determine sliding between the masonry panel and the r.c. foundation, Figure 8 shows a comparison between the total displacement (i.e. the relative displacement between the wall top and foundation pad) and the relative displacement between wall top and the first brick course. The vertical

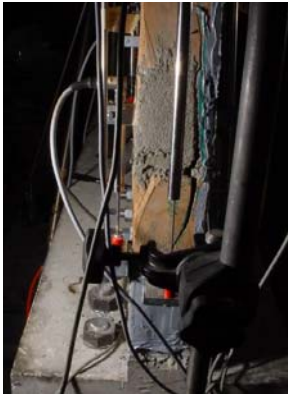
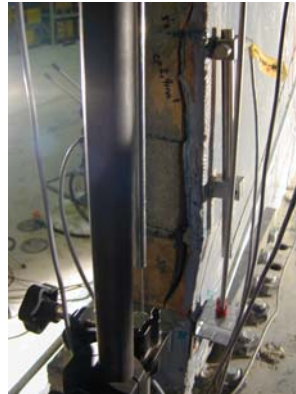
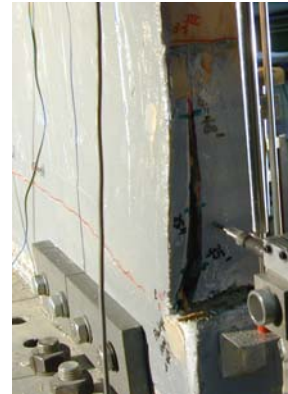
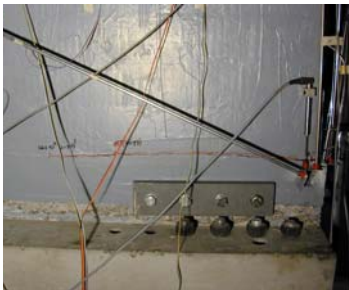
Figure 7 S2-WRAP-G-F-ST (a) opening of first crack in the southern side, (b) propagation of the first crack in the southern side, (c) vertical crack in the northern side, (d) tear of GFRP during the test, (e) rupture of GFRP at the test end, and (f) crushing of masonry at the test end

- During test run 15, a vertical crack of 300 mm length happened in the substrate behind the GFRP the specimen southern side (Figure 7 (a)).
- During test run 16, a 20 mm length horizontal tear in the northern side happened in the GFRP at the first mortar joint.

- During test run 21, the tear of the GFRP extended instantaneously over 400 mm length. This tear extension combined with relatively high increment in the lateral drift (Figure 10 (a) and Table 2). In addition, the maximum lateral load in the north-south direction was recorded during this test run. In the next test runs, the tear extended gradually (Figure 7(c), (d)).

- During test runs 25 to 38, a vertical crack in the substrate behind the GFRP along 150 mm length was observed in the northern side (Figure 7(c)).

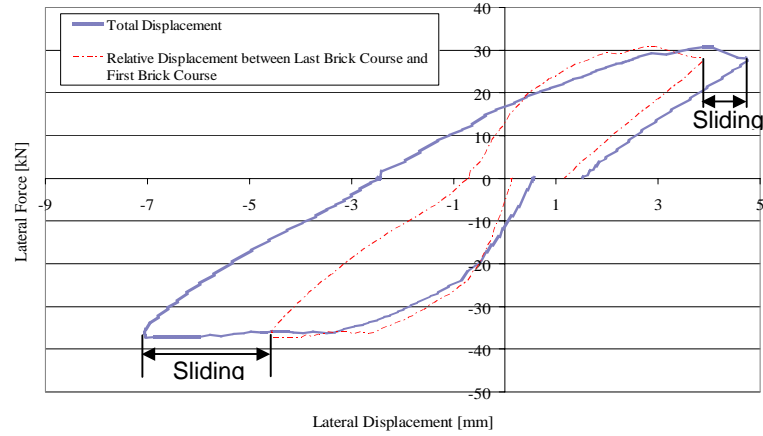
Figure 8 Measured sliding between masonry panel and r.c. foundation during test runs (a) 66, 67 for S2-REFE-ST, and (b) 57 to 59 for S2-WRAP-G-F-ST

- During test runs 66 and 67, sliding occurred with deformation concentrated through the first bed joint. The sliding was about 1 mm in the south-north direction and 2.5 mm in the north-south direction (Figure 8(a)).

- During test runs 58 and 59, sliding occurred with deformation concentrated through the first bed joint (i.e. between the masonry wall and its foundation). The sliding was about 7 mm in the south-north direction and about 1mm in the north-south direction (Figure 8 (b)).
