# MULTILEVEL APPROACH TO THE ANALYSIS OF THE HISTORICAL BUILDINGS: APPLICATION TO FOUR CENTERS IN SEISMIC AREA FINALISED TO THE EVALUATION OF THE REPAIR AND STRENGTHENING TECHNIQUES

An investigation procedure proposed by the authors is here applied on a building patrimony in seismic area previously considered as minor, but meaningful testimonies of cultural heritage, aimed to a critical review of the effectiveness of the applied repair techniques. The research suggests a "minimal" investigation program, which can support the designers in their projects. The knowledge of existing buildings is approached by considering different analysis levels: history, materials, structural morphology of the wall section, observed damage mechanisms, effectiveness of retrofitting techniques. The methodology was applied to four historic centres situated in Umbria (Italy) and the survey of the buildings allowed to define an abacus of the typical collapse mechanisms, useful to define the seismic vulnerability also for other similar centres and to critically evaluate the past and future repair techniques.

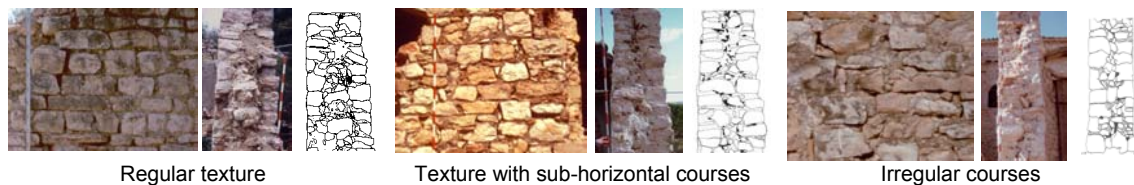
Figure 5 shows some example of masonry texture with the corresponding cross section, which was possible to survey on damaged buildings after the seismic event. In Montesanto and in Roccanolfi were found mainly three masonry typologies for the external walls: regular, sub-horizontal and irregulars courses.

The stones are mainly limestone and travertine, laid in courses with stone ashlar and rough cut stones. The dimension varies from 5 to 25 cm. In some cases also sandstone is present. The mortar joints height is very variable, from 1 cm up to 5 cm, due to the irregularity of the stones. Mortar is compact with colours varying from white to yellow and grey.

Figure 5 Constructive masonry typologies.

The masonry is surveyed by pictures, obtained as parallel as possible to the masonry surface, and by placing close to the section or to the texture a graduated stick in order to know the wall dimension. The dimensions are then verified by the archaeological survey method (scale 1:1). The 2D graphic plotting is realised with a special care in the representation of stones, joints and voids. Successively, the surface occupied by the different materials, which compose the masonry, is measured, evaluating the stone, mortar and voids percentages, the dimension and the distribution of voids. This information is useful both for the definition of the geometry and mechanical behaviour necessary to the modelling phase and for the design of possible strengthening intervention (e.g. grout injection).

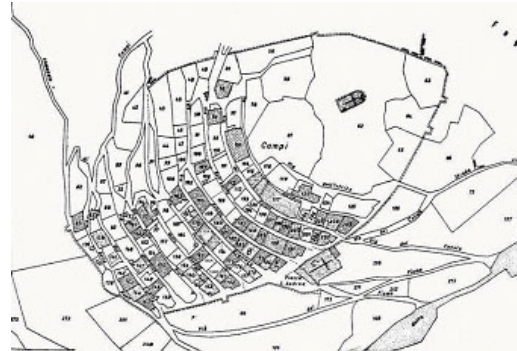
*Figure 10 Plan of Campi di Norcia*

Campi Alto is a castle perched on a slope surrounded by walls, and whose buildings are arranged in concentric terraces and narrow streets connected by short radial flights (see Figs.9 and 10). The buildings follow the orography and are arranged in rows. Campi situated 11 km away from Norcia and at 900 mt above the sea level, belongs to the municipality of Norcia. It still preserves the original medieval aspect. Campi is divided in two parts: the old and lower one, "Campi basso", named "La Civitas Campi", whereas the new one, "Campi alto", is situated on the top of the hill.

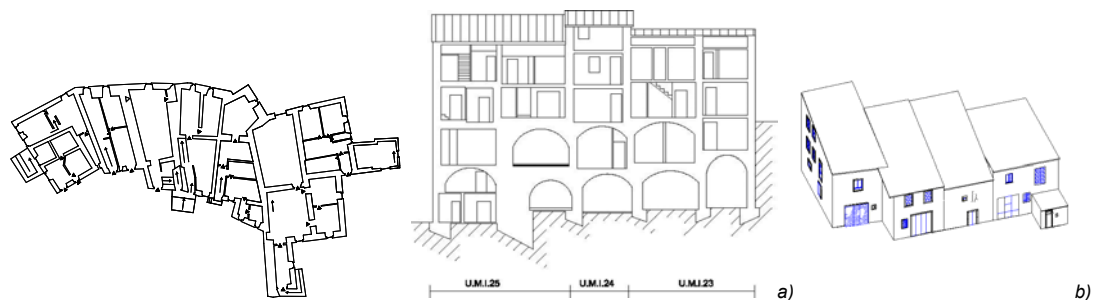
The town-planning development of Castelluccio is shown in two parts: the first one, gathered around Cassero (the highest part of the village, of which only the planimetric plan and the grid of old streets are still preserved) and the second part at the bottom of the hill where there are still standing the old stables. The typology of the top part is very complicated as shown in figure 14a, while the stable typology is very simple (Fig.14b).

Figure 14 The building typology of Castelluccio: a) complex civil buildings and b) simple rural buildings
