THE DEVELOPMENT OF A FREEZE THAW TEST FOR MORTAR

By
Edgell GJ¹ and Wilson N²
CERAM Building Technology

Abstract

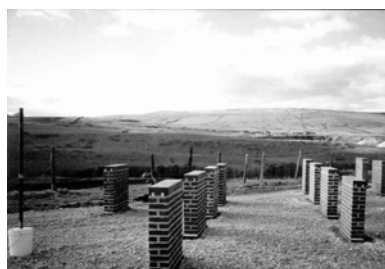
The exposure site panels as described in Table 1 have been constructed on steel bases in the laboratory. Each panel consisted of 12 courses of 4 bricks in half bond and was 215mm wide with a brickwork soldier coping. The first three courses of all the specimens were constructed using a 1:3 sand cement mix with blue engineering bricks as a damp proof course. The panels were left to cure for at least 28 days after which time demec points were fixed to both faces of the wall including the coping to monitor movement on site. The panels were then clamped for transportation to the exposure site. Figure 1 shows the exposure site at Dove Holes quarry, Buxton.

At the exposure site the panels were positioned about 1m apart in rows about 2m apart with their main face facing North.

Figure 1 : Exposure site at Doveholes

In the early work on clay bricks the exposure trials related number of air frosts to the number of laboratory cycles to in each case cause failure. In this study this criterion will be used but in addition the freezing index which is based upon number of air frosts and amounts of rainfall will also be investigated as a parameter to measure the extent of frost loading. A weather station has been installed on the site to continually measure air and surface temperatures, rainfall, wind speed and wind direction.

The exposure site at Dove Holes is examined on a monthly basis and after one winter (October 2001 – March 2002) damage was only recorded on two of the 22 panels. Light spalling was noted on the designation iv cement:lime:sand mortar with soft mud brick. This was mainly on the North face and on perpend joints.
