TESTS ON GLUED MASONRY FOR VENEER WALLS MORTAR-BRICK BOND STRENGTH

Yves Grégoire ¹, Fabrice de Barquin ²

BBRI is performing a research program in order to evaluate the technique of the 'gluing' of units for veneer walls. Final aims are to provide a full range of necessary and accurate information to the sector via a Technical Report and to give a basis for a suitable guideline for certification. This two-parts paper presents only the results in relation with the bond strength.

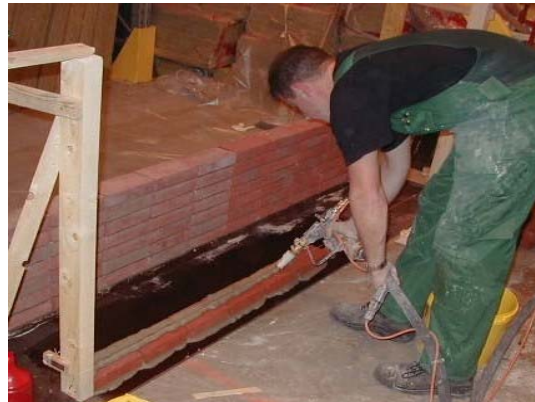
Figure 1 Preparation of specimens

For several intrinsic characterizations, samples were prepared with the trowel by the BBRI staff. It concerns Series T, H and X. The mixing is realised by a lab-mixer. All the bricks were dried and brushed before the setting up. In all the cases, the fresh specimen wasn't loaded (like in practice).

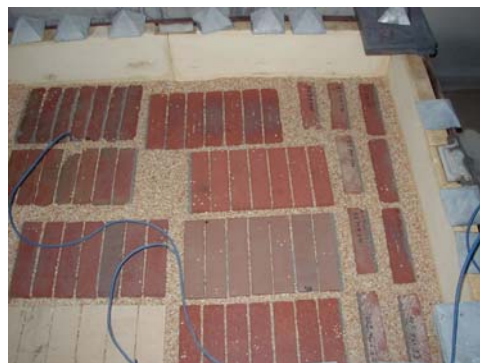
Figure 2 Freeze/thaw test arrangement

The retained test method is adapted from the Belgian test method for clay bricks (NBN B 27-009 (1983) + add. 2 (1995)). It consists in a preliminary immersion of the sample in water during 6 days before the submission to 20 cycli to – 15°C. Thaw occurs by introduction of water in the freezing chamber. Samples are set horizontally in a tank with sand ; the visible face is upward and is the only one without sand contact (see figure 2).

Already present degradation are marked before water impregnation. After the cycli, eventual new degradations are noted and then, mechanical tests are performed in order to evaluate eventual loss of strength.
