## **BEHAVIOUR AND CHARACTERISTIC OF CLAY BRICK MASONRY WALLETES SUBJECTED TO COMPRESSIVE CYCLIC LOADS**

J. KUBICA<sup>1</sup>, I. SEWERYN<sup>2</sup>, A. WAWRZYNEK<sup>3</sup>

### **SUMMARY**

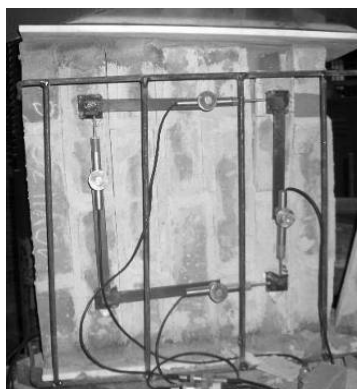
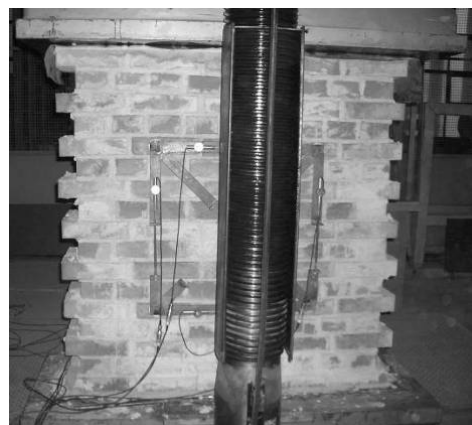
Figure 2 The masonry wallette type **H** (a) and **M** (b) with displacement measuring sensors in hydraulic testing machine – ready to test.

On both sides of each wall a set of displacement measuring sensors was attached before test when wallette was located in the testing machine (with range from 0 up to 6000 kN) – as in Fig.2. The accuracy of these inductive sensors was 0,002 mm. To eliminate the friction between masonry specimens and the machine head a separator made of Teflon (10 mm thick) was used.

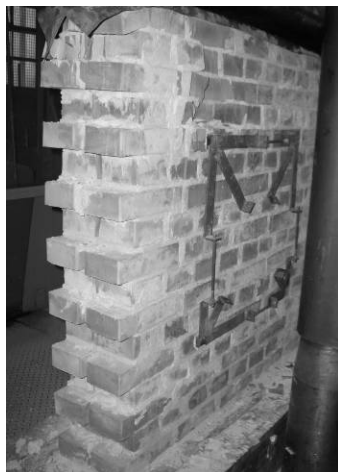
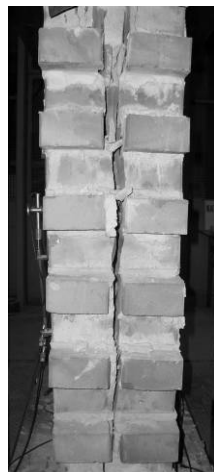
Figure 3 Failure of **M** type model

All tested elements, apart from shape, overall dimensions and direction of loading (perpendicular or parallel to bed joints) fail in a similar manner by internal or set of vertical cracks (see Fig.3 and Fig.4). In case of internal crack appearance the masonry element was divided into two separate leafs.

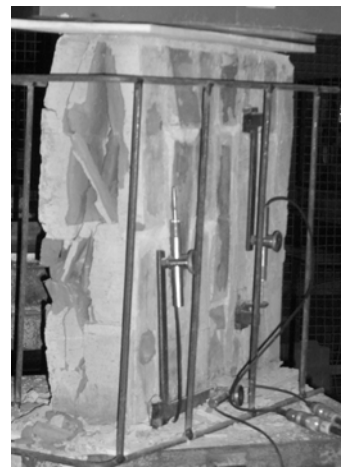
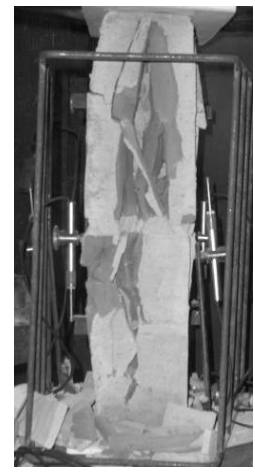
Figure 4 Failure of **H** type model
