STUDY OF A NATURAL RESIN USED AS JOINT FOR THE BRICK MASONRY OF HINDU TEMPLES IN MY SƠN (VIETNAM).

L. BINDA⁽¹⁾, G. ZERBI⁽²⁾, P. CONDOLEO⁽¹⁾, E. MANNUCCI⁽²⁾, C. TEDESCHI⁽¹⁾

⁽¹⁾D.I.S. Politecnico di Milano

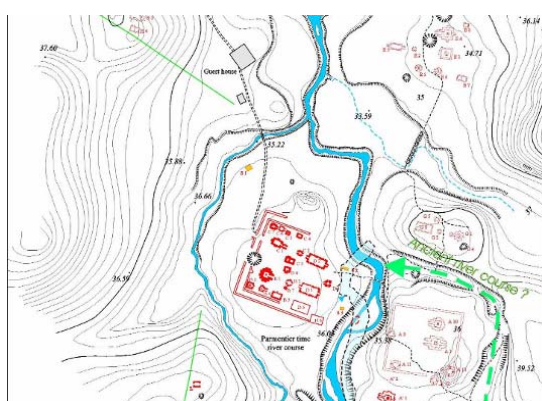
Figure 1. The archaeological area of Mỹ Sơn.

The archaeological area of Mỹ Sơn is situated in Central Vietnam, 30 km South-West from Da Nang; it is located in a valley surrounded by low mountains dominated by the Rang Meo mountain, and it is crossed by the Thu- Bôn river. Mỹ Sơn area (Figures 1 and 2) is 15ha wide and composed by several groups of buildings made with brick masonry, each of them organized around a main temple (*Kalan*). Mỹ Sơn is the most important holy place of the Champa kingdom; the Cham people built here more than seventy buildings, from the 6th to the 14th cent AD, but nowadays only thirty with at least 1m in elevation are still recognizable.

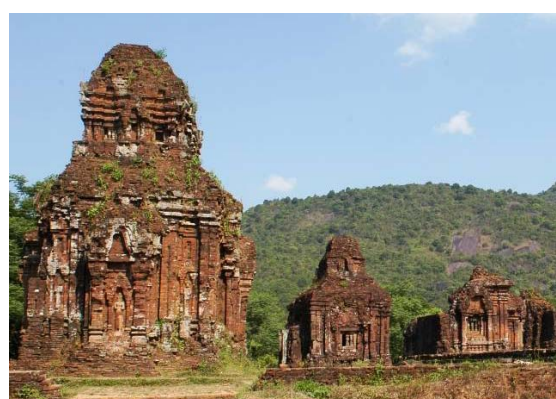
Figure 2. Mỹ Sơn: view of the groups C and D of temples.

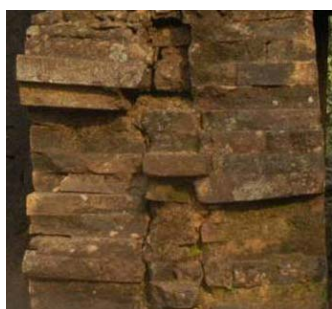
The buildings in Mỹ Sơn were made by fired bricks thinly joined by natural resin. The stone was used as building material only for pillars, lintels and some decoration. The wall section is made of two leaves with small connections or three leaves, externally in bricks and with brick rubble in the middle (Figure 3). The most peculiar characteristic of the brick masonry was the special construction technique which realised the bond between bricks so tight that they did

Figure 3. Section of the wall.

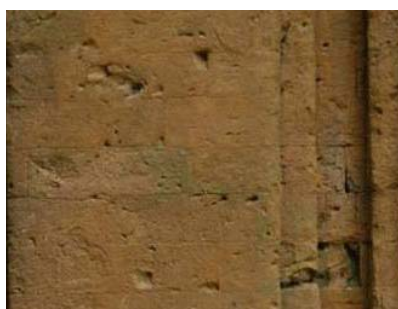
not practically show real joints. The special building technique protects the walls from the affection of the vegetation: where the thin joint is not damaged, there are only very low biological attacks (Figure 4) (Condoleo 2007).

Figure 4: The thin mortar joints in prospect.

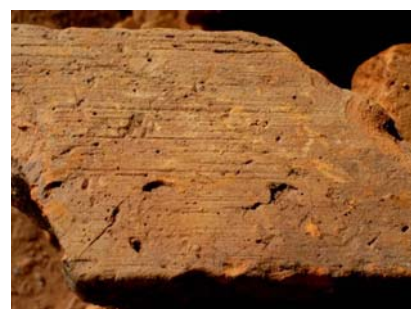
In order to realize a more tight physical bond the technique of *rub-joining* was used during the wall construction before applying the resin. Scratches can be seen on the horizontal and vertical surface of the bricks in contact with other bricks. The scratch can be clearly observed by a magnifier but even by naked eyes (Figure 5) (Bo Xay 2004).

Figure 5. Scratches due to the rub-joining procedure.

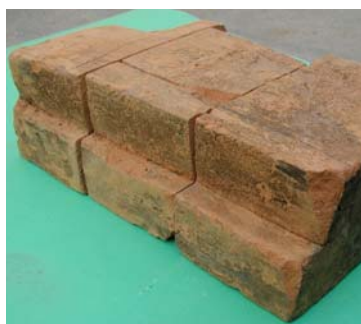
Figure 6. Couplets of bricks stuck together.

Due to the difficulty of sampling without damaging the walls, the number of samples was rather small to be statistically representative of the materials used. Nevertheless the experimental research gave rather reliable results as it will be shown in the next Sections. All the brick samples were taken from the material available on the soil (buildings A1, A13, B9, D4, G1) or on the ruins (E4, E5, E7) in order to avoid spoiling the standing parts of the buildings. When possible, couplets of bricks stuck together by the original joint were collected (Figure 6). Following the hypothesis that the bricks were bond together using an organic binder coming from local trees, samples of vegetal materials were also collected for laboratory research (Figure 7).

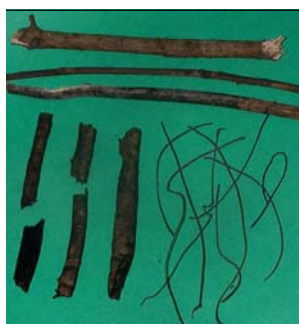
Figure 7. Vegetals collected in Mỹ Sơn in 2000

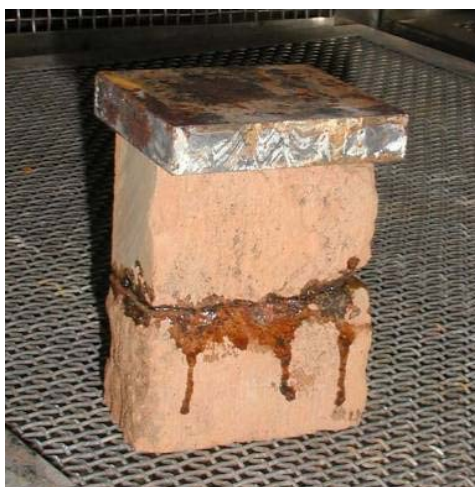
The effectiveness of the second resin coming from Daù Rai tree was tested at DIS Laboratory in Milan, where it was used natural without heating or modifying it. Fourteen specimens made with two portions of bricks from Mý Sơn (80x40x50 mm dimension) (Figure 17) and glued together with the chosen natural resin were prepared and cured under different conditions in order to simulate the local climate in Mý Sơn. Some of the joints were very thin, other thicker in order to test the influence of the thickness variation which can occur on site. After gluing they were left under low compression load for two days. Then they were submitted to different temperature and R.H. in a climatic chamber or also to cycles as listed in Table 2. At the end of the treatments they were submitted to direct tensile tests.

Figure 17. Specimen made with two portions of brick and glued by resin

The testing machine was a servo-controlled hydraulic press of 0.5 t working under displacement control. The test results are also reported in Table 2. The lowest values were reached by specimens with thick joints cured at 20°C and 90% R.H for 60 days and by the specimens cured into water for 60 days, while the highest values were reached by the specimens cured at 30°C and with thin joints. These results were taken into account when applying the resin on site. It can also be observed that the direct tensile strength measured are some specimens was higher than strength measured by the authors on some old masonry with joints based on lime.

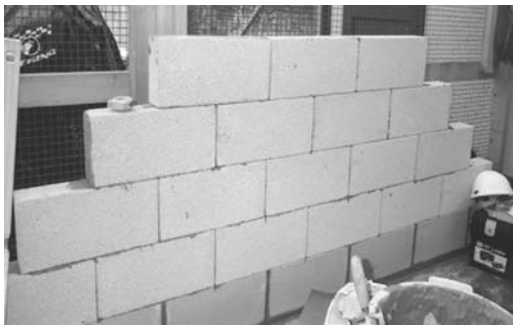
New thin joint mortars have been studied and produced during the last decade in Europe as a mean to join Aircrete and other lightweight blocks and particularly in UK, where the potential benefits of extending the use of thin joints to brickwork have been the subject of recent research at Kingston University (Fried et al. 2005). The experimental research was also applied to dense concrete block masonry for which a tentative to reduce the joint thickness of 3mm by using a glue mortar failed due to the fact that the thin joint could not accommodate variation in the block height (Figure 18). The appealing possibility of using thin glue mortar joints for brickwork was also mentioned even if the possibility of the mortar squeezing into the brick face represents a limit for the application.

Figure 18. New thin joint masonry made with dense concrete blocks and glue mortar.

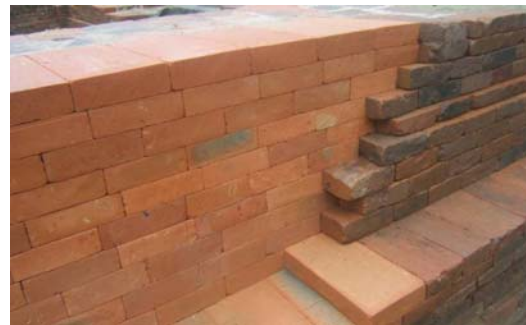
The type of joint found in Mý Son would be so thin if applied to new brick masonry, provided that the brick dimensional variations would be carefully reduced, that no squeezing would occur. In Figure 19 an example of new masonry used as support in the restoration of Mý Son is given. So a future development of the presented research could be the application of resins as a joint to new brickwork. This technique could be applied in humid climates where the natural resin is available or an artificial resin could be synthesized for the purpose.

Figure 19. New masonry in Mý Son used to stabilize the ruins of group G.
