## **6m SPAN LINTELS TESTS ON A NEW WALL PI-BRACKETS TYPE**

**J.M. ADELL<sup>1</sup>, A. GARCÍA-SANTOS<sup>2</sup>, B. LAURET<sup>3</sup>, C. LÓPEZ<sup>4</sup>, H. MARTÍN<sup>5</sup>  
J. PEÑA<sup>6</sup>, M. POL<sup>7</sup>, P. TIMPERMAN<sup>8</sup>, S. VEGA<sup>9</sup>**

<sup>1+2+3+9</sup>*Universidad Politécnica de Madrid. Grupo TISE.* <sup>4</sup>*Instituto Eduardo Torroja*  
<sup>5</sup>*AIA Arquitectura XXI.* <sup>6</sup>*AllWall Systems.* <sup>7</sup>*Halfen-Deha.* <sup>8</sup>*N.V. Bekaert*

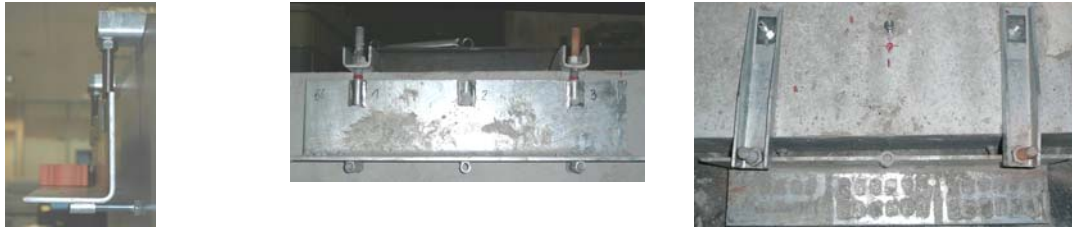
Figure 4 a) Side view of Halfen-AllWall Pi-Bracket with its vertical (Z) and horizontal (Y) adjustments; b) Frontal view; c) View of bracket supporting the first brick in the lintel course.

With this new support, the load of masonry panels in any type of brick or blockwork, may be transferred to the wall supports by means of the braced arch effect provided by reinforced masonry, in accordance with Spanish Murfor Manual calculations and as a result of this new type of patented support (Figures 4a, b and c).

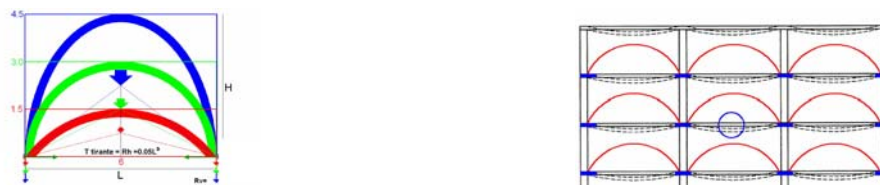
Figure 5 a) Braced arches of different heights all fitted with the same section of steel bracing; b) Braced masonry facing wall set on a framed structure and using the arch effect.

The reinforcement between spaced supports is the same regardless of the height of the arch supported, as the thrust provided by the arch at its base depends on the span and not on the height when considering the load as that of its deadweight: the same bracing is then valid for both reduced linteled arches or raised wall lintels (Figure 5.a). When walls are supported at regular intervals coinciding with the vertical supports, the enclosure assembly no longer loads the slabs and, instead, transfers loads through the vertical supports and prevents defects associated with the deformation of the slabs and their ensuing transfer to the facing wall (Figure 5.b).

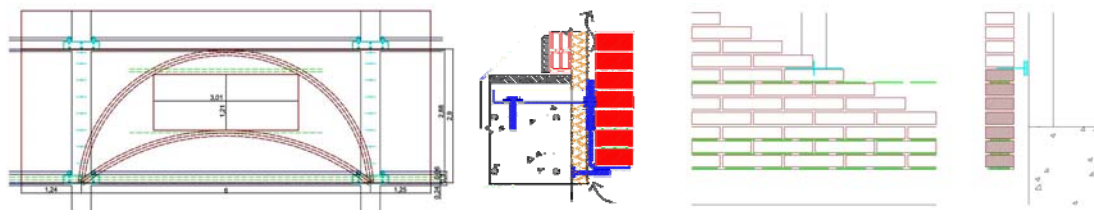
Figure 6. Possible reduced or circular arches for the same bracing set between 2 supports  
Figure 7. Vertical section of the Pi-Bracket, showing continuous, insulated+ventilated cavity.  
Figure 8. Vertical section through the centre of the brick panel at the same level of support.

This has the advantage that in facing walls with openings, the arch formed within the masonry may pass both above and below the opening in a panel of standard floor height and only requires 2 or 3 reinforcements of 5 or 4mm diameter for distances between supports of 6 to 7 m respectively (Figure 6).

The section of the wall support for this type of facing wall has all the necessary adjustment components to provide suitable cavity width and continuous insulation in front of the slab and incorporates reinforcement between the 6m spaced supports (Figure 7). Furthermore, the section of this same wall in the centre of the panel clearly reveals that it is not necessary to support the masonry on account of the “braced arch” effect (Figure 8).

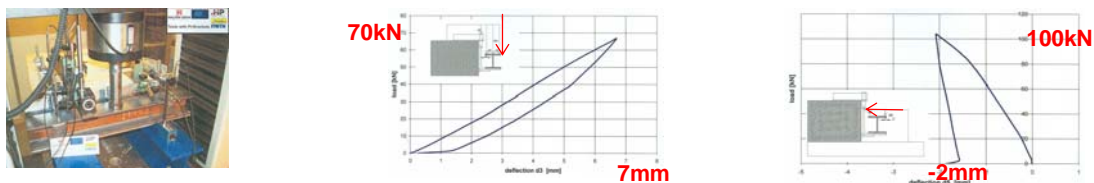
Figure. 9. Testing of one of the three Halfen-AllWall Pi-Bracket prototypes in Germany.  
Figure. 10. a) Graph of vertical deformation “d3”; b) Graph of horizontal deformation “d5”.

The test consisted of vertically loading the brackets by a jack set on an “I” beam profile which uniformly distributed the load on the bracket until reaching the maximum working values and, at the same time, verifying whether support strains were within admissible limits (Figure 9).

Three wall brackets were tested in their normal working position with the brackets fixed on the top of a slab and reacting against the face of the slab. The deformation (strain) recording method is shown in the figures where the values “d0”, “d1”, “d2” and “d3” (Figure 10a) refer to the vertical deformations and values “d4” and “d5” refer to horizontal deformations produced by the moment generated on the application of the load (Figure 10b).

The first two tests reached loads of 66kN, without plastic deformation, and revealed the horizontal reaction of the bolts in the concrete. On reaching maximum deformation load there was evident rotation of the bracket. The third test reached a maximum load of 104kN and caused cracking in the concrete around the supports of the “U” angles and around the horizontal reaction bolts.

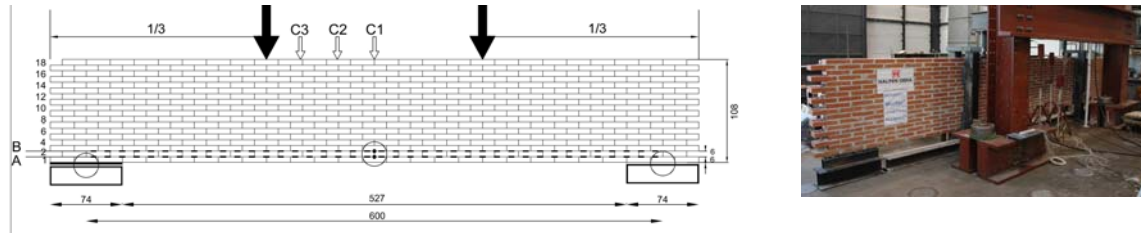
Figure 16: a) 1<sup>st</sup> brick 6m span lintel, simply braced, with A and B Murfor (inox. B800)  
b) 1<sup>st</sup> brick lintel of 6.75x1.08x0.115m, set on Pi Brackets, ready for testing.

The walls were tested for vertical bending using 2 hydraulic jacks with the same load, set at one third span distances from the edge of the wall, in order to simulate the effect of uniform load equivalent to its deadweight. Vertical strain gauges were set on the wall in addition to two extensometric gauges in the centre of each Murfor “A” and “B” truss-type bed joint reinforcement forming the bracing to the brick panel (Figure 16 a y b).

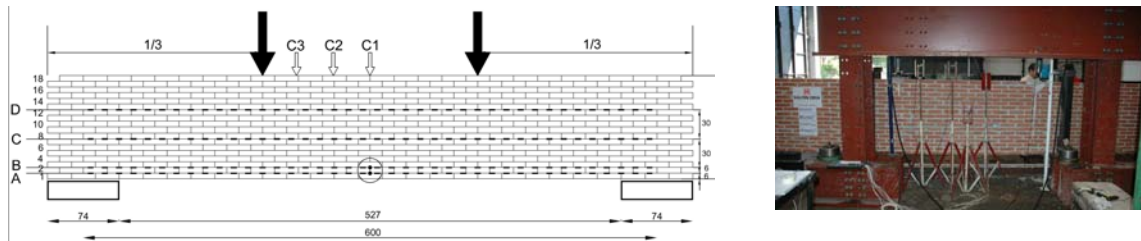
Figure 17: a) 2<sup>nd</sup> brick 6m span lintel, simply braced, with A, B, C and D Murfor (inox. B800)  
b) 2<sup>nd</sup> brick lintel of 6.75x1.08x0.115m, set on Pi Brackets, ready for testing.

The 2<sup>nd</sup> lintel was built with perforated brick of standard quality (M-10) with M8 mortar, reinforced with bed-joint reinforcement (“A” and “B”) and additional uniform reinforcement (“C” and “D”) of Murfor RND.5/S-80 stainless steel (B-800), with brickwork set directly on wall brackets at both sides (Figure 17 a and b).

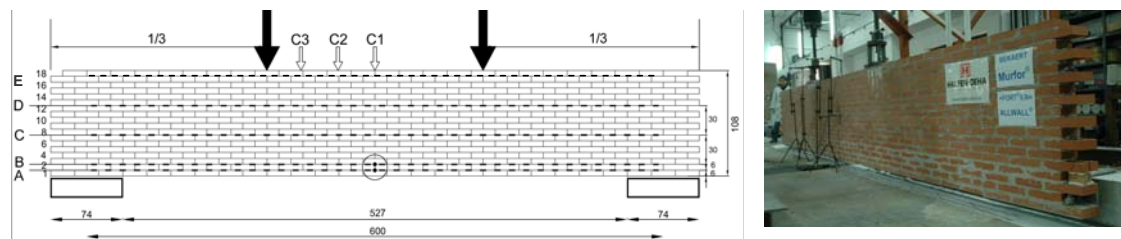
Figure 18: a) 3<sup>rd</sup> brick 6m span lintel, simply braced, with A, B, C, D and E Murfor (galva. B 500)  
b) 3<sup>rd</sup> brick lintel of 6.75x1.08x0.115m, set on Pi Brackets, ready for testing.

The 3<sup>rd</sup> lintel was built with perforated brick wall of standard quality (M-10) with M8 mortar, reinforced with bed-joint reinforcement (“A” and “B”) and additional uniform reinforcement (“C”, “D” and “E”) of Murfor RND.5/Z-80 standard galvanized steel (B-500), with brickwork set directly on wall brackets at both sides (Figure 18 a and b).

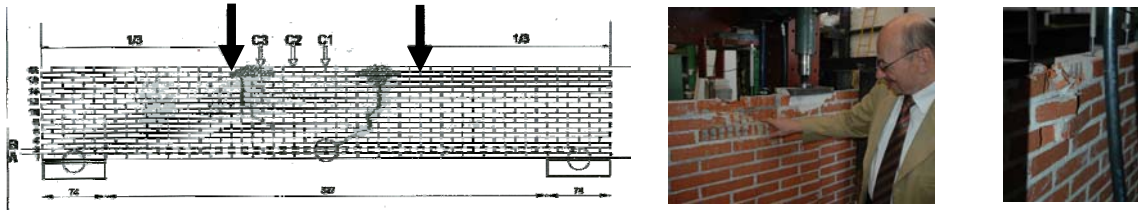
Figure 19. Failure due to horizontal compression of the 1<sup>st</sup> tested brick lintel (2 inox. B 800).  
Figure 20. View of collapsed brickwork after testing: a) At the left jack; b) At the right jack.

The test on the 1<sup>st</sup> wall (with only 2 stainless steel bed joint reinforcement as a brace) (inox. B800) was satisfactory in accordance with the safety margins established for the materials. The first lintel to be tested failed by compression in the direction of the bed joints in the upper central third close to the jacks, without reaching the breaking stress of the reinforcement of the lower brace (Figure 19). The crack in the centre of lintel in the tensile area barely exceeded 1 mm and the overall cohesion of the wall was retained (Figure 20 a and b).

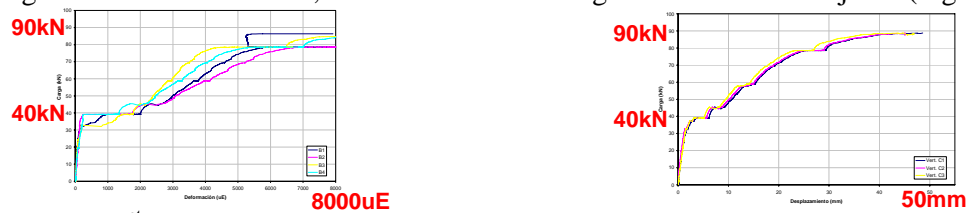
Figure 21: 1<sup>st</sup> Test: a) Stress-strain diagram of extensometric gauges (B1, B2, B3, B4) set on reinforcement; b) Readings of the vertical displacement load recorded by LVDTs (C1, C2, C3).

The stress strain diagrams corresponding to the extensometric gauges set on bed joint reinforcement (B1, B2, B3, B4, B5) of the 1<sup>st</sup> test, show that these work almost in unity until the loss of mortar bond, and do not indicate potential reinforcement failure (Figure 21.a). The LVDTs placed to record vertical strain (C1, C2, C3) deformed together until reaching the cracking stress of the brickwork, at around 40kN loading on each of the two jacks (Figure 21.b).

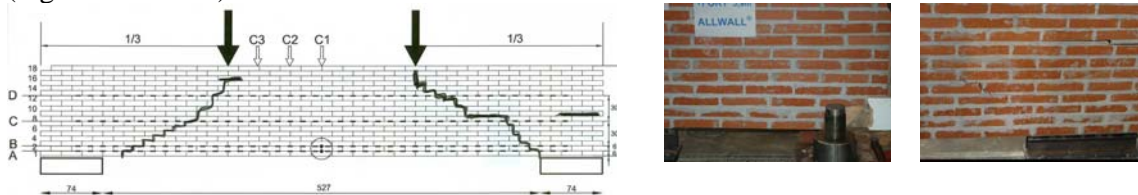
Figure 22. Type of shear failure of the 2<sup>nd</sup> tested brick lintel (4 Inox. B 800).  
Figure 23. View of collapsed lintel after testing: a) left shear crack; b) right shear crack.

The test on the 2<sup>nd</sup> wall (with 4 stainless steel bed joint reinforcement) (inox. B800) was totally satisfactory in accordance with the safety margins established for the materials. The 2<sup>nd</sup> lintel tested failed by shear in 45° direction from the laterals supports, without reaching the breaking stress of the reinforcement of the lower brace (Figure 22). The crack in the centre of lintel in the tensile area barely exceeded 1 mm and the overall cohesion of the wall was retained (Figure 23 a and b)

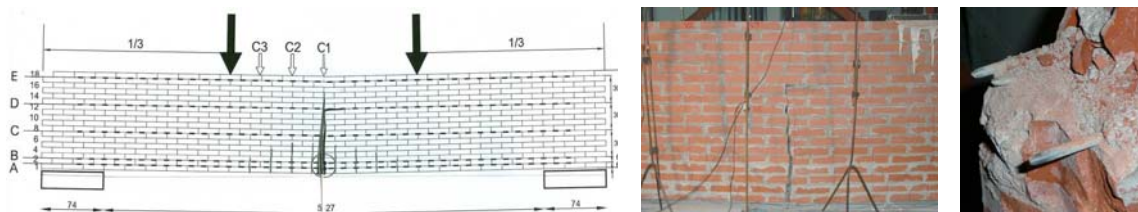
Figure 24. Shear failure of the 3<sup>rd</sup> tested brick lintel (5 galva. B 500).  
Figure 25. View of collapsed lintel after testing: a) central crack; b) reinforcement detail.

The test on the 3<sup>rd</sup> wall (with 5 stainless steel bed joint reinforcement) (galva. B500) was totally satisfactory in accordance with the safety margins established for the materials. The 3<sup>rd</sup> lintel tested failed by traction in the bottom in the centre of the lintel, reaching the breaking stress of the reinforcement of the lower brace (Figure 24) (Figure 25 a and b).

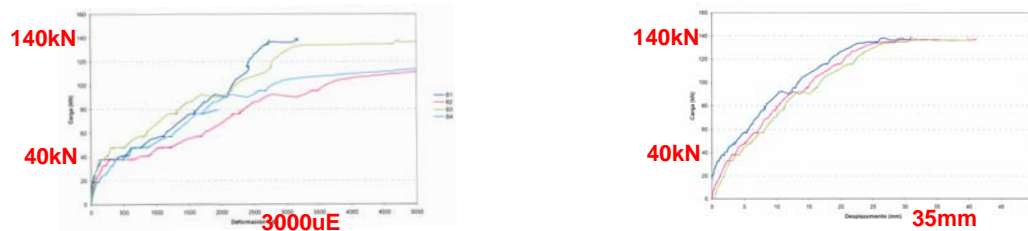
Figure 26: 3<sup>rd</sup> Test: a) Stress-strain diagram of extensometric gauges (B1, B2, B3, B4) set on reinforcement; b) Readings of the vertical displacement load recorded by LVDTs (C1, C2, C3).

The stress strain diagrams corresponding to the extensometric gauges set on bed joint reinforcement (B1, B2, B3, B4, B5) of the 3<sup>rd</sup> test show that these work almost in unity until the loss of mortar bond, and do not indicate potential reinforcement failure (Figure 26.a). The LVDTs placed to record vertical strain (C1, C2, C3) deformed together until reaching the cracking stress of the brickwork, at around 140kN loading on each of the 2 jacks (Figure 26.b).
