IN-PLANE CYCLIC TESTS OF CALCIUM SILICATE MASONRY WALLS

GUIDO MAGENES and PAOLO MORANDI

Department of Structural Mechanics, University of Pavia and EUCENTRE
Pavia, Italy

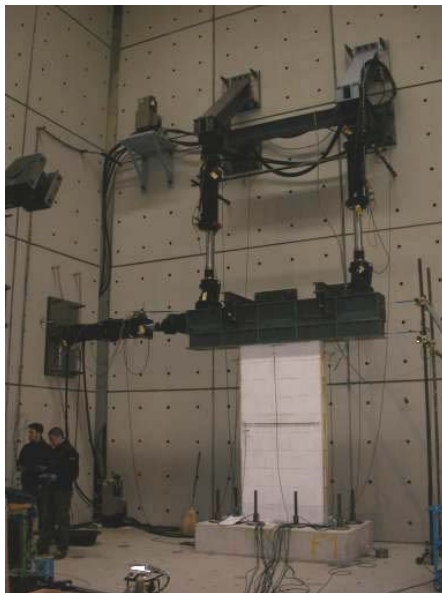
a)

The adopted test setup is shown in Figure 1(a). The walls are built on a 400 mm thick reinforced concrete footing which could be clamped to the strong floor by means of post-tensioned steel bars. A horizontally mounted servohydraulic actuator applies a horizontal shear force to the top of the wall through a composite steel spreader beam. The steel beam is stiffened with steel plates positioned orthogonally to the development of the beam. The wall is restrained from out-of-plane deflections by a sliding restrainer system. Two vertical servohydraulic actuators apply the vertical load on the wall, reacting on a steel frame fixed on one of the strong walls of the laboratory.

Figure 1. Test set-up and instrumentation

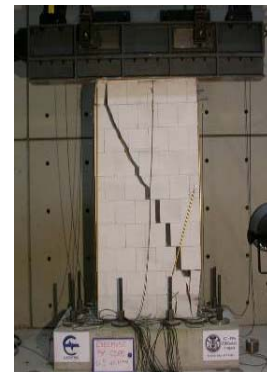
Figure 7 Wall CS05. Double fixed, $l=1.25$ m, $\sigma_v=1.0$ MPa, filled head joints

Wall CS05 remained undamaged, with the exception of some tension cracks in bedjoints, up to a horizontal top displacement of 35 mm. When this displacement level was exceeded, the wall failed suddenly in shear with the development of a diagonal crack formed in the mortar bedjoints and in the units. Before this damage, the force-displacement curve presented “S-shaped” cycles without any relevant energy dissipation, similar to a typical rocking behaviour.

Although wall CS05 was constructed and tested with the same characteristics of wall CS01 and wall CS02, head joints filled by mortar allowed to attain a larger displacement capacity in comparison with the displacements found in the tests on wall CS01 and wall CS02.

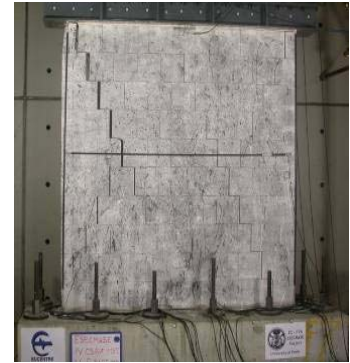
Figure 9 Wall CS07. Double fixed, $l=2.50$ m, $\sigma_v=1.0$ MPa

Wall CS07 was characterized by a force-displacement response typical of rocking failure. At a horizontal displacement of about ± 17 mm the opening of the unfilled head joints was very evident. Cracking of bedjoints concurred to form a system of stepped diagonal cracks along the wall. These cracks closed during unloading. The hysteresis cycles showed very low energy dissipation and no strength degradation since no cracks in the units or sliding in bedjoints occurred. The test was interrupted when the top displacement was 30 mm (1.2% drift) because very wide vertical cracks in the joints had developed and separation of a large wedge of masonry took place, with the danger of a partial collapse of the wedge itself.

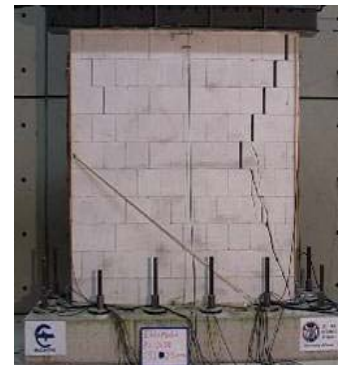
Figure 10 Wall CS08. Cantilever, $l=2.50$ m, $\sigma_v=1.0$ MPa

Wall CS08 had same geometric characteristic and same vertical load of wall CS07 but it was tested as a cantilever system. At a horizontal displacement of about ± 12 mm opening of the unfilled head joints became visible to form stepped inclined cracks along the height of the wall. Low energy dissipation and no strength degradation occurred. Cracks closed during unloading. Rocking-type response of the wall was displayed. Beyond a top displacement of 20 mm several diagonal cracks in the units of the right bottom half part of the wall developed and in these last cycles a slightly higher energy dissipation was displayed.
