FIRE RESISTANCE TESTS OF BRICK VENEER / WOOD FRAME WALLS

J. GREGG BORCHELT

JOHN SWINK

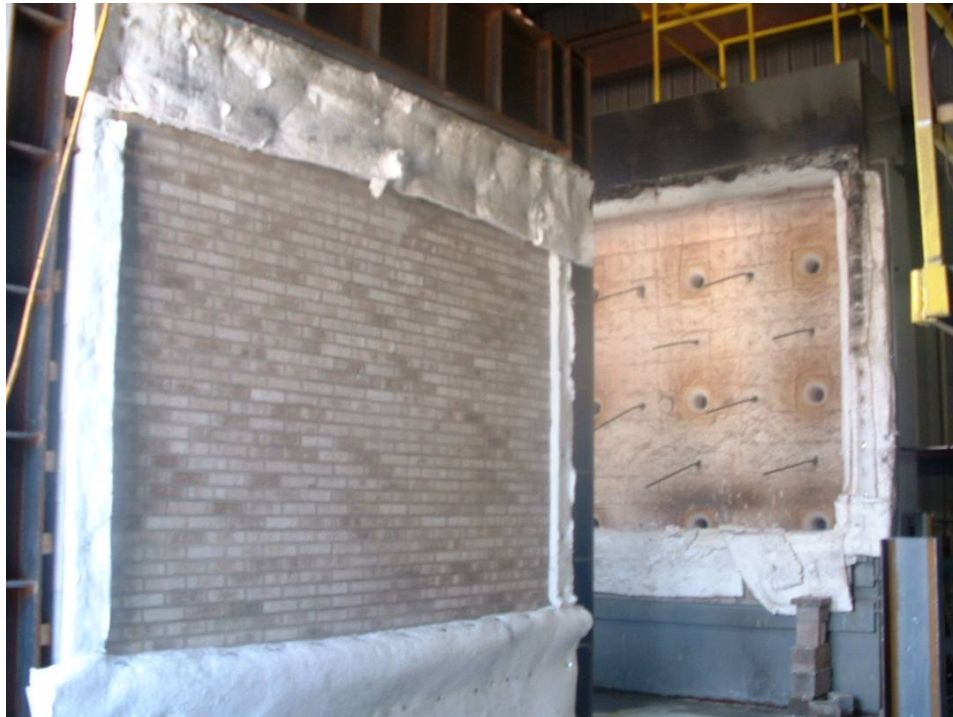
Figure 1. Wall of Brick 2 in Frame, Being Moved to Furnace

This test method requires wall specimens of at least 9.3 m² (100 ft²). The wall assembly is built in a steel frame and the frame and wall assembly are positioned as one wall of a gas-fired furnace. See Figure 1. The fire exposed face is not visible during the test. If tested wall is designated as a load-bearing assembly the prescribed load is applied with jacks to the top of the load-bearing portion of the wall.

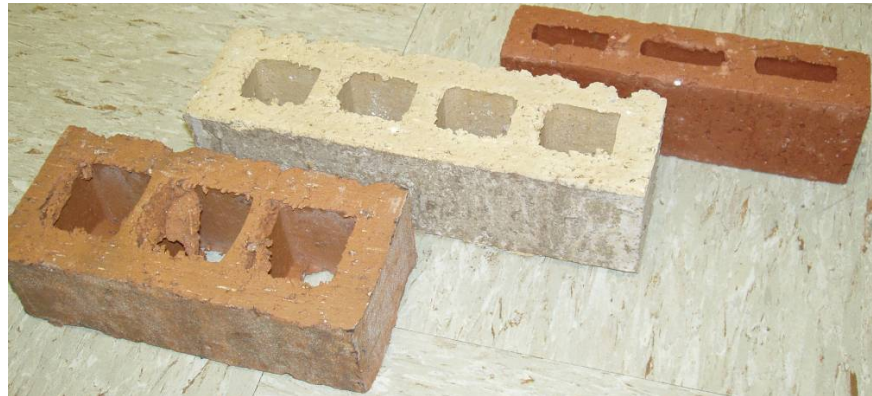
Figure 2. Brick 1, 2 and 3, from left to right

Each of the three brick veneers tested was built of brick with different widths and coring percentages. See Table 1 and Figure 2. Brick 1 and 2 were from commercial construction. Brick 3 was made as a special run at a brick plant and is purposely less than the 50 mm (2 in) minimum thickness permitted by the International Residential Code. Each of the brick is classified as meeting the requirements of ASTM International C 652, *Standard Specification for Hollow Brick*, Grade SW (ASTM 2006b).

Brick Designation	Width, mm (in)	Height, mm (in)	Length, mm (in)	Void Area, %	Equivalent Thickness, mm (in)
1	90 (3.5)	57 (2.25)	190 (7.5)	34.5	58 (2.3)
2	73 (2.87)	64 (2.5)	241 (9.5)	36.5	46 (1.8)
3	44 (1.75)	57 (2.25)	197 (7.75)	26.9	32 (1.3)

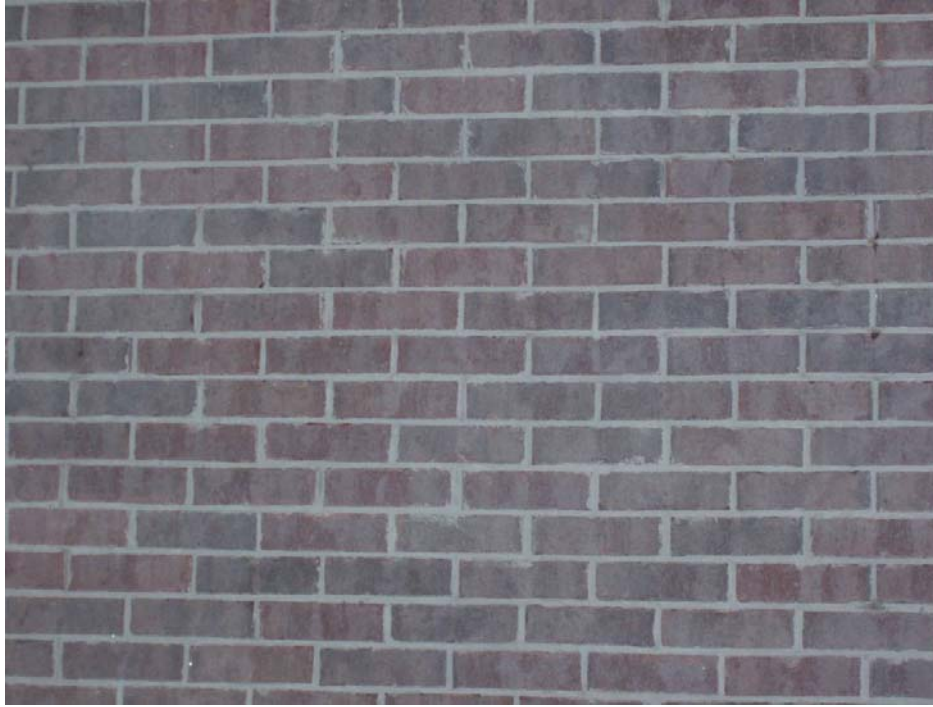
Figure 3. Veneer of Brick 1 after Fire Exposure for 1 Hour and Hose Stream

The fire exposed face of Brick 1 veneer, after both the fire test and the hose stream, is shown in Figure 3. The maximum temperature rise on any of the thermocouples was 10.6 degrees C (19 degrees F) and the average of all thermocouples was 9.4 degrees C (17 degrees F). The hose

stream was conducted for 65 seconds. The wall assembly did not allow passage of water. There was no visible cracking in the veneer prior to or following the hose stream. After the wall cooled slight mortar loss in a few head and bed joints was noticed.

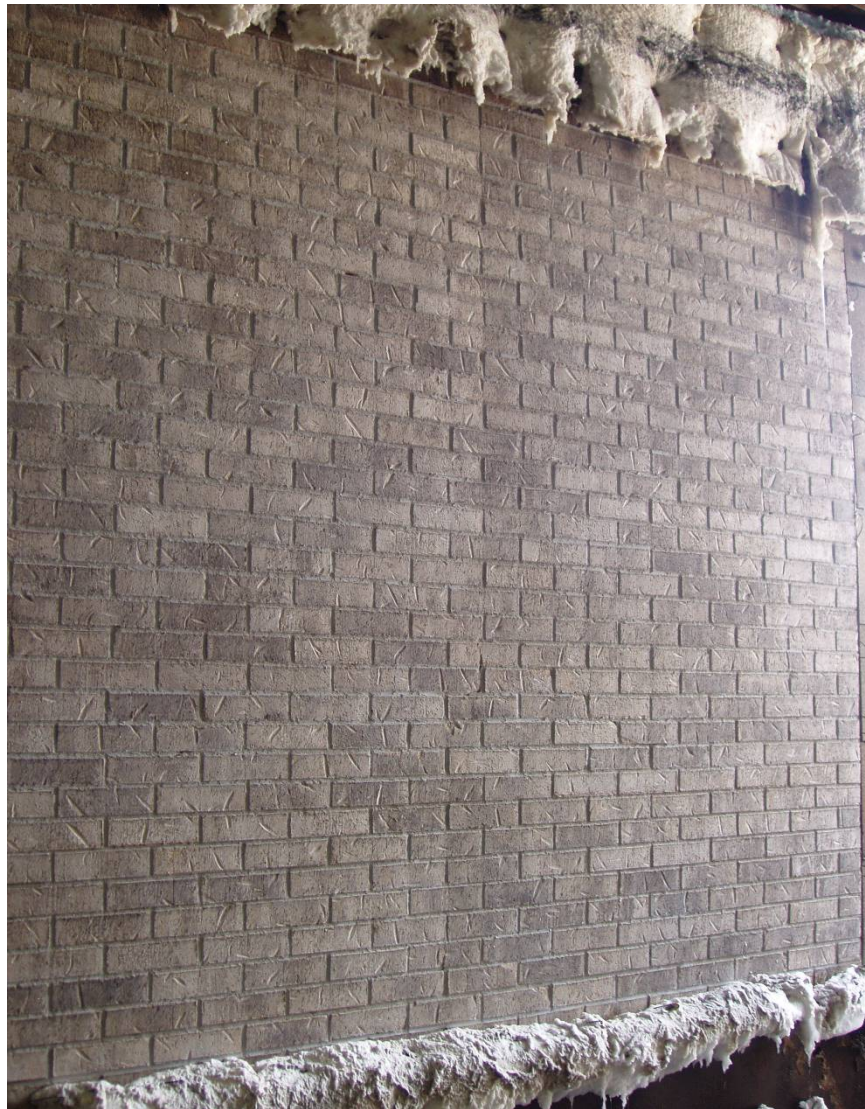
Figure 4. Veneer of Brick 2 after Fire Exposure for 1 Hour and Hose Stream

The fire exposed face of Brick 2 veneer, after the hose stream application, is shown in Figure 4. There was visible bowing of the plane of the veneer and a vertical crack about 380 mm (15 in.)

long, extending down from the top center of the veneer prior to the hose stream. The maximum temperature rise on any of the thermocouples was 11.7 degrees C (21 degrees F) and the average of all thermocouples was again 9.4 degrees C (17 degrees F). The hose stream was conducted for 65 seconds. The wall assembly did not allow passage of water. The building paper had a slight embrittlement and the OSB was slightly charred near the crack. There was minor loss of mortar from one bed joint, approximately 50 mm (2 in.) long. The maximum temperature rise registered by the thermocouples on the OSB was 128 degrees C (231 degrees F).

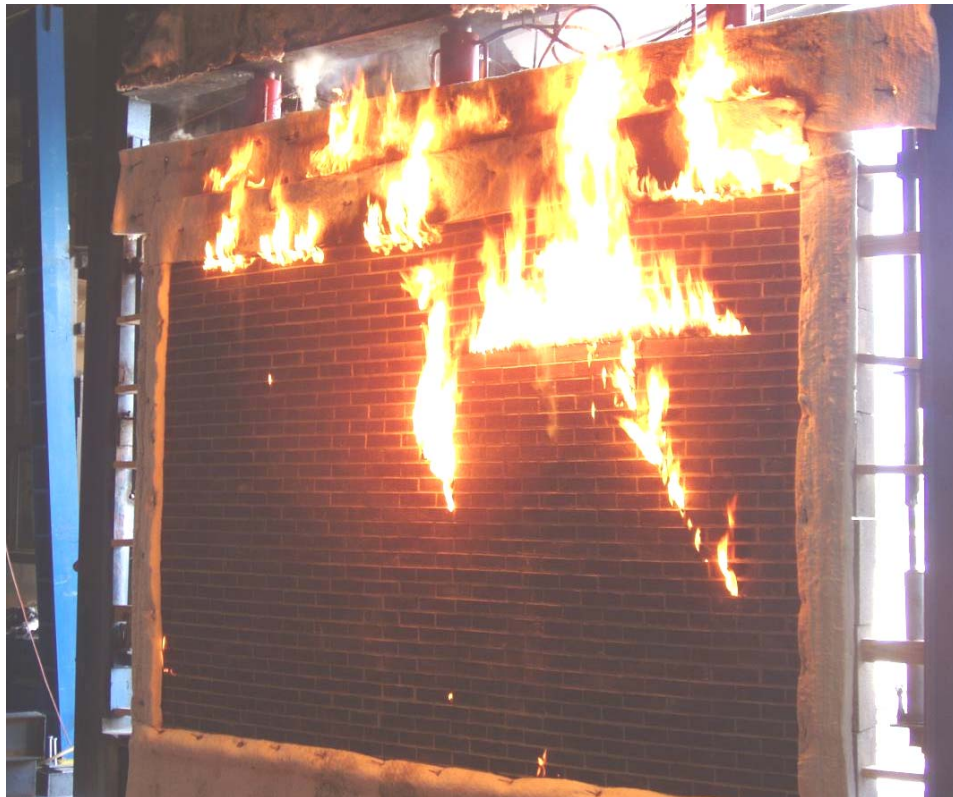
Figure 5. Veneer of Brick 3 after Fire Exposure for 1 Hour

The fire exposed face of Brick 3 veneer, prior to the hose stream, is shown in Figure 5. The veneer experienced several horizontal, one vertical and one diagonal cracks near the top of the veneer wythe after the fire test. The maximum temperature rise on any of the thermocouples was 32 degrees C (57 degrees F) and the average of all thermocouples was 26 degrees C (47 degrees F). The hose stream was conducted for 65 seconds. The wall assembly did not allow passage of water. The veneer remained intact through the hose stream application. Portions of the building paper had burned; the OSB was burning and charred in many locations. The maximum temperature rise registered by the thermocouples on the OSB was 390 degrees C (702 degrees F).
