ESECMASE – SHAKING TABLE TESTS AT THE NATIONAL TECHNICAL UNIVERSITY IN ATHENS

SUMMARY

This paper presents preliminary results of shaking table tests on two-storey high specimens representing cut-outs of typical terraced houses in low seismicity regions in Central Europe.

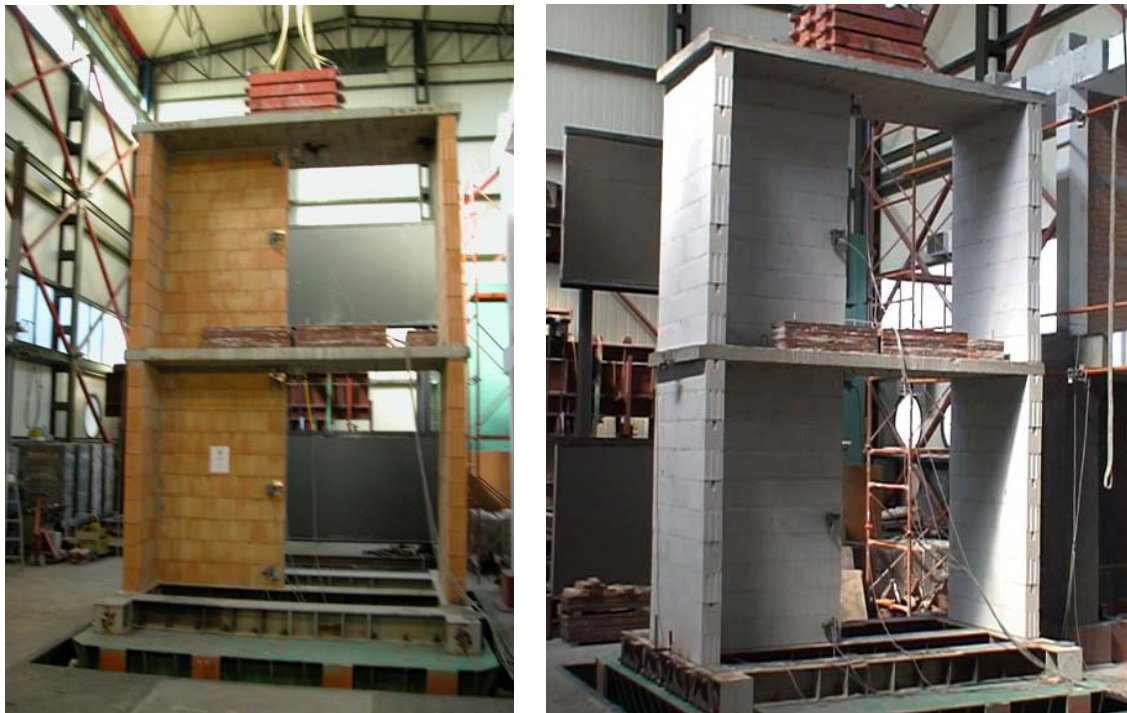
Figure 2. View of two specimens, clay units type HLz 12 (left) and calcium silicate units type KS-R P 20-1,8 6 DF (right)

The investigations were carried out using two storey high specimens representing a cut-out of a terraced house adopted to the dimensions of the available shaking table (see figure 1). Figure 2 shows two of the tested specimens.

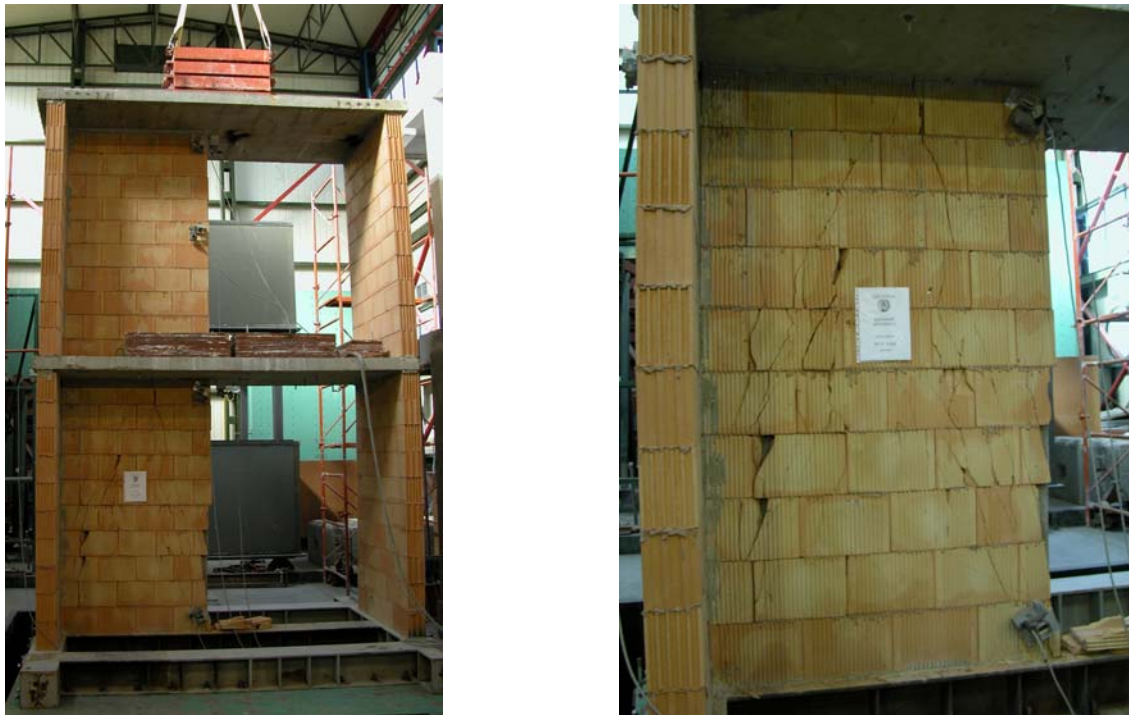
Figure 6 Specimen B3 (shear wall hollow clay units with concrete infill and frame reinforcement) after the cycle with a nominal ground acceleration of 2,6 m/s² Overview (left) and shear wall on ground floor (right)

All tested specimens were capable to carry the applied vertical load after the last test cycle. Figure 6 shows an overview and the ground floor shear wall of specimen Nr. B3 (hollow clay units with frame reinforcement) after the test cycle with a nominal ground floor acceleration of $\text{nom } a_g = 2,6 \text{ m/s}^2$. Significant cracking only occurred in the ground floor walls, the walls in the storey above are more or less uncracked.

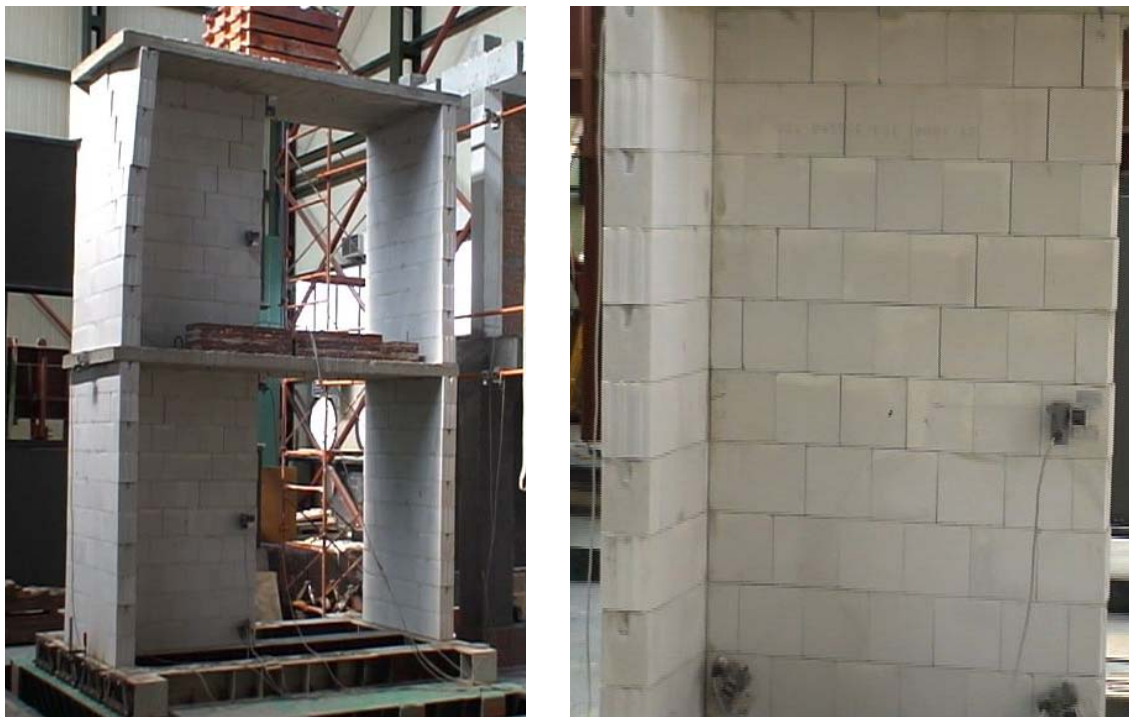
Figure 7. Specimen A1 after a simulated earthquake with a nominal ground acceleration of 1,6 m/s²; Overview (left) and shear wall on ground floor (right)

The failure of the specimens was not in all cases caused by a shear wall failure but, especially in the case of the calcium silicate specimens by a failure of the transverse walls on first floor.

The failure was caused by an uplift of the ceiling due to the shear wall displacement and a resulting lack of vertical load on the transverse walls, especially on first floor. The transverse walls were consequently free cantilevers fluttering and colliding with the shear walls. This failure mode is not likely to occur in real building situations as the uplift of the ceiling will be restricted to a limited area and the remaining length of the transverse walls will restrain the fluttering tendencies in the area of the shear wall.

Figures 7 and 8 show the specimens A1 and A2, both specimens without vertical reinforcement after the cycle with a nominal ground acceleration of $a_{g,max} = 1,6 \text{ m/s}^2$. Figure 7 shows the failure of the upper transverse wall described above, caused by a collision of this transverse wall with the shear wall in first floor. The cracks in the shear walls followed the joints, the calcium silicate units were more or less undamaged, see figures 7 and 8 (right).

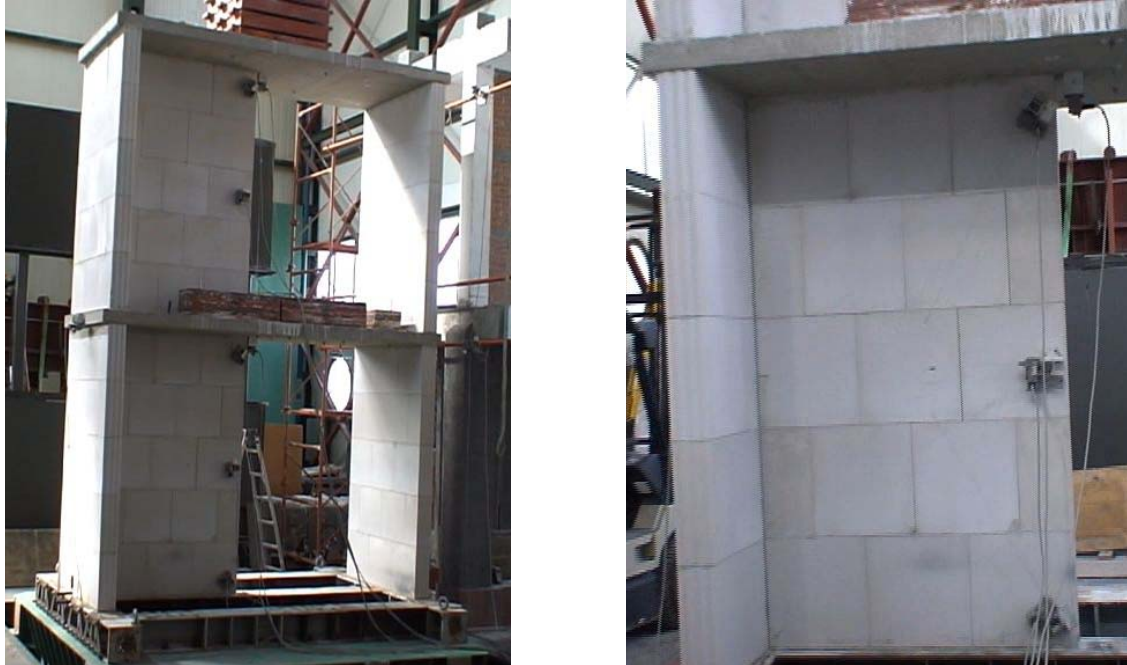
Figure 8. Specimen A2 after a simulated earthquake with a nominal ground acceleration of $1,6 \text{ m/s}^2$; Overview (left) and shear wall on ground floor (right)
