## **INVESTIGATION INTO THE SUITABILITY OF INDUSTRIAL FIXING SYSTEMS FOR THE REPAIR OF HISTORIC MASONRY**

B. GIGLA; Prof. Dr.-Ing., Professor  
F. SCHLESINGER; Dipl.-Ing., M. Eng., Research Assistant  
IfAB, University of Applied Sciences Lübeck, Germany

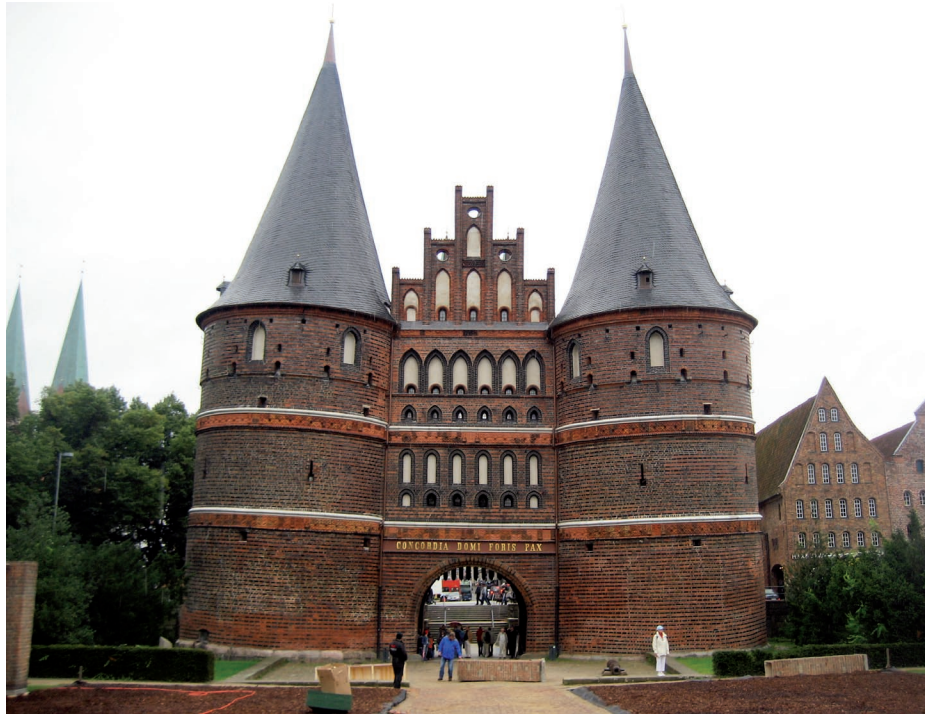
Figure 2: Holstentor Lübeck, Aug. 2007 (town gate, built between 1464 and 1478)

Germany's national monument Holstentor (town gate) in Lübeck was built in brick masonry between the years of 1464 and 1478, as a part of the city's fortification. It consists of two round towers with a diameter of 12 m and a wall thickness of up to 4.00 m. The towers are 40 m high and are connected with a gate-house (fig. 2). On account of the weak ground, progressive and uneven settlement appeared affecting the whole building and reached a final value of about 4.00 m in the year 1934. Beginning in the 19<sup>th</sup> century, the Holstentor was no longer essential for the city's defence. Furthermore, the forthcoming railway system demanded new areas and a demolition of the building was discussed. After years of discussions, the city council decided in the year 1863 to preserve and restore the Holstentor as a historic site. Thereafter, it became one of the first officially protected monuments in Germany. In the meantime, it is one of the most popular national monuments. It is depicted on a banknote, on a new 2€ coin, and is used as a symbol for the conference of German municipal authorities (*Deutscher Städtetag*).

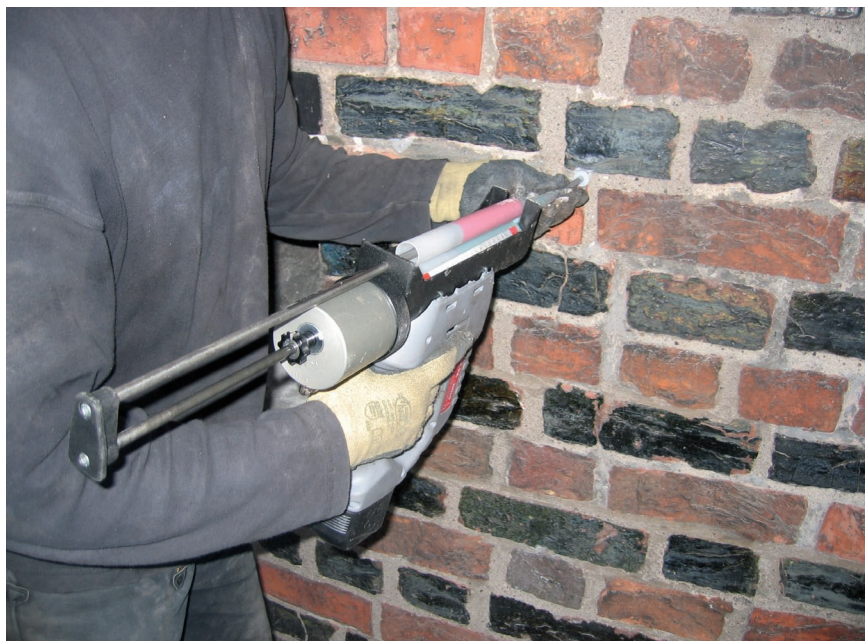
Figure 5:

Grouting of an industrial fixing system (wall tie Fischerwerke VBS 8) on Holstentor Lübeck

For construction, the anchor is placed in the bed joint of the outer leaf and inserted into an 8 mm hole. It is suitable for bridging air gaps and insulation layers up to 150 mm with a required minimum bond length in the outer leaf of 90 mm. The whole system comes in one unit (fig. 5).

Grouting is done with a system of specially perforated capsules, joined by a static mixer and an injector nozzle. The system ensures, that no grout is applied inside the gap between both leafs. Mixing is done automatically during grouting. After grouting, the tie is manually inserted into the fresh grout. Polymerisation time is specified by the manufacturer to be 35 minutes at 20°C.

The application of the VBS 8 wall tie at the Holstentor took place, after the consultants resigned from the contract. The wall ties were placed around the complete façade in a grid of 60 cm into the bed joints. Fig. 5 shows a picture of the grouting works on the Holstentor. During the grouting works, FIS HB mortar was used instead of FIS V. Chemical mortar FIS HB from Fischerwerke AG is similar to FIS V, but consists of only one methacrylate and does not contain Portland cement. The FIS V-mortar is not approved for anchoring the VBS 8 wall-tie.
