# **THE USE OF RADAR TECHNIQUE AND BOROSCOPY IN INVESTIGATING HISTORIC MASONRY: APPLICATION OF THE TECHNIQUES IN BYZANTINE MONUMENTS IN GREECE**

This paper summarizes the results obtained from the application of two investigation techniques, namely radar and boroscopy, in the masonry of three Byzantine Monuments in Greece. The techniques were applied to investigate the type of construction and the presence of timber ties in the masonry. The application of the two techniques proved to be efficient, as their results provided reliable information regarding both the thickness of stones, and the presence and the state of timber ties. In the paper, problems encountered and constraints related to the application of the techniques are commented upon.

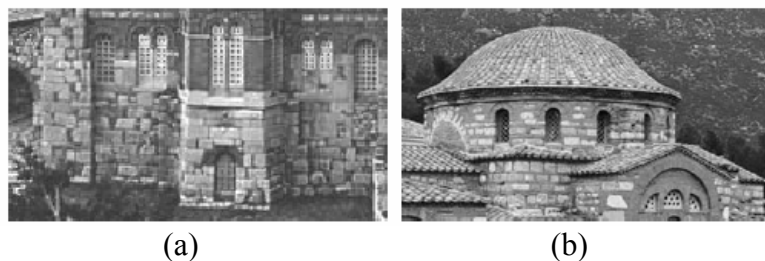
Figure 7. Katholikon of Osios Loucas Monastery: (a) Lower and (b) Upper zone of masonry.

The three-leaf masonry of the Katholikon in Osios Loucas Monastery consists of two zones (Figure 7): The upper zone is made of smaller dimension stones than the lower one. In the outer leaf of the walls, which is unplastered, trial measurements were made in regions where the geometry of the stones is known (e.g. in the corners of the walls). The results were satisfactory (Figure 8a), and allowed for adequate settings for the radar.
