ENHANCEMENT OF GEO-ELECTRICAL TECHNIQUES FOR NDT OF MASONRY

SUMMARY

CASE STUDY: MAAGDENTOREN ZICHEM (B)

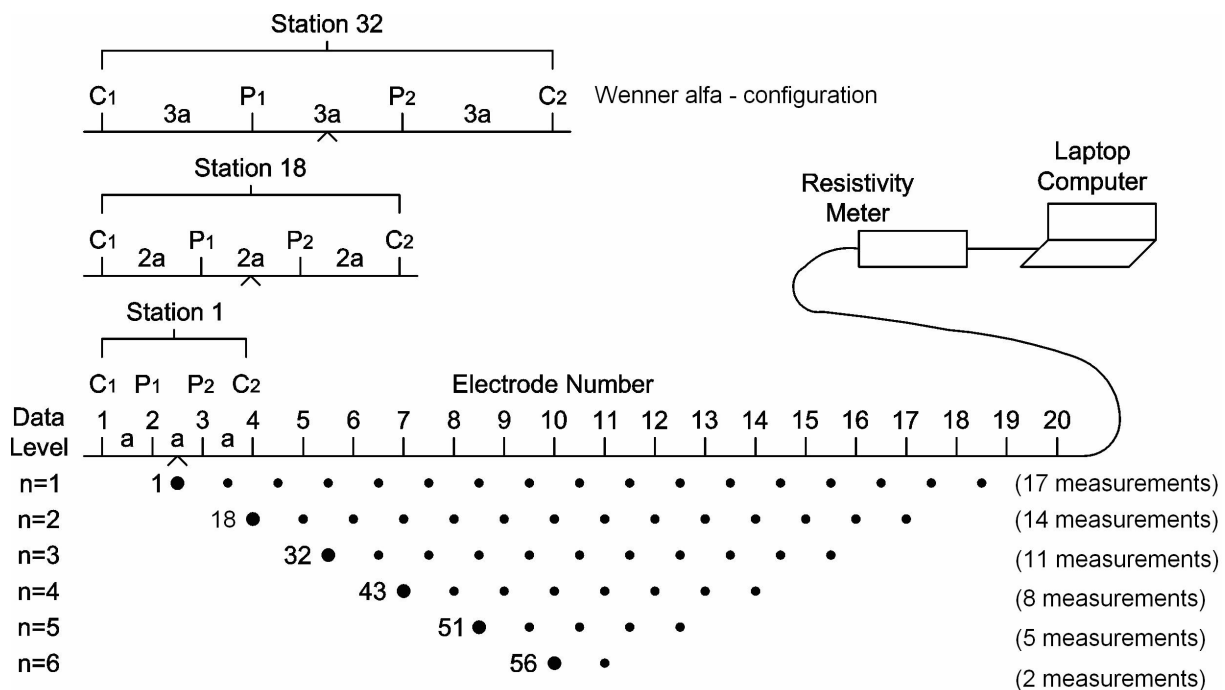
Figure 1: 2D geo-electrical tomography; Wenner-alfa electrode-configuration; subsequent measurements for building a pseudo-section

The technique is known in geophysics as geo-electrical tomography. Figure 1 shows the necessary measurements for a Wenner-alfa electrode-configuration with 20 electrodes. Each of these electrodes, mostly stainless steel nails, can be used to inject current (current electrodes C1, C2) or to measure potential (potential electrodes P1,P2). Conducting the first row of measurements, a distance “a” ($n = 1$) between C1P1, P1P2, P2C2 is kept constant, leading to 17 (20-3) measurements on this particular row. Raising the electrode distance to “2a” ($n = 2$) gives a bigger influenced zone of the masonry (i.e. more profound penetration of the potential field), resulting in an apparent resistivity value representative for a larger and deeper zone of the masonry. Conventionally, this apparent resistivity value is allocated to a physical point, centrally located between the four electrodes and on a depth equal to the average depth of the influenced zone of the potential field. Note that the second row of measurements (with an electrode distance “2a”) has only 14 (20-2×3) measurements. The number of measurements decreases with augmenting electrode spacing (i.e. higher penetration depth). In this way apparent resistivity values are gathered over the depth of the masonry structure and a “pseudo-section”, which is the graphical representation of the measured apparent resistivity values, is built.

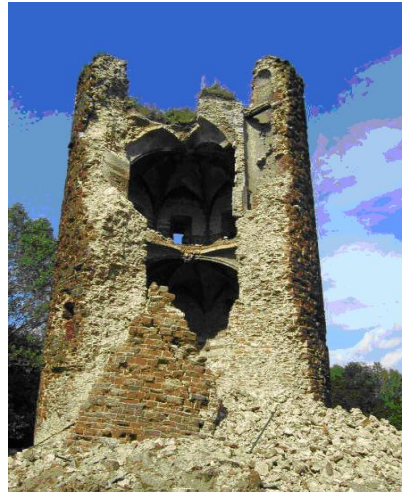
Figure 2: after the collapse on June 1st, 2006

A series of necessary repairs were executed in 1863 and 1905. After that, the tower deteriorated for the rest of the century, resulting in a partial collapse of a part of the outside parement in 1995. The biggest catastrophe occurred on June 1st, 2006, when a huge part of the outside wall collapsed (see Figure 2).

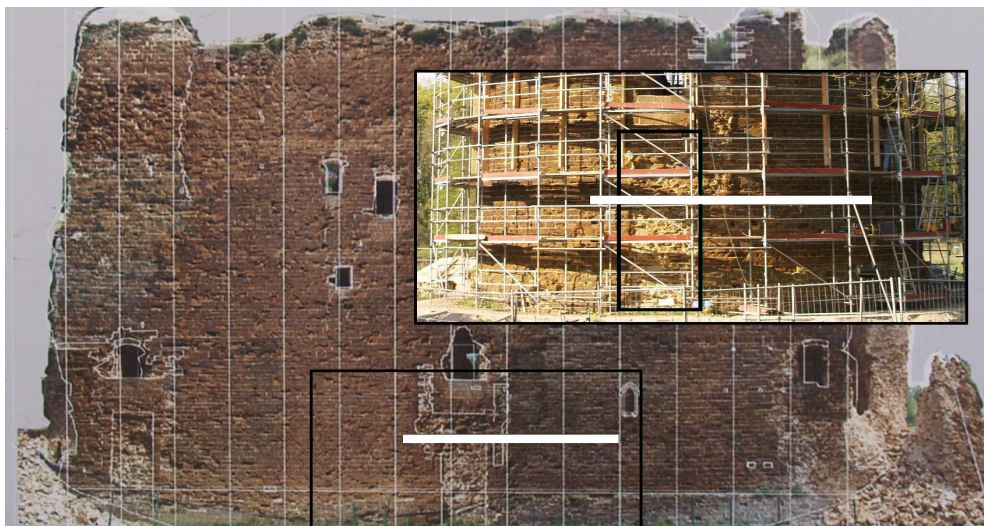
Figure 3: position of the survey line on the tower

Insert: detail with in white the position of the electrodes and in black the position of the historic defence platform, removed in an unknown past

Figure 3 shows the location on the tower where a dipole-dipole electrode configuration was used to perform a geo-electrical tomography (white line). The survey line of the tomography was deliberately partially placed over a visually good looking part of the wall and a bad looking zone. This visually bad looking zone is caused by the demolition of an historic defence platform that was situated there (see Figure 3).

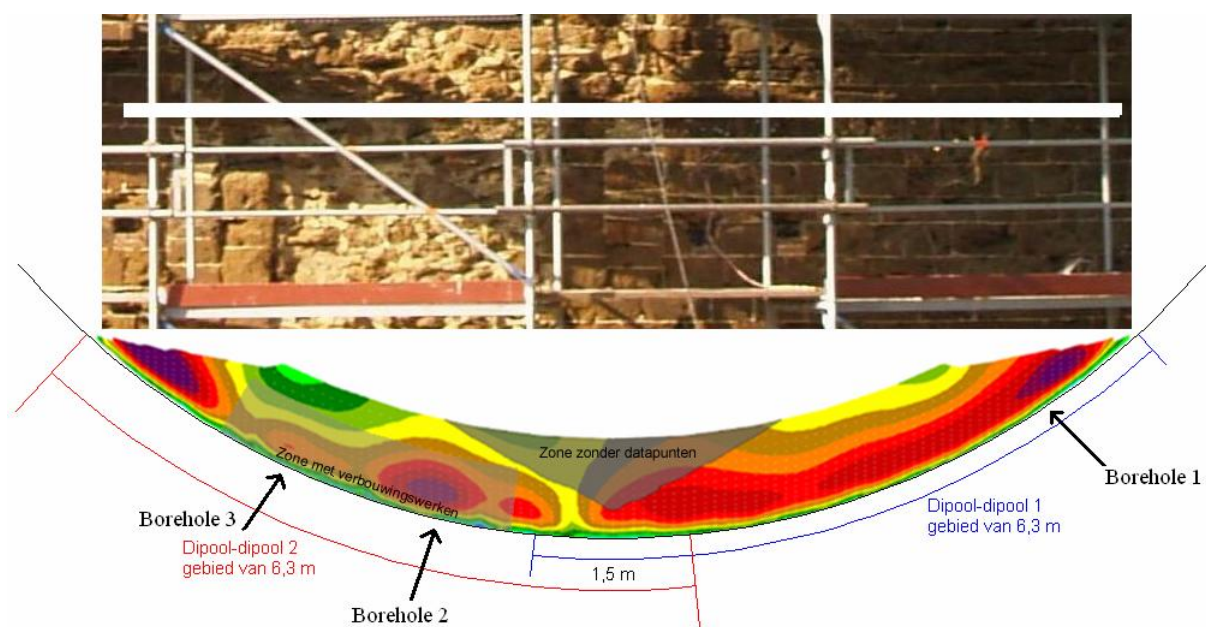
Figure 4: Above: position of the electrodes on the wall (white line)
Below: inversion result of dipole-dipole measurements and the location of the boreholes for the endoscopic survey

Figure 4 shows the inverted section of the measured survey line, using the dipole-dipole electrode configuration. Remark that the inversion result does not lead to the same conclusions as would be drawn from a visual inspection of the surface only. A dark colour represents a high electrical resistivity, meaning a deteriorated zone in the masonry. From the outside visually good looking zones of the masonry show high resistivity values on a depth of 30 to 40 centimetres on the tomography. This depth corresponds with the thickness of the outer leaf of the wall. These high resistivity values continue over a thickness of 50 to 60 centimetres. After that the resistivity values decrease, meaning less deteriorated and less eroded masonry. This conclusion was verified with an endoscopic (borehole 1) examination. The following damage mechanism can explain this phenomenon. The ferruginous sandstone of the outer leaf absorbs rainwater like a sponge. This water penetrates the outer leaf by capillary forces, wetting the inner core of the three leaf masonry and dissolving lime from the mortar. When the wall dries, leaching of the dissolved lime from the inner core takes place. After several centuries, this led to a much deteriorated zone of approximately 50 centimetres thickness behind the outer leaf. Deeper in the wall, the masonry is less deteriorated and shows better cohesion (lower resistivity values).

The masonry that visually look the worst (zone of the defence platform), show lower resistivities on the tomography (i.e. better cohesion) compared with the adjacent masonry. An exception can be observed at borehole 2, where a more deteriorated zone is seen on the tomography. This zone was verified by the endoscope. Borehole 3 confirmed the overall better state of the masonry. The explanation for the fact that the bad looking masonry from the outside is less deteriorated and has a better cohesion than the good looking masonry is the following. At this place there was a defence platform witch protected the now exposed masonry for centuries for deterioration. Around the tower, evidence of foundations of three of these defence platforms were discovered by archaeological surveys conducted in the eighties of the past century. When these platforms were removed is not clear until the present day (Oost and Geyskens 1982).

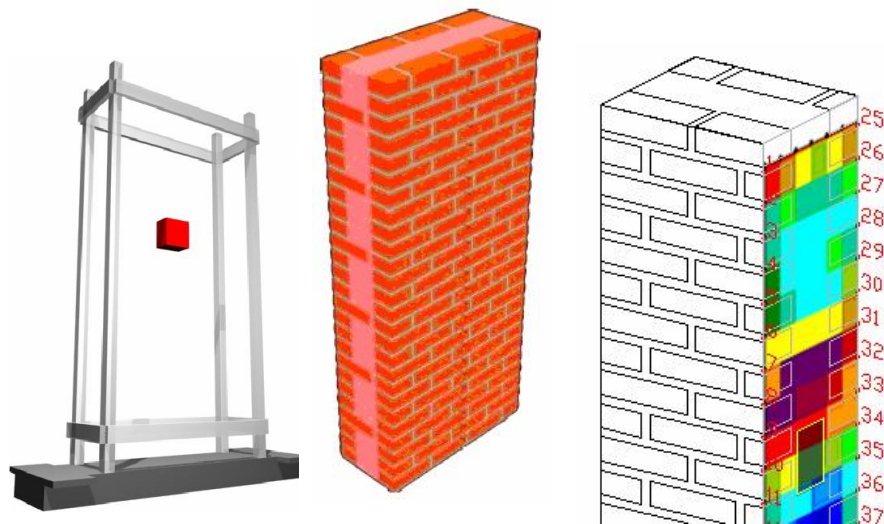
Figure 5: Left: position of insulation as a simulation of a void
Middle: position of the electrodes

Right: inversion result of the cross-borehole survey, with the high resistivity at location of insulation block

Geo-electrical tomographies, as described above, have the disadvantage that the resolution decreases with the penetration depth of the measurements. Nevertheless, very interesting conclusions can be drawn based on these tomographies as was clearly shown in the case study above. In the research project, a new technique was adapted for masonry, based on a two sided approach of the wall, whereby on both sides electrodes are placed. In geophysics this technique is referred to as “cross-borehole”. Theoretical research and numerical simulations showed that this approach leads to a constant resolution over the depth of the wall (Bernaerts and Moens, 2006; Stroobant and Verkest, 2007). Figure 5 shows the result of a successful cross-borehole measurement, without going into the technical aspects. A replica of a three leaf masonry wall was built in the laboratory, containing a piece of insulation simulating a void in the wall. The inversion result (Figure 5 Right) clearly shows that the insulation is detected as a high resistivity within the graphical representation of the resistivity distribution.

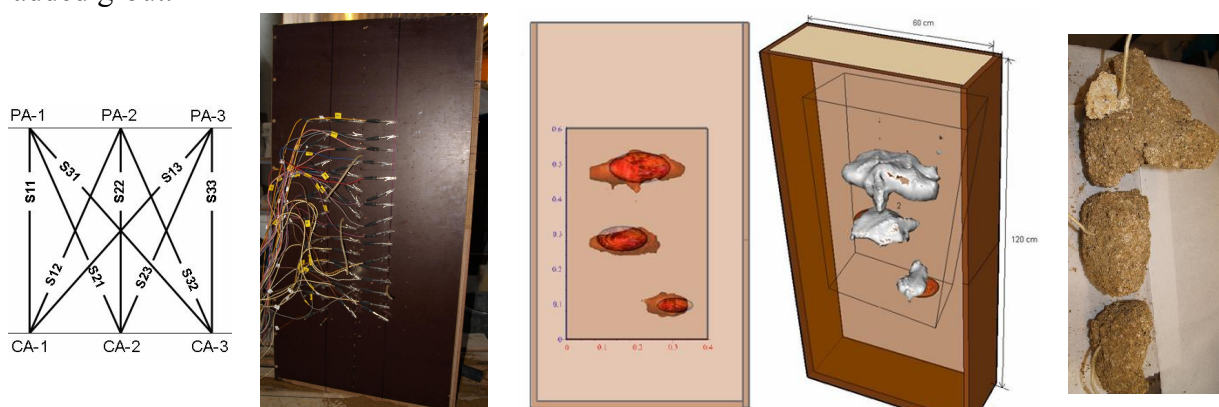
Figure 6: Left: 9 cross borehole tomographies used to construct a 3D image of the inversion
 Middle left: 3×16 current electrodes, the potential electrodes (3×16) at the backside
 Middle: position of the volumes of gravel to be injected and the result of the inversion
 Middle right: 3D-inversion result at the end of the injection
 Right: injected volumes, excavated after hardening of the grout

Likewise, on the backside of the wall 3 parallel rows of potential electrodes are placed and connected to the data logger. This is called the passive side and here the response of the injected currents is measured. In this way it is possible to measure 9 cross borehole tomographies in 90 to 120 seconds (see Figure 6: Left). After inversion the nine 2D-images are combined to a 3D-image of the resistivity distribution (Stroobant and Verkest, 2007).

A laboratory test was built in order to test new procedures for on-line follow up of grout injections. Three zones with high resistivity (representing deteriorated, little cohesive masonry) were placed in a volume of sand. This was done by inserting three volumes of tennis court gravel (different sizes) in the sand volume (Figure 6: Middle). Gravel consists of crushed bricks, an easily injectable material. A reference measurement was made before injection started. Then every gravel volume was gradually injected with hydraulic grout. Simultaneously, the set of 9 cross borehole tomographies was measured every two minutes.

Drawing of the relative difference charts, witch gives graphic representation of the difference in resistivity between two subsequent 3D-tomographies, clearly shows the gradual filling of the different gravel volumes. Beneficial hereby is the good electrical conductivity of the grout, which leads to local resistivity drops in contrast with the former high resistivity of the gravel, giving an excellent condition to detect the injected area on a relative difference chart. Figure 6 (Middle right) gives the 3D relative difference chart between the last measurement (at the end of the injection of the three volumes) and the reference measurement before injection. Notice the clearly visible injected zones in the image. The three volumes were excavated after hardening of the grout (Figure 6: Right). A good correlation between these volumes and the inversion result was observed.
