THE IMPLICATIONS OF THE MAY 27TH 2006 JAVA EARTHQUAKE FOR MASONRY DESIGN AND CONSTRUCTION.

J. M. Nichols

SUMMARY

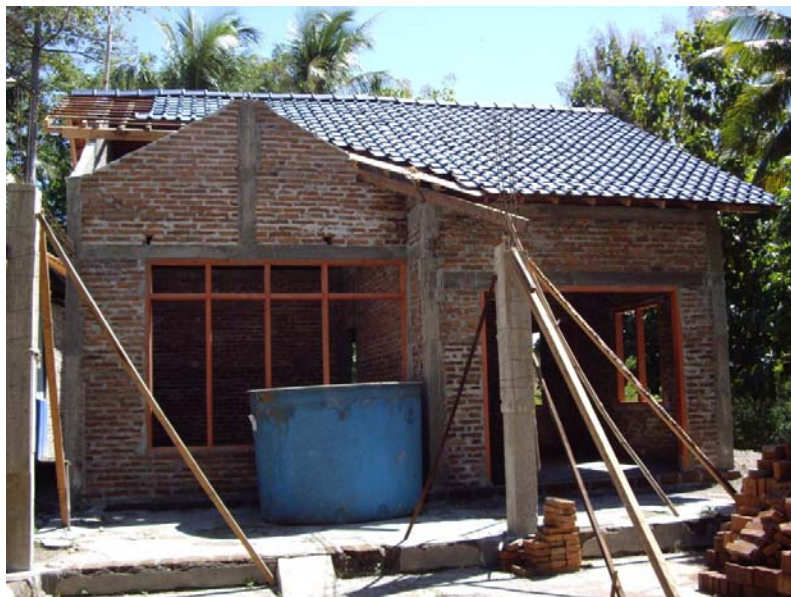
The Geological Engineering Department of the Gadjah Mada University issued the first major English language report on the 2006 earthquake (Karnawati, Pramumijoyo and Husein, 2007). This report presents initial reports on the earthquake including the geology, building issues and health issues. The critical issue for understanding the fatality count in this event is the form of housing used in the region. Figure 2 shows a typical house construction procedure observed by the author in the region south of Yogyakarta, near to the epicenter of the earthquake.

Figure 2. Typical Single Storey Dwelling under construction in Java (Nichols, 2007).

The village of Bantel in the Kampung of Becari lies on the eastern bank of the Opek River, which is one of the main rivers draining the valley containing the Yogyakarta regional area. The village is about 30 kilometers south of Yogyakarta. The village suffered a coarse death toll of about 15% from a population of approximately 200 people. The dwelling shown in Figure 2 is one of the recent additions to the village after the earthquake.

The brick type used in this regional area appears to be a flat pressed brick of low strength. Figure 10 shows a sample of the brick used in the construction shown in Figure 2. The bricks are handled at least three times from the kiln to the field. The method of delivery is not automated at all. This handling provides one quality control measure to reduce the incidence of soft bricks.

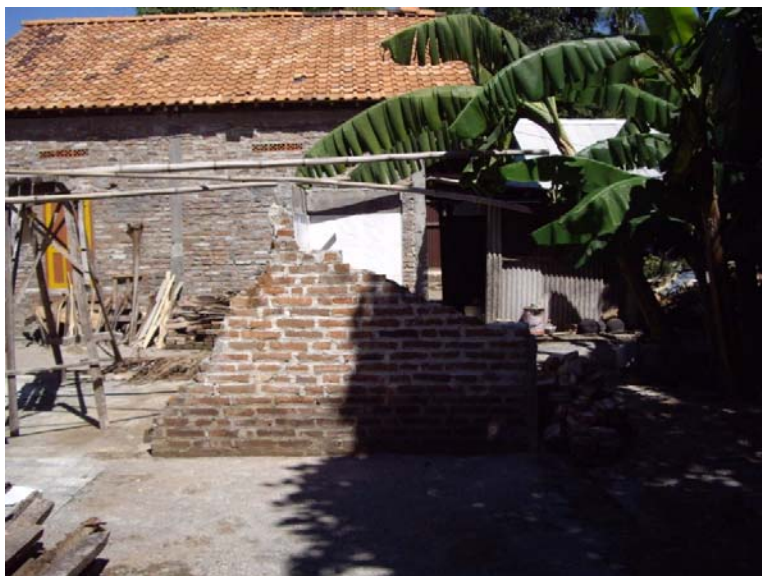
Figure 6 shows one of the remaining remnants of a damaged wall. One of the recently constructed houses can be seen in the background to the picture. A sample of the mortar from the wall was obtained for further analysis.

Figure 6. Damaged Wall Remnant from the 2006 Yogyakarta Earthquake.

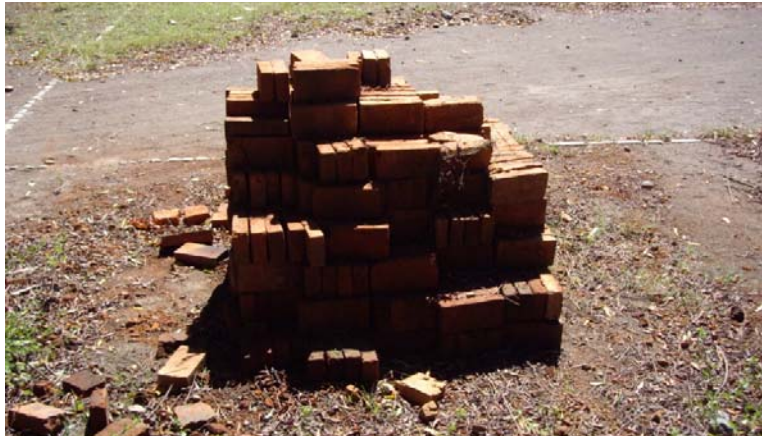
Figure 10. Brick Samples

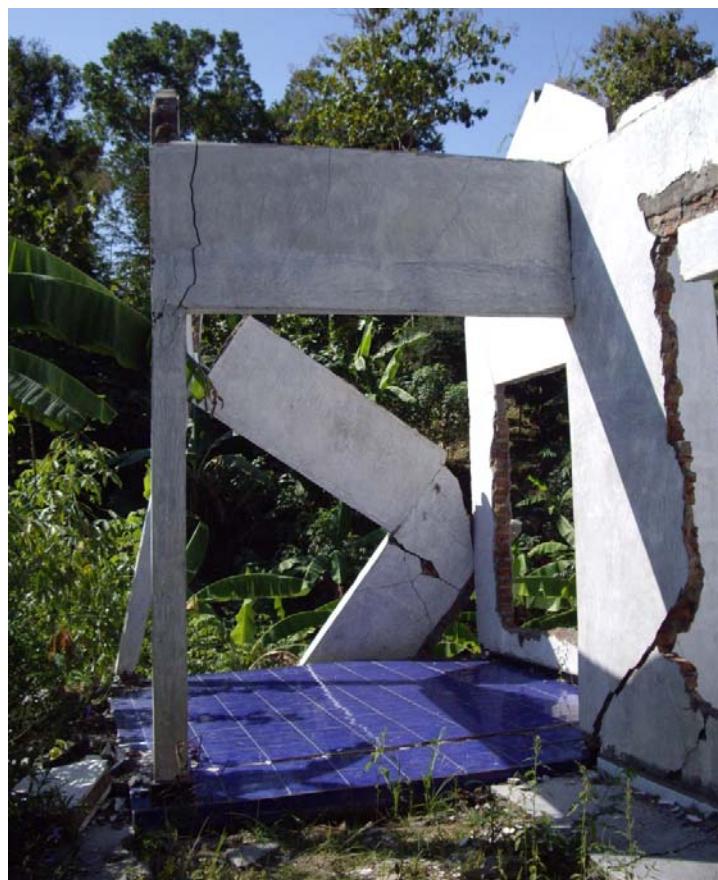
About 10 kilometres north of the village is a small valley nestled in the foothills to Mt Merapi. A landslide occurred in the valley resulting in the loss of at least three houses. Figure 11 shows one of the two remaining houses in the valley. This house sits on a small hill and the landslide passed on either side of the hill.

Figure 11. Building damaged in Landslip
